| REPORT DOCUMENTATION PAGE | | READ INSTRUCTIONS<br>BEFORE COMPLETING FORM |
|---|---|---|
| 4. TITLE (and Subtitle)<br>National Program of Inspection of Non-Federal Dams<br>Tennessee. Crystal Lake Dam (Inventory Number TN<br>06932) near Saulsbury, Tennessee, Hardeman County,<br>TN., Hatchie River Basin | | 5. TYPE OF REPORT & PERIOD COVERED<br>Phase 1 Investigation Report |

PHASE I REPORT  
NATIONAL DAM SAFETY PROGRAM  
TENNESSEE

Name of Dam ..... Crystal Lake  
County ..... Hardeman  
Stream ..... Trib. of East Fork  
                                    of Spring Creek  
Date of Inspection ..... February 23, 1981

PHASE I INSPECTION REPORT  
NATIONAL DAM SAFETY PROGRAM  
CRYSTAL LAKE DAM  
HARDEMAN COUNTY, TENNESSEE

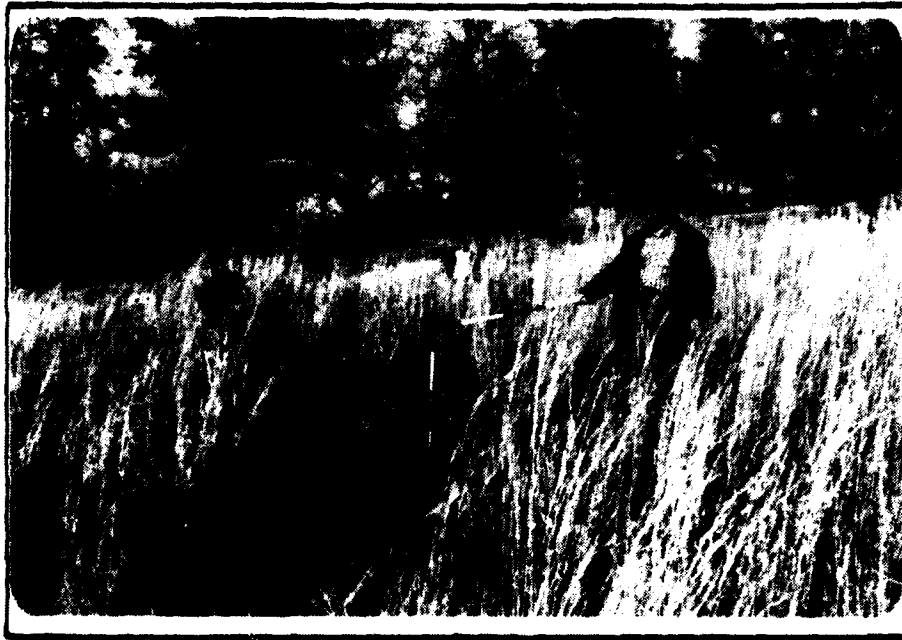
e. The seep or spring on the dam appears to be groundwater and does not appear to present any immediate hazard to the structure.

Photo Nos. 9 & 10 - A seep or spring on the right embankment abutment contact starting about one foot below the pool elevation.

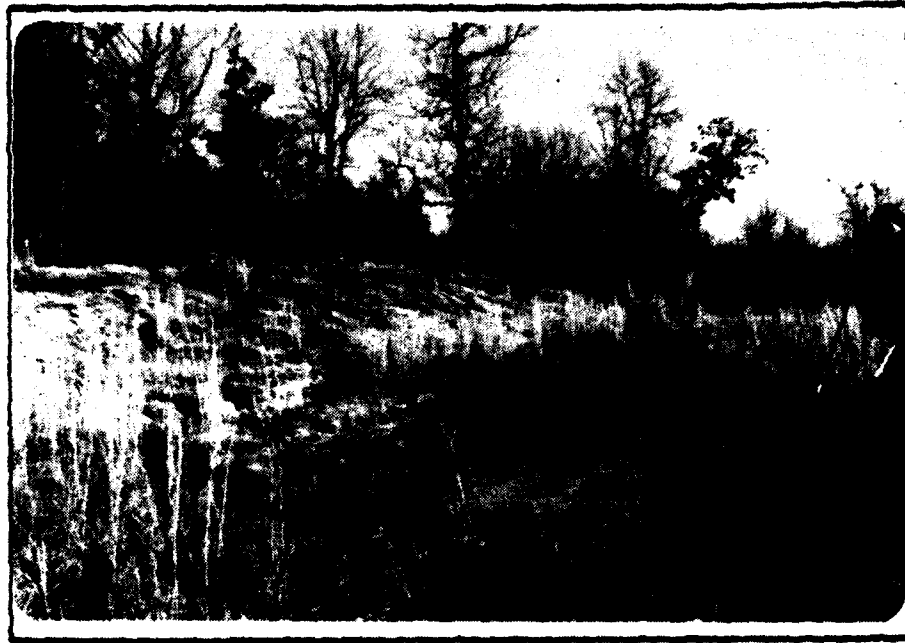
Photo Nos. 11 & 12 - The emergency spillway channel showing the sparse vegetation and excessive erosion of the side slopes.
