REPORT DOCUMENTATION PAGE		READ INSTRUCTIONS BEFORE COMPLETING FORM
1. REPORT NUMBER	2. GOVT ACCESSION NO. HD-A108250	3. RECIPIENT'S CATALOG NUMBER
4. TITLE (and Subtitle) National Program of Inspection of Non-Federal Dams, Tennessee. Chancellor & Son Dam (Inventory Number TN 06939) near Saulsbury, TN., Hardeman County, TN., Hatchie River Basin		5. TYPE OF REPORT & PERIOD COVERED Phase I Investigation Report

PHASE I INSPECTION REPORT
NATIONAL DAM SAFETY PROGRAM
TENNESSEE

Name of Dam Chancellor and Son
County Hardeman
Stream Unnamed trib. of
Spring Creek
Date of Inspection March 10, 1981

PHASE I INSPECTION REPORT
NATIONAL DAM SAFETY PROGRAM
CHANCELLOR AND SON DAM
HARDEMAN COUNTY, TENNESSEE

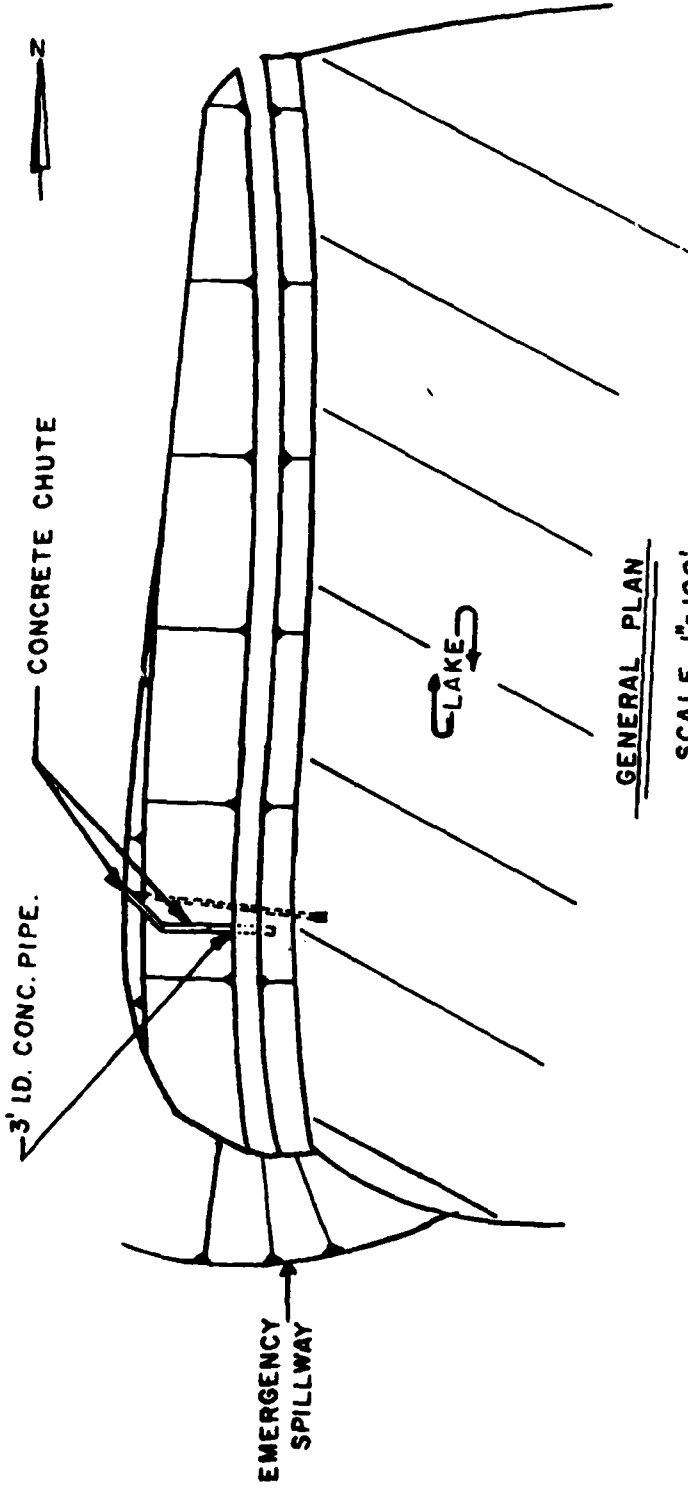
GENERAL PLAN

3.1.1 A flow of about 2-3 gpm is emerging from the area around the end of the service spillway chute and the left embankment abutment contact (photos 11-13, sketch p. 1 of 4). The owner reported that a spring was located in this area prior to construction of the dam. The water has been discolored by FeO_2 . There is no clear evidence indicating that the water is transporting embankment material due to the erosion deposits in the area from the abutments. About 1 gpm is emerging around the exterior of the toe drain outlets. No distinct sources could be pinpointed for the remainder of the flow.
