| REPORT DOCUMENTATION PAGE | | READ INSTRUCTIONS<br>BEFORE COMPLETING FORM |
|---|---|---|
| 4. TITLE (and Subtitle)<br>National Program of Inspection of Non-Federal Dams,<br>Tennessee. Lever Lake Dam (Inventory Number TN<br>18708) near Kingston Springs, Tennessee, Williams<br>County, TN., Harpeth River Basin. | | 5. TYPE OF REPORT & PERIOD COVERED<br>Phase 1 Investigation Report |

Lever Lake Dam  
Williamson County  
April 2, 1981

PHASE I INSPECTION REPORT  
NATIONAL DAM SAFETY PROGRAM  
TENNESSEE

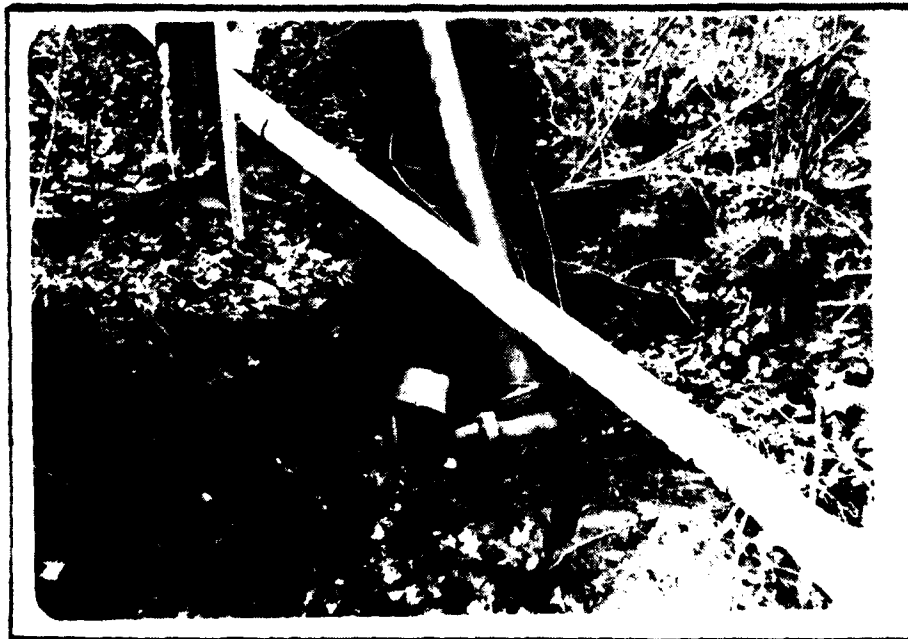
PHOTO NO. 6

The concrete culvert drawdown leaks approximately 2 gpm. Whether the flow is from a leak at the inlet or from infiltration through the culvert could not be ascertained. (See photo nos. 6 and 7)
