| REPORT DOCUMENTATION PAGE | | READ INSTRUCTIONS<br>BEFORE COMPLETING FORM |
|---|---|---|
| 4. TITLE (and Subtitle)<br><b>National Program of Inspection of Non-Federal Dams<br/>Tennessee. Akers Dam (Inventory Number TN 16503)<br/>near Turners Station, Tennessee, Sumner County, TN<br/>Barren River Basin</b> | | 5. TYPE OF REPORT & PERIOD COVERED<br><b>Phase 1 Investigation Report</b> |

PHASE I INSPECTION REPORT  
NATIONAL DAM SAFETY PROGRAM

Name of Dam ..... Akers  
County ..... Sumner  
Stream ..... Unnamed Trib. of  
Little Trammel Creek  
Date of Inspection ..... April 15, 1981

Akers Dam, Sumner County, Tennessee

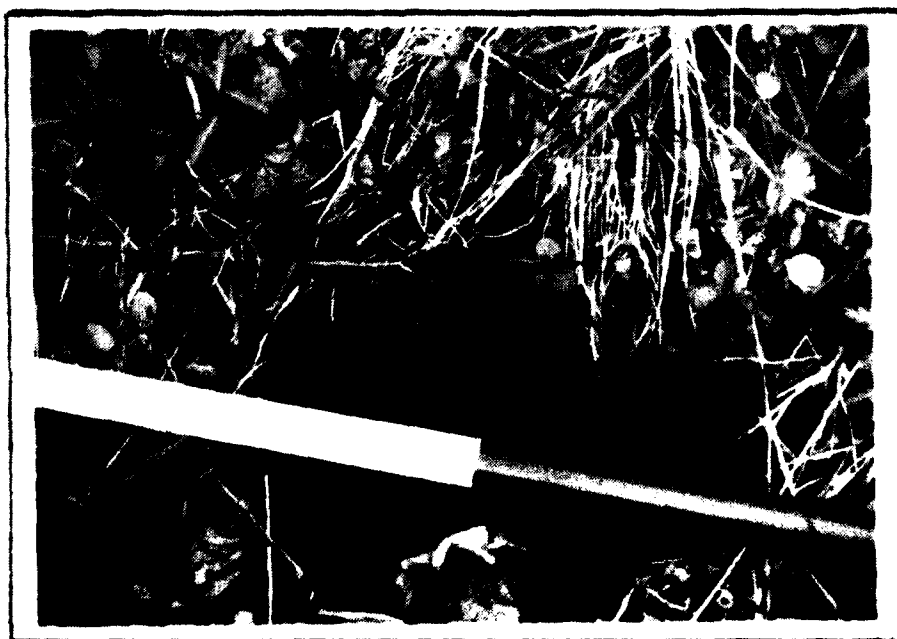
PHOTO NO.16

The downstream face has some briars, brush, and small trees but is mainly covered with deciduous trees between 2 and 8 inches in diameter (photo no. 3). No erosion of the downstream face was noted. The downstream slope flattened to a variable slope roughly halfway down the face. A large area of saturation was found along the left half of the dam and generally started at the change in slope and extended to the toe (photo nos. 11 and 12). Shallow, spotty sloughing was noted in the saturated area (photo nos. 9 and 10). A flow of 1 gpm was found roughly 30 feet from the left abutment and about 10 feet below the crest. The flow appeared clear but residual gravels from the embankment material were observed at the opening (photo nos. 13 and 14). Total flow from the saturated area was estimated to be 4 gpm (photo no. 17). Another small flow was found about 5 feet upstream from the drain valve. Flow was clear and less than  $\frac{1}{2}$  gpm (photo nos. 15 and 16). A

- Photo No. 16 - Close up of small flow
- Photo No. 17 - Cumulative flow from seepage area.
- Photo No. 18 - Stream channel from culvert at Old Hwy 31.
