PHASE I INSPECTION REPORT
NATIONAL DAM SAFETY PROGRAM
TENNESSEE

Name of Dam Mary's Creek Watershed Dam No. 9
County Shelby
Stream Unnamed Tributary of Mary's Creek
Date of Inspection March 11, 1981

Mary's Creek Watershed Dam No. 9
Shelby County
March 27, 1981

PHASE I INSPECTION REPORT
NATIONAL DAM SAFETY PROGRAM

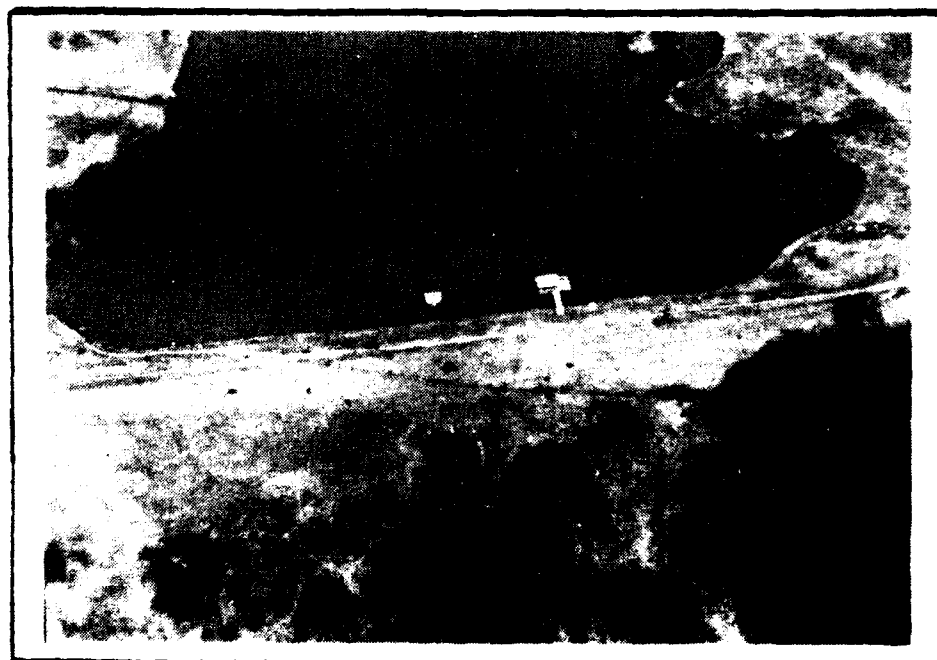
PHOTO NO . 12

- Photo No. 1 - Lake and dam from upstream left.
- Photo No. 2 - Upstream slope of dam left of center.
- Photo No. 3 - Upstream slope from right end of dam.
- Photo No. 4 - Downstream slope of dam from emergency spillway exit channel.
- Photo No. 5 - Minor erosion along upstream slope of dam right of center.
- Photo No. 6 - Riser from dam crest.
- Photo No. 7 - Emergency spillway entrance channel from dam centerline.
- Photo No. 8 - Principal spillway outlet.
- Photo No. 9 - Downstream channel and plunge pool.
- Photo No. 10 - Dam crest showing location of soil sample hole and emergency spillway in background.
- Photo No. 11 - Aerial view of lake and dam showing small upstream lake.
- Photo No. 12 - Aerial view of dam showing cattle on embankment.

3) control cattle grazing to minimize damage to the embankment.
