PHASE I REPORT
NATIONAL DAM SAFETY PROGRAM
TENNESSEE

Name of Dam Construction Products Dam
County Madison
Stream Tributary - Dyer Creek
Date of Inspection February 5, 1981

This report is based on the findings of a Phase I investigation of Construction Products Dam on February 5, 1981. This study was done in accordance with "Recommended Guidelines for Safety Inspection of Dams", Department of the Army, Office of the Chief of Engineers.

PHASE I INSPECTION REPORT
NATIONAL DAM SAFETY PROGRAM
CONSTRUCTION PRODUCTS DAM
MADISON COUNTY, TENNESSEE

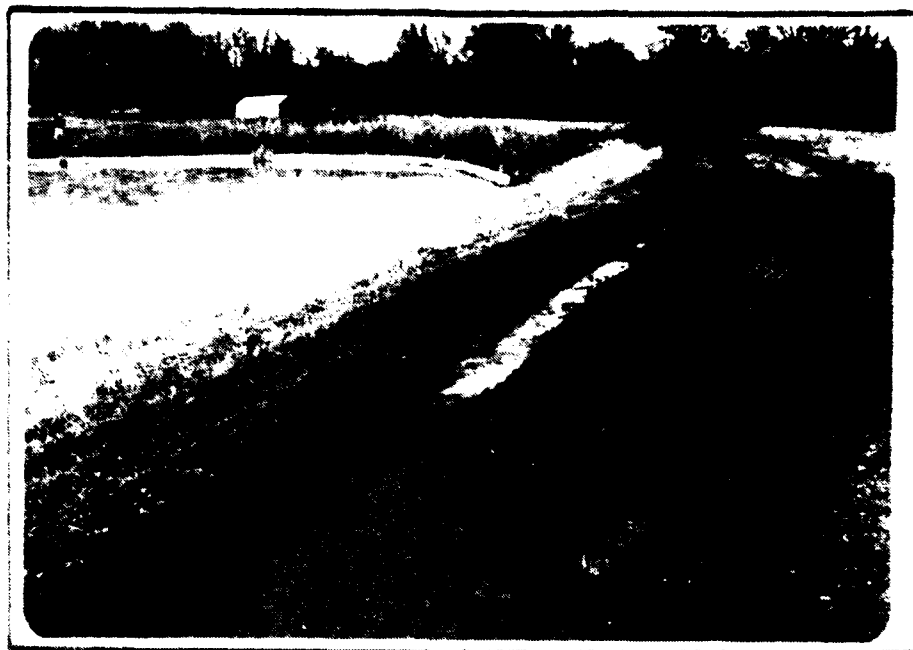
PHOTO NO. 3

The crest of the dam has deep gullies caused by vehicular traffic (photo no. 3). There is no erosion protection except for a small amount of gravel at the south (left) end (photo no. 4).

3.5.1 Conclusions - Based on visual evidence and engineering judgment, the dam is considered to be structurally stable. The slopes are moderate and there was no evidence of cracks, slides, differential settlement, serious erosion, or uncontrolled seepage. Vegetation and wave protection on the slopes are adequate. A hard protective surface is needed on the crest to prevent erosion.

- 1) Provide additional storage and/or spillway capacity to allow the dam to safely pass the recommended $\frac{1}{4}$ PMF.
- 2) Provide a protective surface on the crest to accommodate vehicular traffic. (An asphalt roadway was observed on 5/4/81.)
- 3) Establish a program for general maintenance and regular inspection.
- 4) An emergency action plan should be established to alert downstream residents in case a major problem develops with the project.

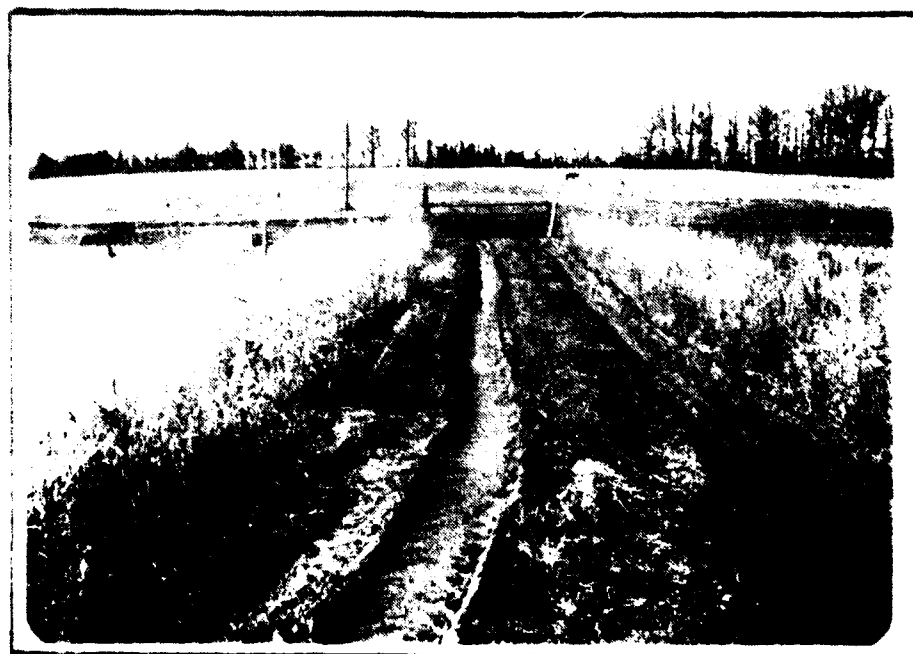
PHOTO NO. 4

- Photo No. 4 - Erosion of the crest at the left end caused by vehicular traffic.
- Photo No. 5 - View of a concrete wave wall along the upstream slope at the left portion of the embankment.

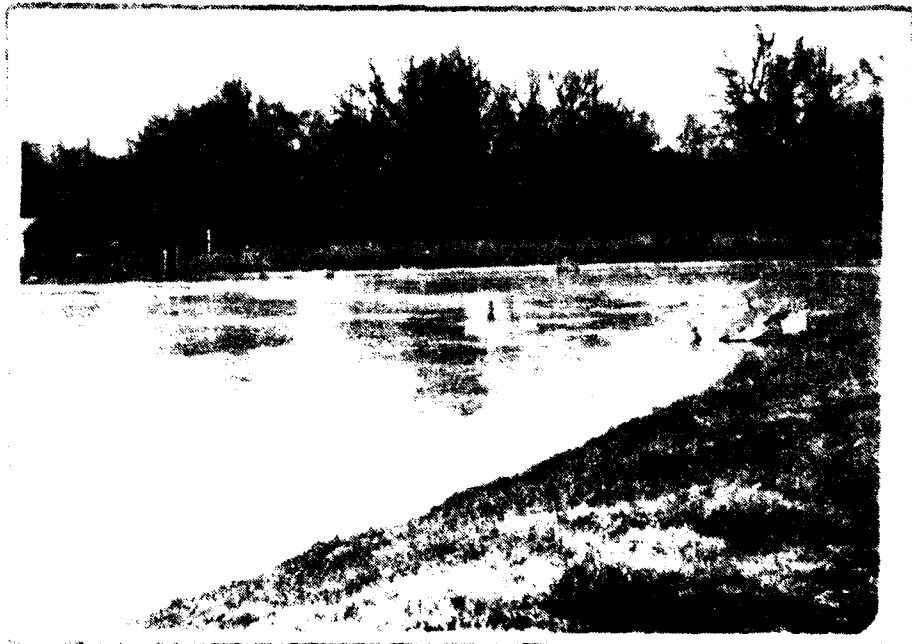
PHOTO NO 10

2.4.3 Drawdown Facilities - A manually operated slide headgate of unknown size is located at the bottom of the upstream side of the riser. The operating stem is bolted to the riser and extends above the water surface (photo no. 10).

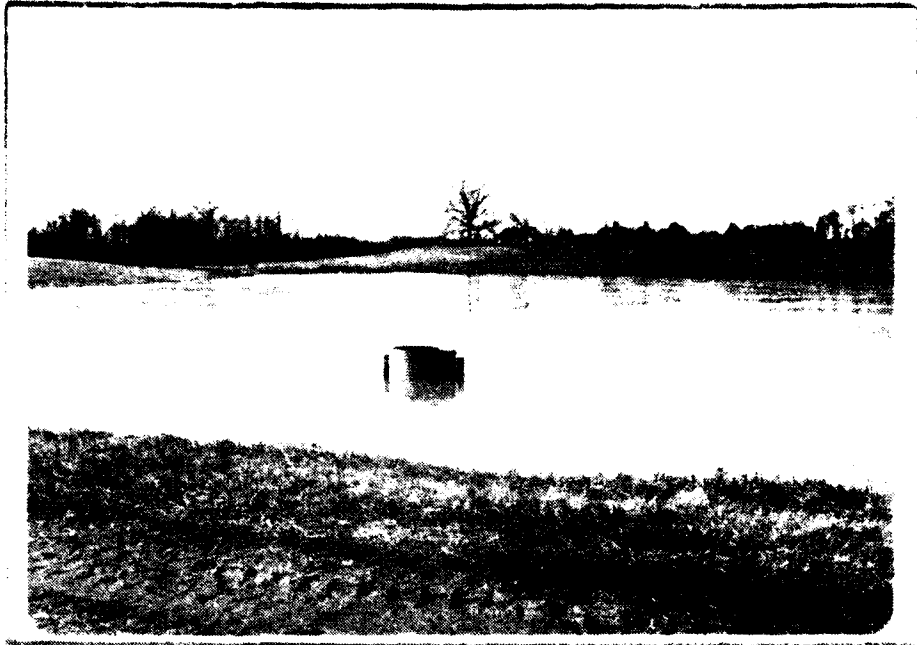
PHOTO NO 11

2.4.2 Principal Spillway - The principal spillway consists of a 36 inch CMP riser enclosed in a 48 inch CMP anti-vortex baffle (photo no. 11). The outlet pipe is a 30 inch CMP (elevation 373.2), approximately 115 feet in length (photo no. 12). The pipe reportedly has anti-seep collars. It empties into a small earthen stilling basin that partially submerges the pipe. The outlet channel runs along the toe of the right embankment section.

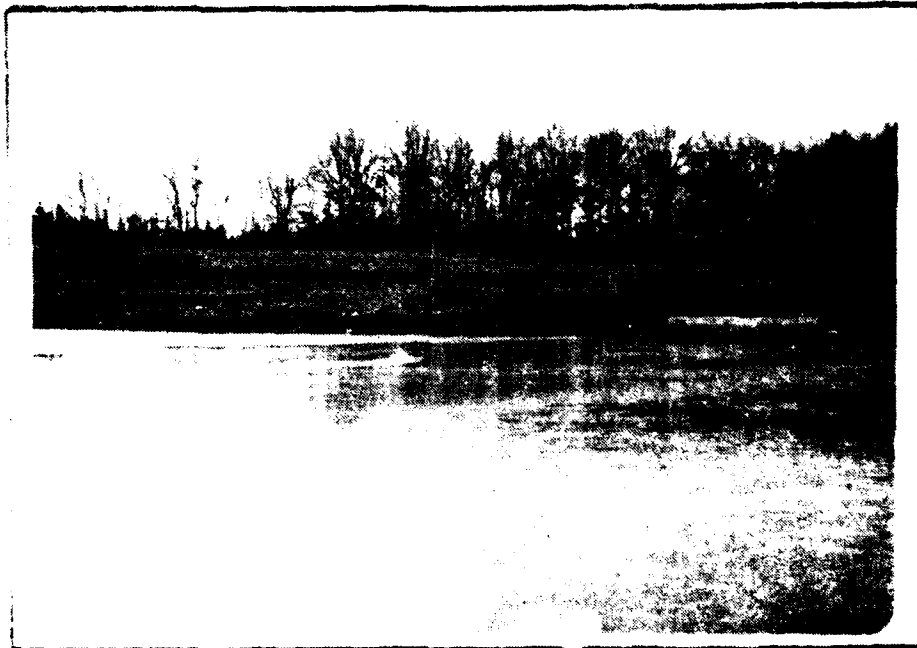
PHOTO NO . 14

2.4.4 Emergency Spillway - The emergency spillway is an unlined earth channel at the left abutment (elevation 386.4). The channel is very shallow and approximately trapezoidal in shape (Sheet 3 of 5, Appendix B). Downstream of the dam, the channel becomes less defined and enters a wide flat pasture (photo nos. 14, 15, & 16).

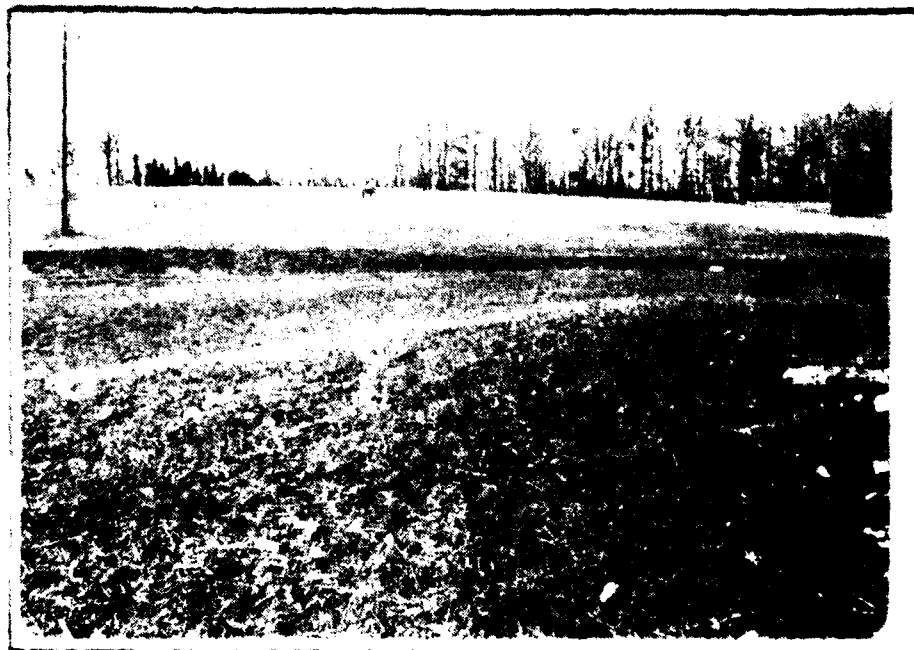
PHOTO NO . 16

- Photo No. 16 - View of the emergency spillway entrance channel.
- Photo No. 17 - View of storage and maintenance facilities located downstream of the dam.

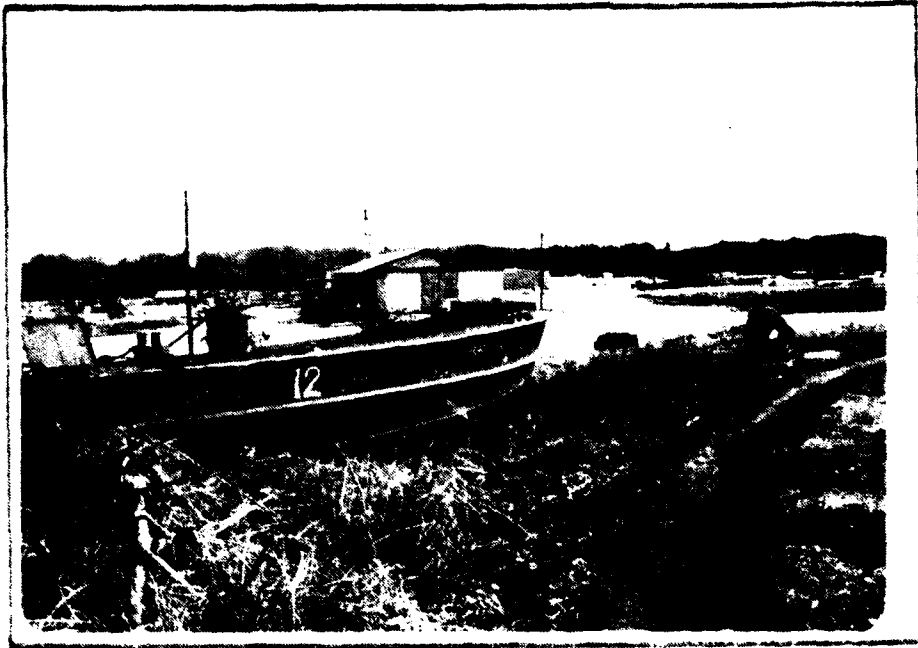
PHOTO NO. 17

The dam is classified in the high hazard potential category due to the downstream presence of several storage, maintenance, and manufacturing buildings owned and operated by Construction Products, Inc. (photo nos. 17 & 18).

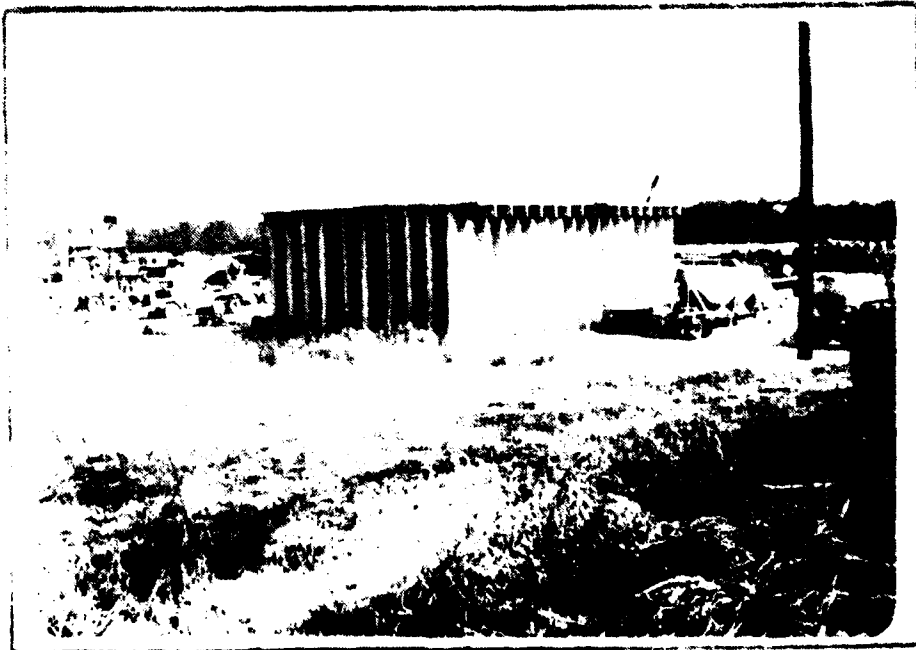
PHOTO NO. 18

- Photo No. 18 - View of plant facilities located directly below the dam.
