REPORT DOCUMENTATION PAGE		READ INSTRUCTIONS BEFORE COMPLETING FORM
1. REPORT NUMBER	2. GOVT ACCESSION NO. AD-A108465	3. RECIPIENT'S CATALOG NUMBER
4. TITLE (and Subtitle) National Program of Inspection of Non-Federal Dams, Tennessee. Cumberland Springs Lake Dam (Inventory Number TN 12701) near Lynchburg, TN., Moore County, TN., Elk River Basin		5. TYPE OF REPORT & PERIOD COVERED Phase 1 Investigation Report

20. ABSTRACT (Continue on reverse side if necessary and identify by block number) Cumberland Springs Dam has an 8.3 acre lake and is located near the head of Hurricane Creek in Moore County, Tennessee. The concrete gravity structure has a maximum constructed height of 33 feet and a length of 192 feet, including a 36 foot long ogee spillway. The spillway section also includes a drawdown pipe that is gated on the upstream face. The concrete dam is reinforced with six buttresses on the downstream face. The exposed surfaces of the buttresses are badly weathered with horizontal cracks 6 inches deep on the vertical faces. A horizontal crack was observed on the downstream face of the dam approximately

PHASE I INSPECTION
CUMBERLAND SPRINGS DAM
MOORE COUNTY, TENNESSEE

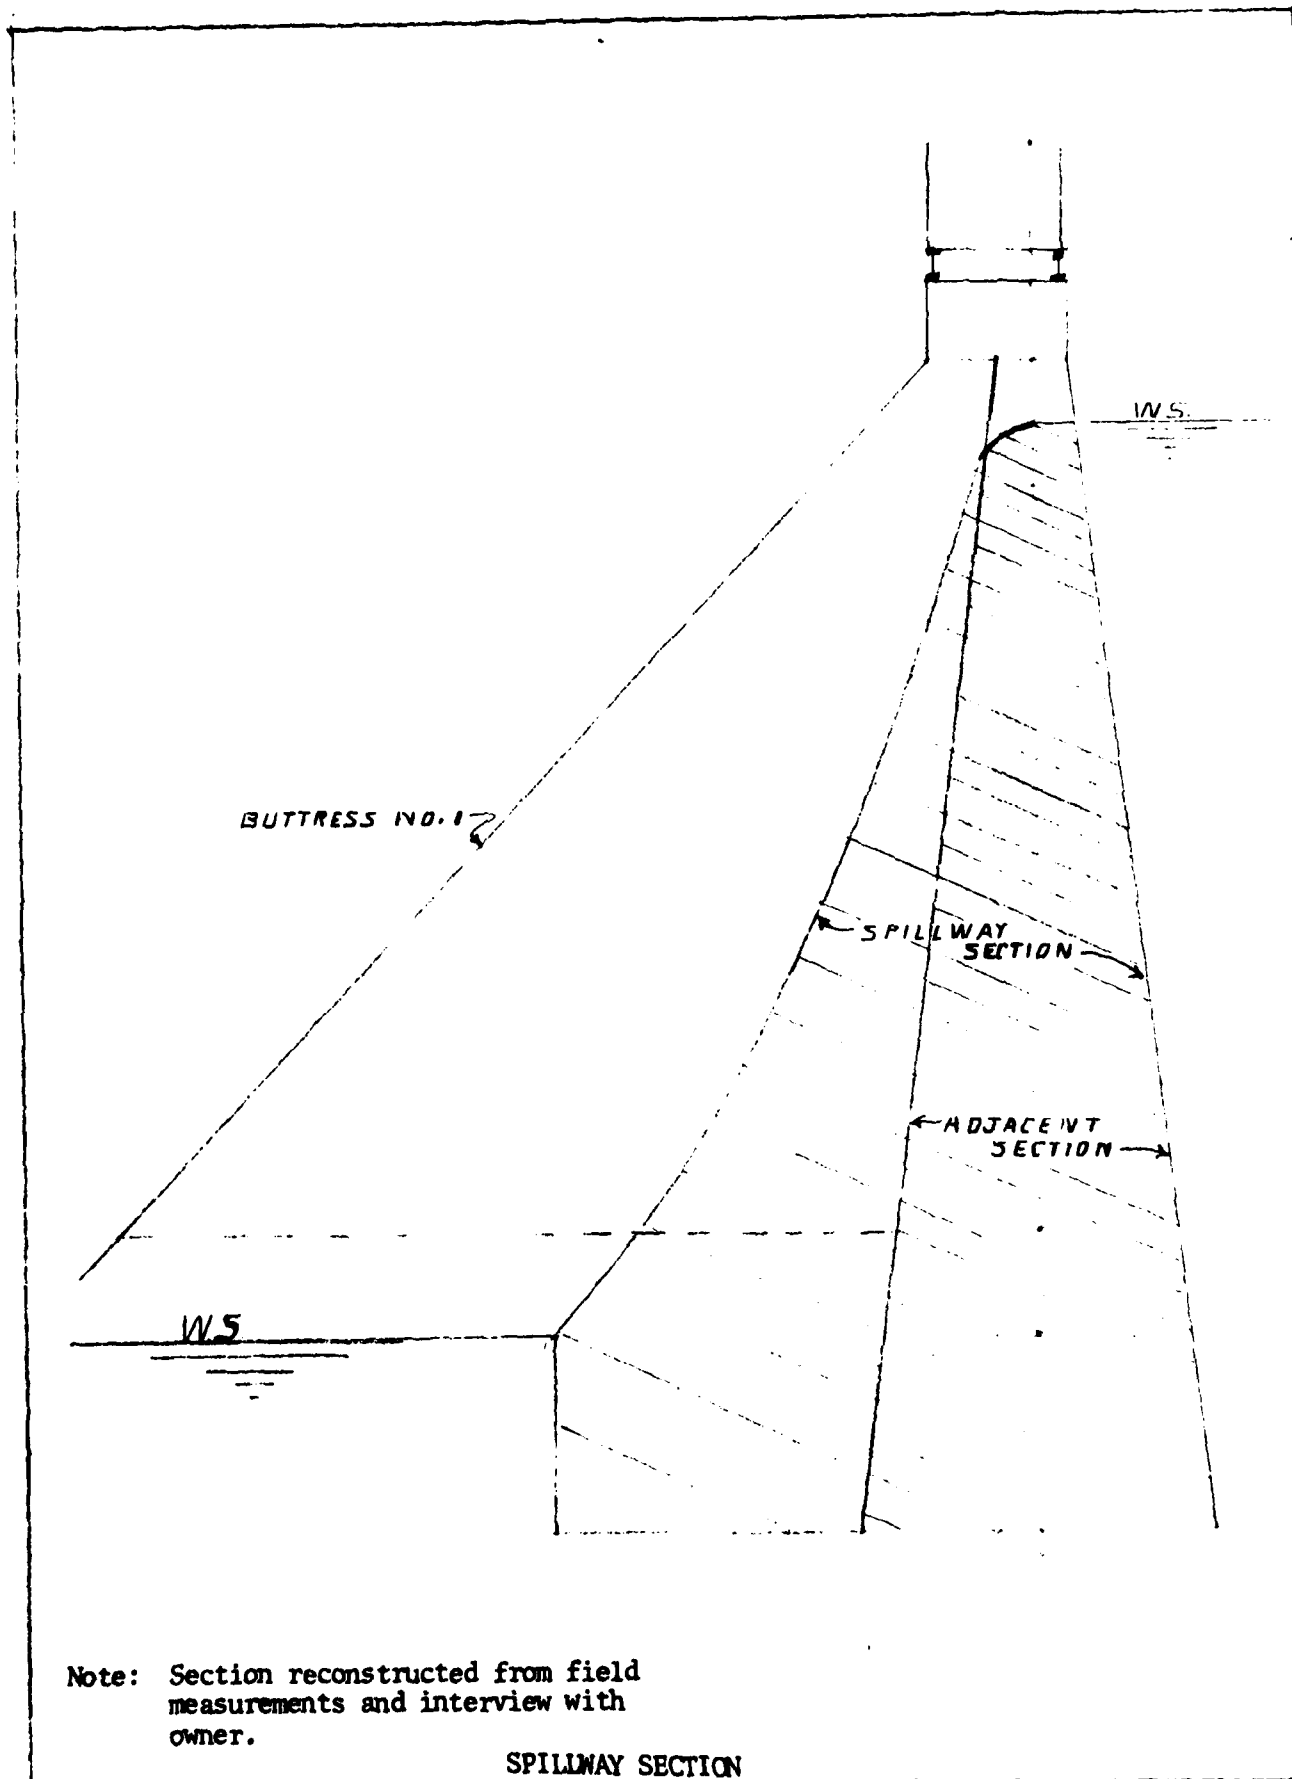
SPILLWAY SECTION

Note: Section reconstructed from field measurements and interview with owner.

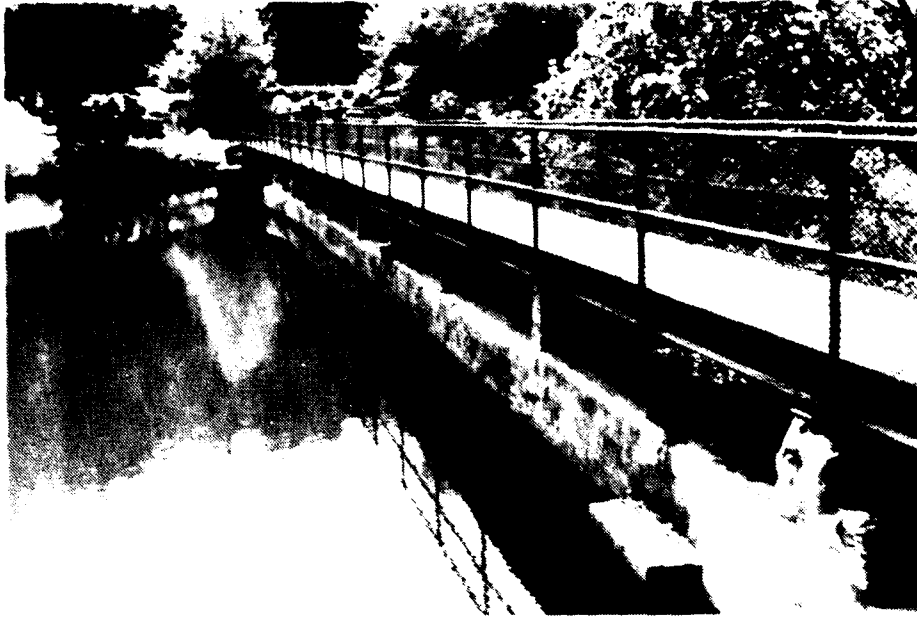
1. Top of dam and upstream face. From west abutment.

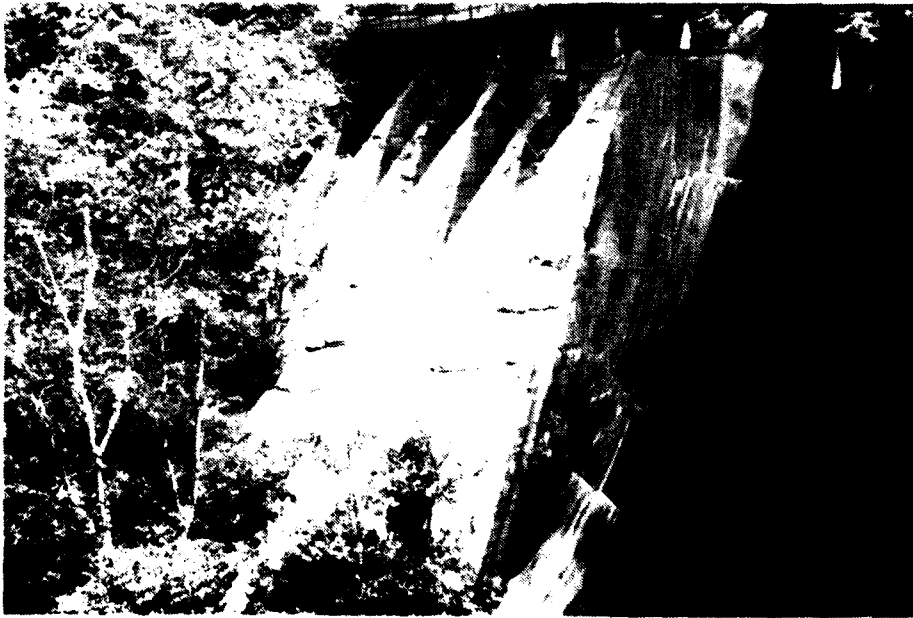
2. Downstream face of Cumberland Springs Dam. Note erosion of buttresses.

The downstream side of the dam has cracks as much as 6 inches deep. A horizontal surface crack extending practically the length of the dam is believed to be a cold joint. This crack or cold joint is approximately 10 feet above the foundation sill, and has opened as much as 6 to 8 inches in depth.

For the purpose of this report the buttresses are numbered 1 through 6 with Buttress No. 1 on the southeast side. Buttress No. 1 is the largest buttress and is approximately 5 feet in width and extends outward 25 feet the other 5 buttresses vary from 2 to 3 feet in width and extend out in varying lengths from 20 feet to 15 feet. In the bays between buttresses no. 1-2 and 2-3, there are seeps along the foundation sill of the dam. These seeps are red in color and have an oily sheen.

RECOMMENDATIONS. It is recommended that the leak in the east end wall be stopped. The undermined foundations of the buttresses should be repaired and protection should be provided to prevent future undermining of the buttresses. Open construction joints and the weather surface of the abutments should be

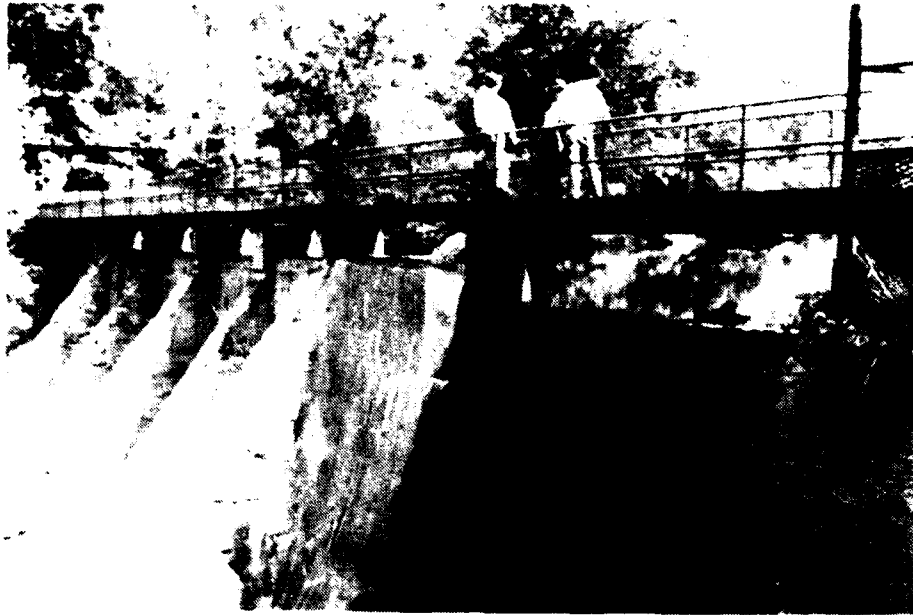
3. Emergency spillway section at top of Cumberland Springs Dam. Note drawdown gate hoist on upstream face of dam and at center of spillway.

It is also recommended that the owner should maintain the draw-down gate so that it remains operable.
