| REPORT DOCUMENTATION PAGE | | READ INSTRUCTIONS<br>BEFORE COMPLETING FORM |
|---|---|---|
| 4. TITLE (and Subtitle) National Program of Inspection of Non-Federal Dams, TN. Spring Lake Dam (Candlewood II) Old Hickory Dam (Candlewood III) (Inventory Number TN 06930) (Inventory Number TN06926) near Saulsbury, Tennessee, Hardeman County, TN, Hatchie River Basin | | 5. TYPE OF REPORT & PERIOD COVERED<br>Phase 1 Investigation Report |

Based upon the inspection and subsequent evaluation, Spring Lake and Old Hickory Dams are classified as deficient due to minor erosion that is occurring on the embankments and in the emergency spillways, and some seepage present on the downstream toes of the dams.

PHASE I INSPECTION REPORT  
NATIONAL DAM SAFETY PROGRAM

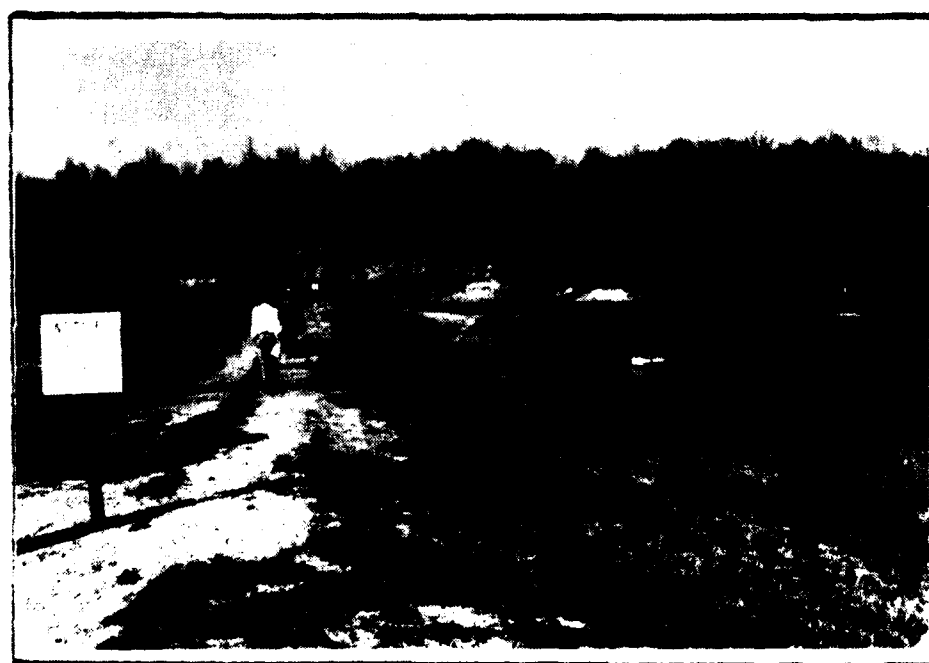
PHOTO NO.2

3.1.1 Embankment - The upstream slope of the dam is in good condition with a fair covering of grass. A berm at the water surface is the only wave protection and some minor sloughing has occurred (photo no. 2). The crest has almost no cover but appears to be in good condition. Vehicular traffic has been restricted from the crest. The downstream slope is eroding and in some areas the erosion is becoming significant. Jug holes indicative of dispersive soils were found in some areas (photo nos. 4-8). Minor erosion is also occurring along the embankment abutment contacts (photo nos. 19 & 20). A hand auger sample of the embankment material is a clayey sand of group SC in the Unified Classification System.

2) Repair the erosion on the embankments and in the spillways. All areas should be stabilized by a soil binding grass cover.

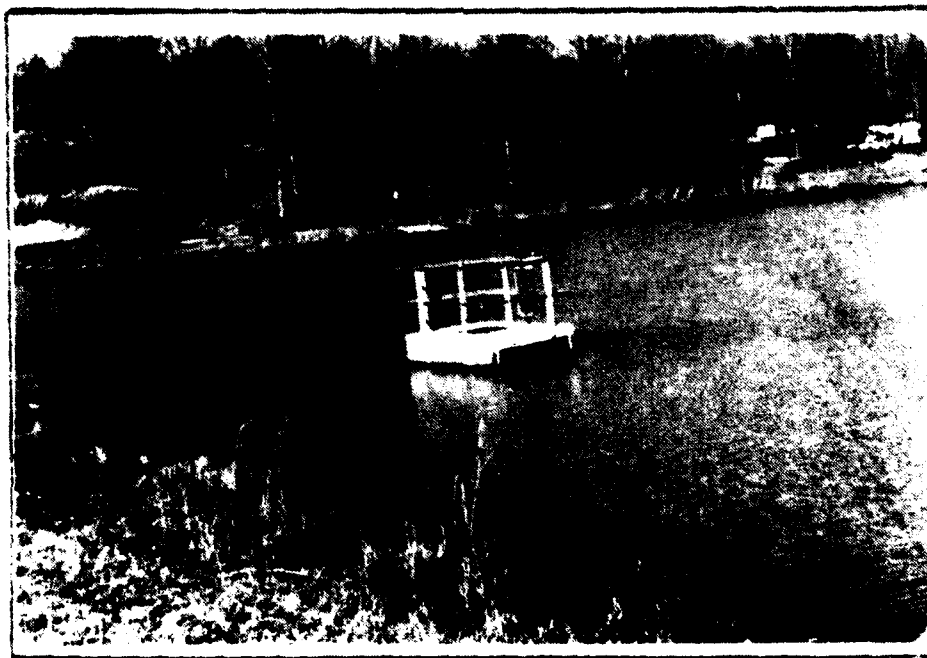
PHOTO NO. 10

3.1.2 Service Spillway - A thorough inspection of the service spillway system could not be made but the visible portions of the spillway appeared in generally good condition. A few cracked spots were found on the outlet of the pipe. A small depression was found in the fill above the pipe near the toe of the embankment. It could not be determined if the depression was related to the spillway (photo nos. 9-11).

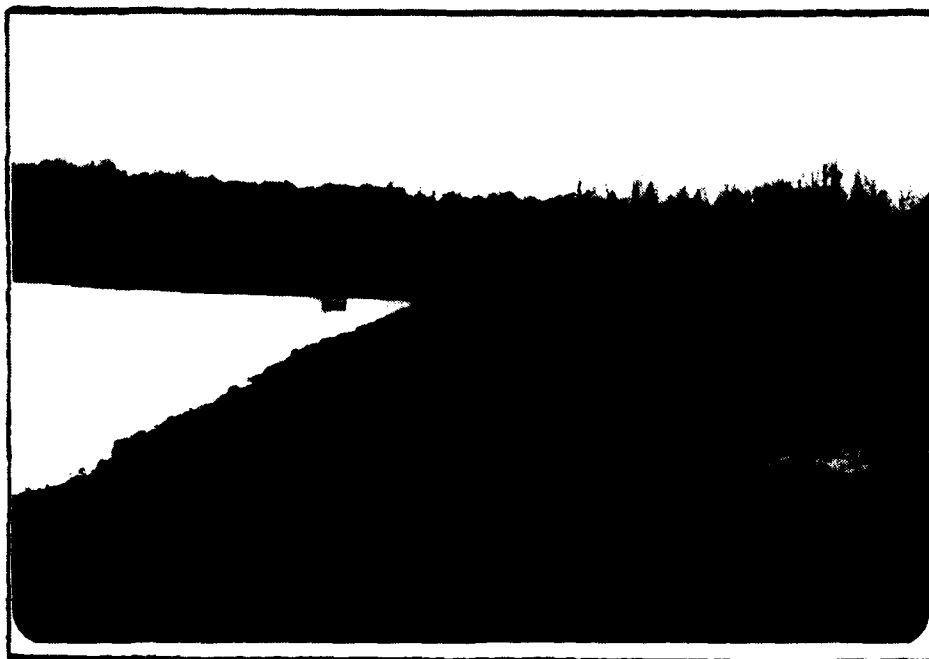
PHOTO NO .24

3.2.1 Embankment - The upstream slope is in generally good condition. Minor erosion is occurring along the water surface. One small jug hole was found near the right end of the dam on the upstream slope. The grass cover of the upstream slope is moderate to poor. The crest has almost no cover. Several small depressions, about 2 feet in diameter and 6 inches deep, were located on the downstream edge of the crest (photo no. 24).

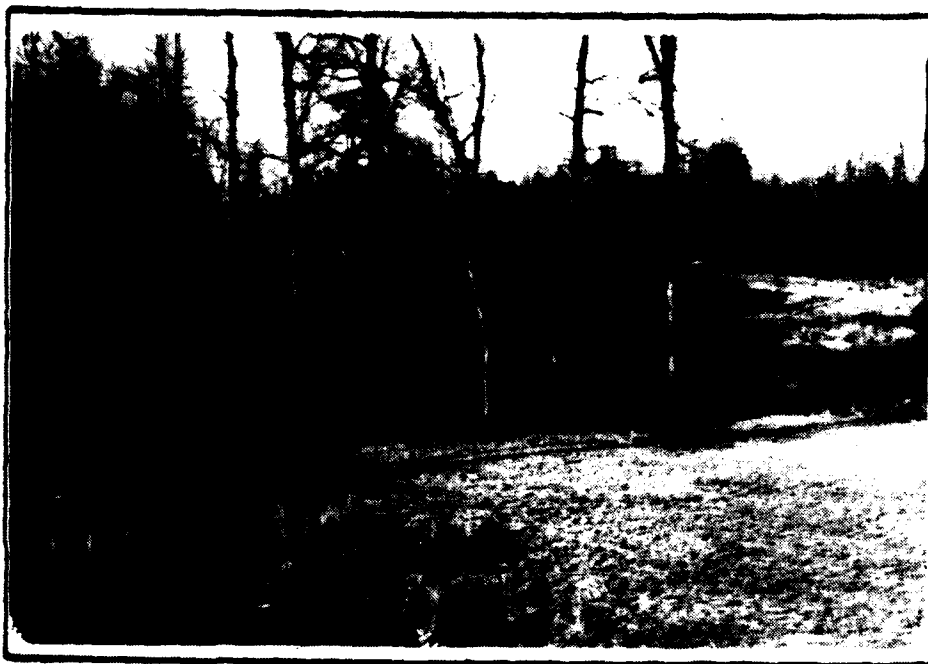
PHOTO NO.33

3.2.5 Downstream Channel - The downstream channel appeared to be in good condition with no accumulated debris or obstructions (photo no. 33).

Photo No. 33 - The downstream area from the toe of the dam.

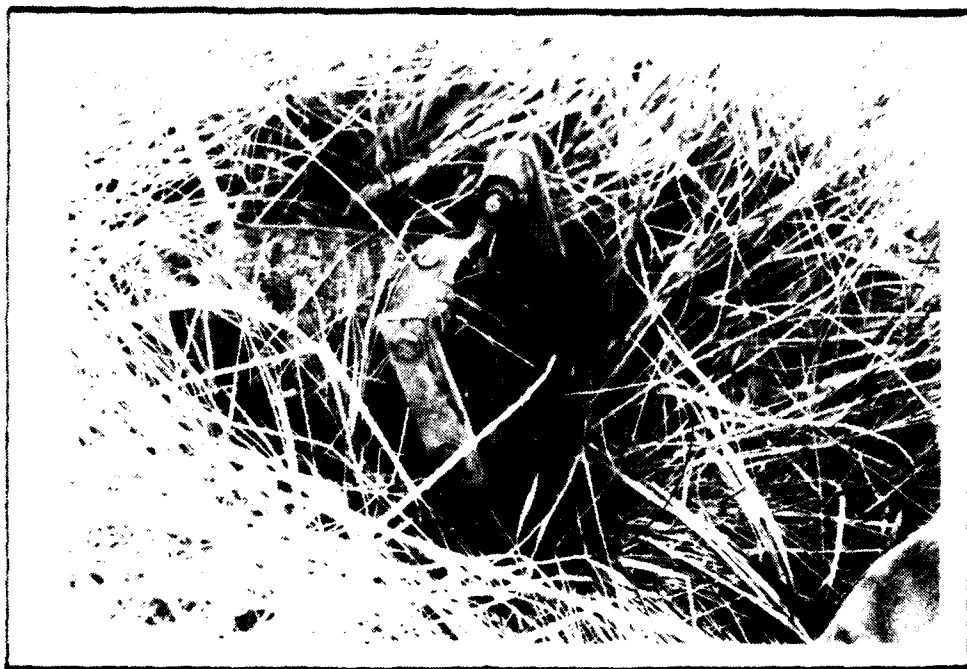
The entrance channel of the emergency spillway has a large erosion gully and a moderately large gully runs down the left D/S embankment abutment contact area. These areas should be repaired and reseeded. Two possible wet areas were observed along the toe near each abutment. There is no wet area vegetation. These areas should be reinspected in dryer weather. Water has backed up behind the flap gates on the toe drains. According to information provided by Jerry Shide of Armco, there should be no back up of water behind the flap gate (Model 10-C). The gate and the area immediately in front of the gate should be cleared of any obstructions to the correct operation of the gate. This report is accompanied by photos.

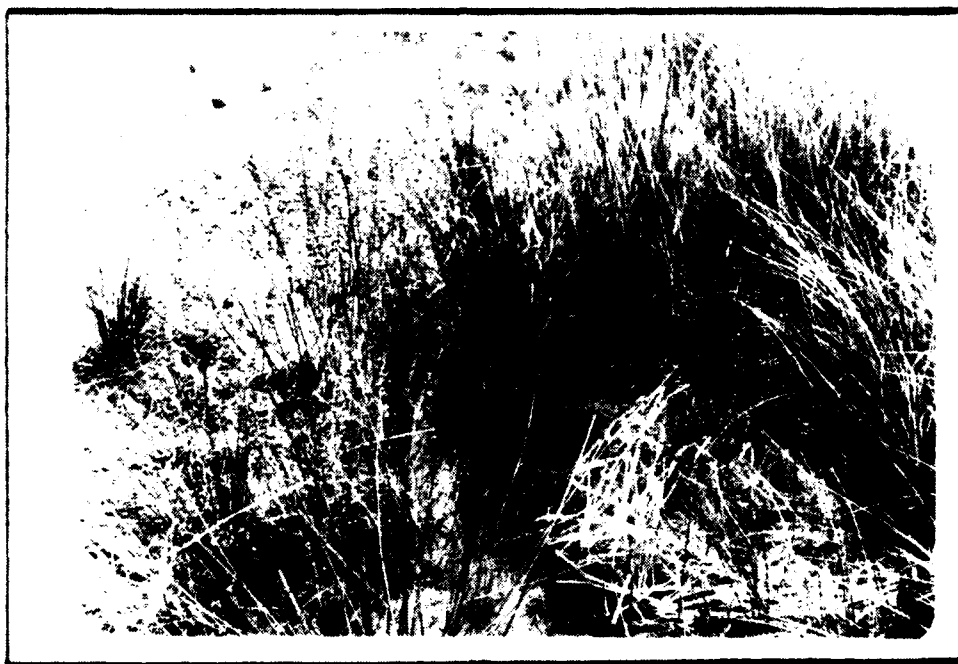
PHOTO NO. 1

An area of wetland vegetation and a small flow of water were located on the right downstream embankment toe. The flow did not appear to be carrying any material and is reportedly coming from a spring. The area should be monitored for any change in flow rate or turbidity. There is some minor erosion on the slopes. This should be stopped before it becomes worse. This report is accompanied by a photo.
