<table><tr> <td><b>Dams</b></td> <td><b>Sumner County, TN</b></td> </tr><tr> <td><b>Portland City Lake Dam, TN</b></td> <td><b>Structural Analysis</b></td> </tr></table>

Furnished herewith is the Phase I Investigation Report on Portland City Lake Dam near Portland, Tennessee. The report was prepared under the authority and provisions of PL 92-367, the National Dam Inspection Act, dated 8 August 1972.

PHASE I INSPECTION  
PORTLAND CITY LAKE DAM  
SUMNER COUNTY, TENNESSEE

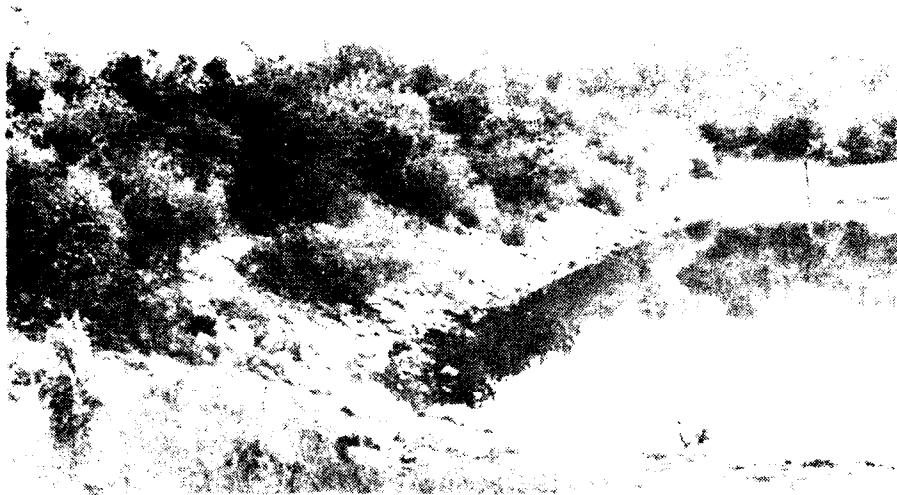
3. Upstream slope of Portland City Lake Dam. Note undesirable vegetation on slope.

- a. Plan and supervise the removal of all trees and underbrush from both slopes of the dam.
- b. Determine if unsafe conditions exist on both slopes of the embankment after removal of the trees and underbrush and design and supervise construction of remedial measures to provide a safe embankment.

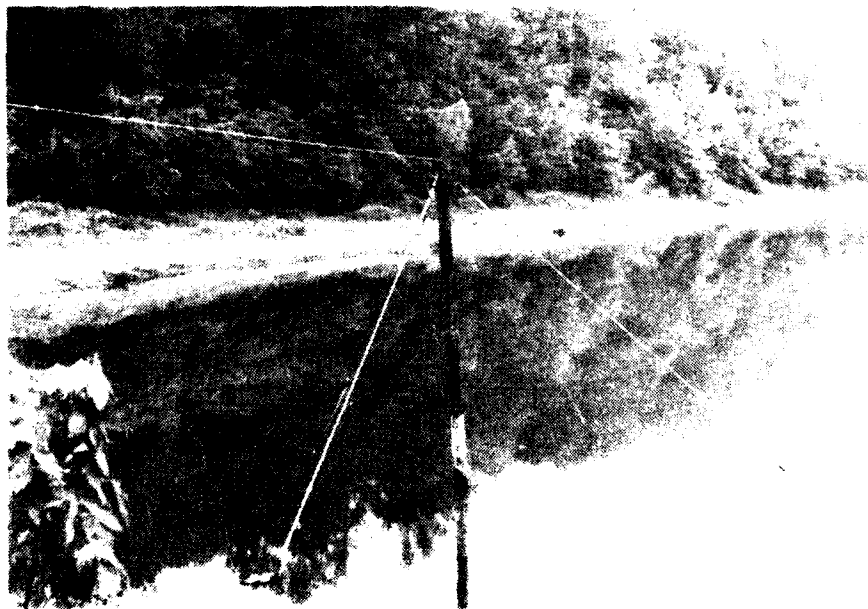
4. Pipe supporting cable left for raw water intake valve.

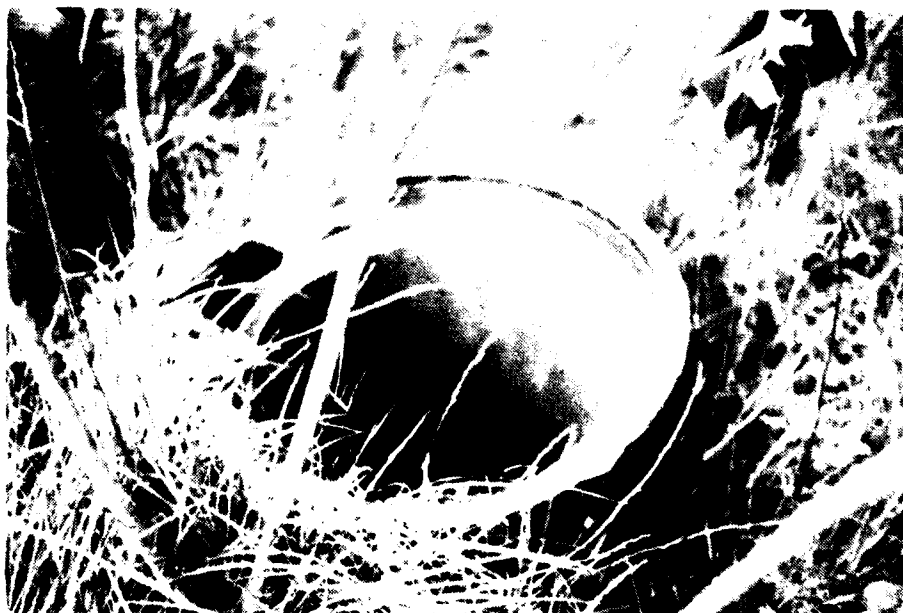
6. Top of open terra cotta pipe well found on downstream slope.

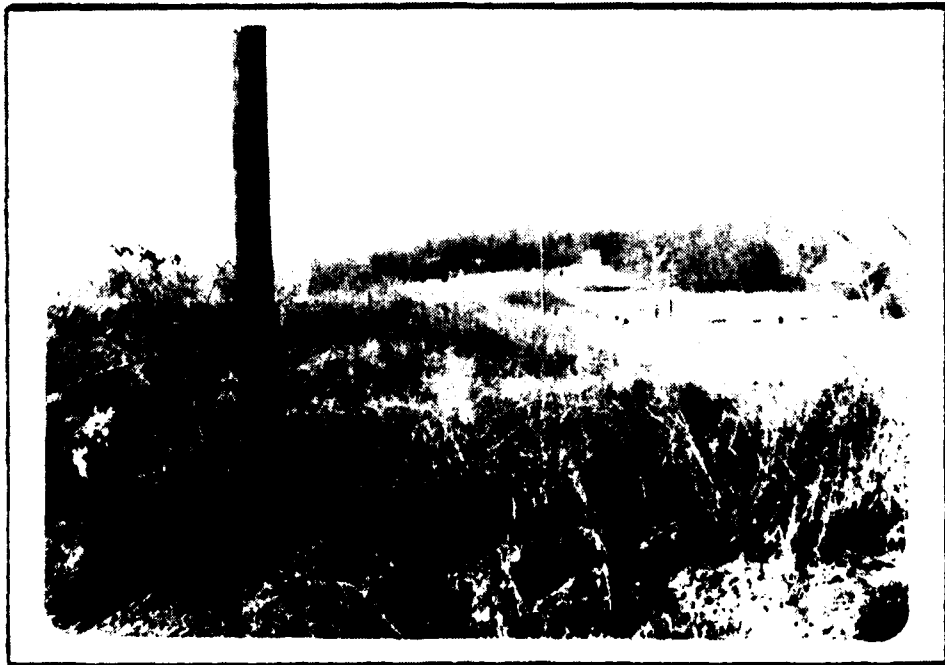
PHOTO NO. 8

- Photo No. 8 - View of leakage and undermining under the concrete spillway exit channel.
- Photo No. 9 - View of a boil type leak below the dam in the spillway exit channel.
