PHASE I INSPECTION  
JESSE BYRD DAM  
HAYWOOD COUNTY, TENNESSEE

PHASE I INSPECTION REPORT  
NATIONAL DAM SAFETY PROGRAM  
TENNESSEE

Name of Dam	Jesse Byrd Dam
County	Haywood
Stream	Tributary South Fork Forked Deer River
Date of Inspection	May 14, 1981

Wm. E. Bush, P.E., Director  
Civil & Water Resources Engineering

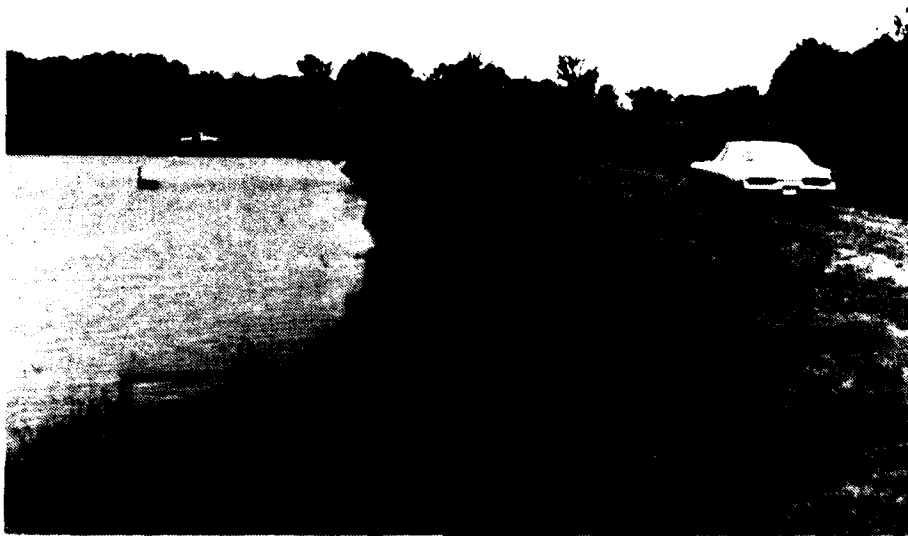
1. Top and upstream slope of Byrd Dam. Note emergency spillway at upper left.

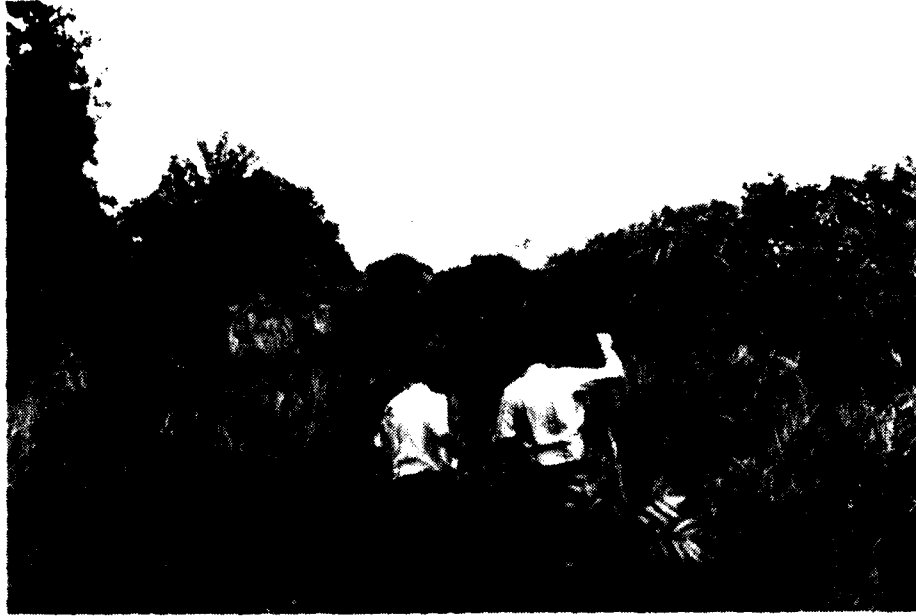
Downstream Slope - Head high weeds and small saplings made it difficult to observe if holes and other deformities were present on the downstream slope. In a few open areas, deep rills, apparently old, were observed. No surface cracks were observed on the face of the slope nor evidence of heaving at the embankment toe. A recent rain had caused several damp spots at the toe of the slope. No toe drain system was observed.

- b. On the basis of engineering judgment and visual observation, both the upstream and downstream slopes appear to be stable.
- c. High vegetation, found on the downstream slope, made observation of the slope difficult and possibly hid other deformities.

3. Height of vegetation on backslope made close observation of slope difficult.

the tall grass and saplings on the backslope should be removed and the backslope inspected in detail after their removal. The gulleying of the backslope of the emergency spillway should be filled in and seeded to effectively eliminate the gulleying of the exit slope. The springs in the east abutment should be monitored and if they should continue to flow to the driest part of summer, remedial measures should be taken to correct this situation. The service spillway structure should be maintained to keep the corrugated metal pipe from rusting through and setting up piping conditions under the dam.

- a. Inspect the downstream slope for any indications of failure.
- b. Investigate the cause of seepage in the east abutment and suggest remedial measures if necessary.
- c. Investigate the service spillway structure and recommend remedial measures.

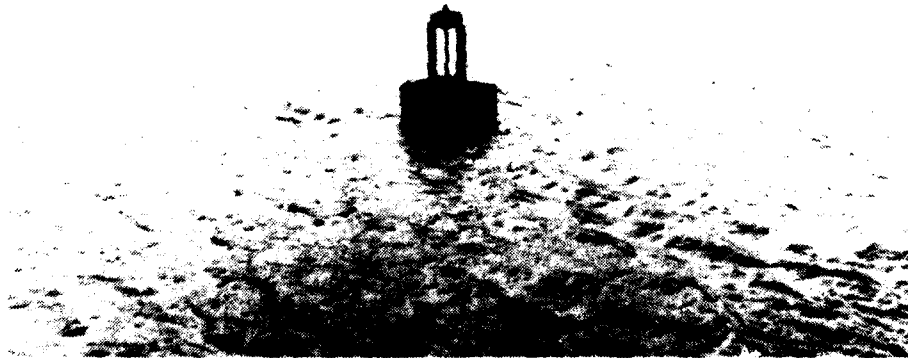
4. Service Spillway Byrd Dam.

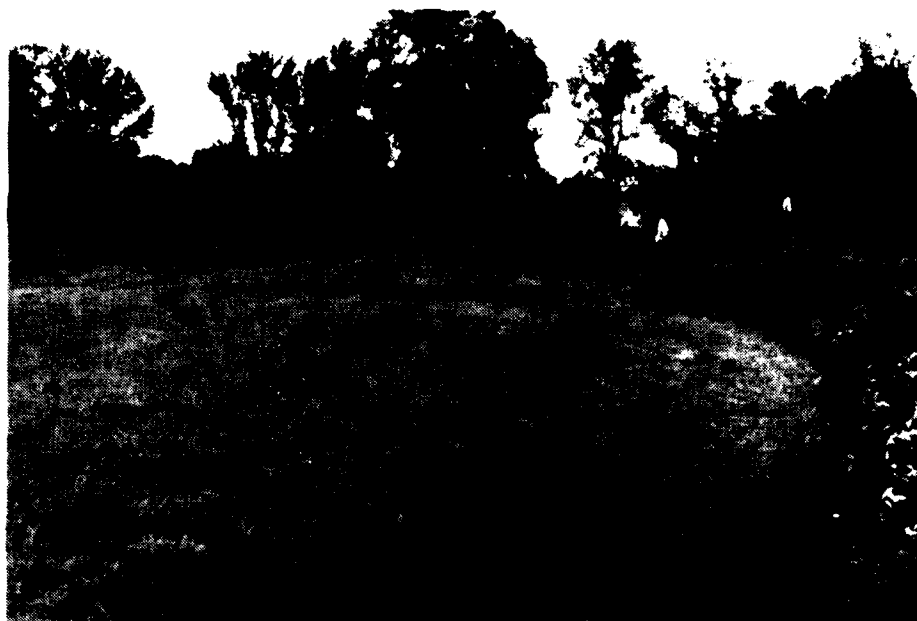
7. Approach section and control section emergency spillway Byrd Dam.

EMERGENCY SPILLWAY. The emergency spillway is located in the left abutment. The general condition of the approach slope and control section is good. The entrance channel has a good sod and is estimated to have about a one percent entrance slope to the control section. The control section has a good sod and appears to be 15 to 20 feet in length. The exit channel is the natural slope and is experiencing a good deal of gulleying. Debris and hay bales have been thrown into this gullied area to stop the erosion. The service spillway side slopes appear to have taken advantage of a natural swale rather than cut with a flat bottom and 3:1 side slopes.

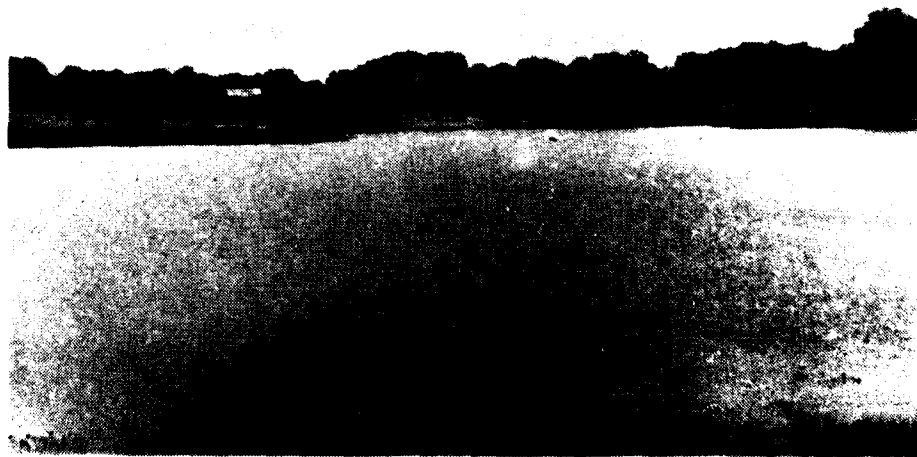
8. Byrd Dam impoundment.

RESERVOIR. The reservoir slopes appear to be in good condition. Sedimentation within the reservoir is unknown. The lake appeared to be a little muddy at the time of inspection, probably due to the rain that occurred about two hours before the inspection.
