| REPORT DOCUMENTATION PAGE | | READ INSTRUCTIONS<br>BEFORE COMPLETING FORM |
|---|---|---|
| 4. TITLE (and Subtitle)<br>National Program of Inspection of Non-Federal Dams, Tennessee. Grand Valley Dam No. 1 (Inventory Number 06924) near Hickory Valley, TN, Hardeman County, TN, Hatchie River Basin | | 5. TYPE OF REPORT & PERIOD COVERED<br>Phase 1 Investigation Report |

Based upon the inspection and subsequent evaluation, Grand Valley Dam No. 1 is classified as unsafe-nonemergency due to insufficient storage and spillway capacity to pass the one-half probable maximum flood and questionable stability of the embankment due to seepage and erosion problems.

PHASE I INSPECTION  
GRAND VALLEY DAM NO. 1  
HARDEMAN COUNTY, TENNESSEE

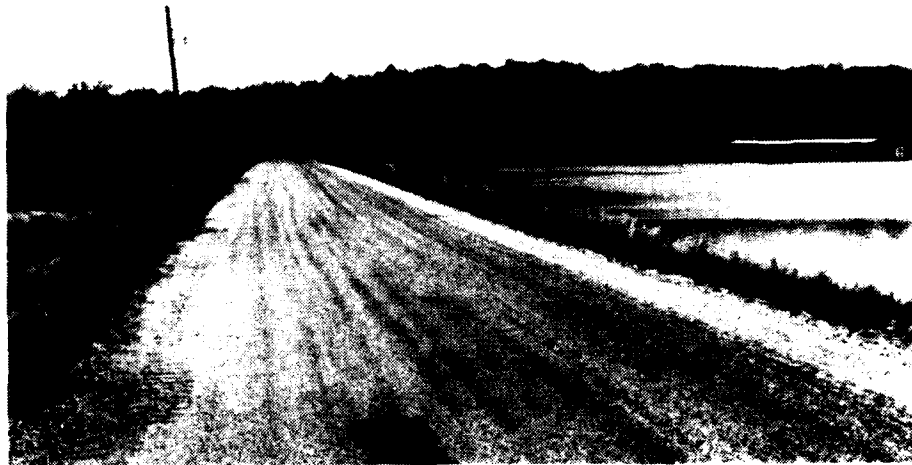
traverses the crest of the dam. The longitudinal alignment is straight for most of the dam with a dog leg near the right abutment. No longitudinal or transverse surface cracks were noted along the crest. There was no undesirable growth on the crest of the embankment.

1. Top of Grand Valley Dam No. 1.

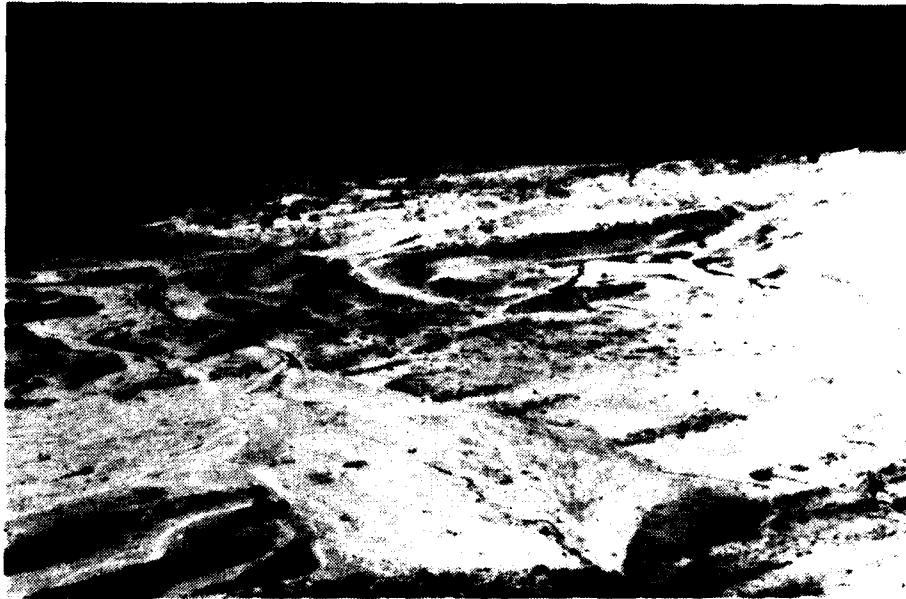
7. Wet area at toe of downstream slope, Grand Valley Dam No. 1. Note flowing water.

- a. Recommend project modifications that will allow the emergency spillway to safely pass the design flood.
- b. Investigate seepage problems on the downstream slope and toe, and recommend remedial measures.
- c. Recommend methods to stop erosion on both upstream and downstream slopes.
- d. Investigate conditions of service spillway outfall pipe and propose remedial measures if needed.
- e. Investigate embankment stability problems as evidenced by slippage failures on the downstream slope and propose corrective measures to provide stable slopes for the dam.
- f. Develop an inspection and maintenance program for the dam to be carried out at least annually.
- g. Develop an emergency action plan to alert downstream residents in the event a major problem develops with the dam.

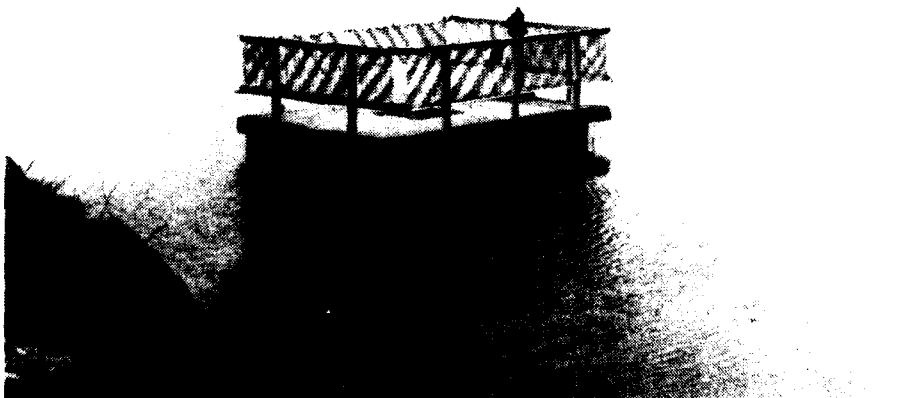
- 3.1.4 Spillways - The service spillway intake structure is a concrete box riser with weir openings on two sides. The 42 inch outlet pipe is corrugated metal and is cantilevered about six feet over the plunge pool at the exit end. No structure was observed to support this section of pipe as it is undermined by the plunge pool. No leakage was observed between the pipe and the soil at the discharge end. Approximately 40 feet from the outlet back toward the dam, the ground has caved in over the pipe. This hole is approximately five feet in diameter at ground level. An auger hole bored

- d. The service spillway outfall pipe appears to have a failure approximately 40 feet from the discharge end of the pipe, but this should not affect the stability of the dam if corrected in a reasonable length of time.

8. Service spillway, Grand Valley Dam No. 1.

The outlet pipe back of the discharge pipe should be exposed beyond the sink hole that has developed over it, the leak in the pipe repaired and a soil cement backfill placed immediately around the pipe with a well-compacted backfill above it.

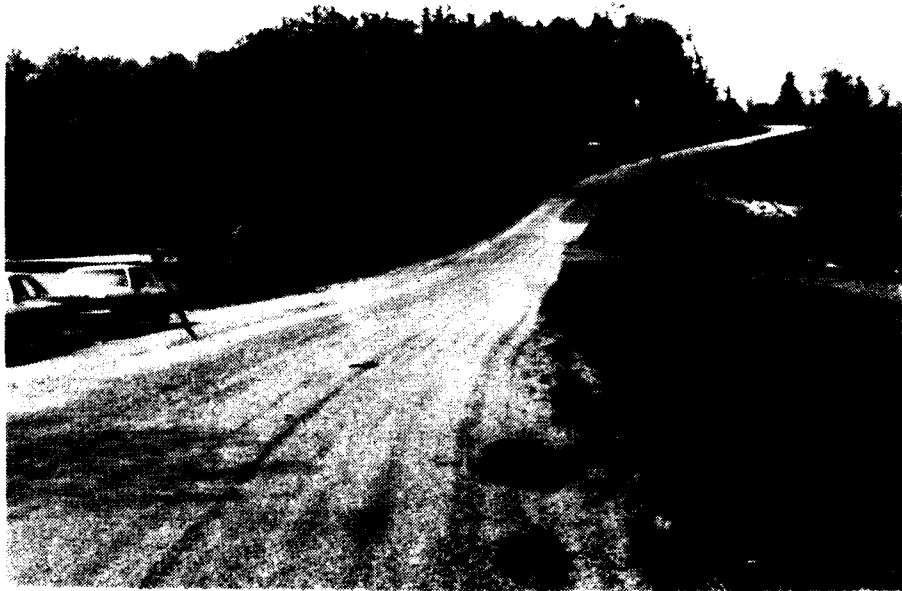
- a. Hydraulic analysis indicates that Grand Valley Dam No. 1, in the event of the design flood, will sustain depths of flow up to four feet in the area designated for the emergency spillway for a total flow duration of nine hours. On the basis of engineering judgment and visual observations, the spillway will sustain major damage causing possible breaching of the structure.
- b. On the basis of engineering judgment and visual observations, the downstream slope appears unstable for the following reasons: Several areas of dampness and flowing water were noted on the downstream

9. Low area at top of dam near left abutment used as emergency spillway.

No emergency spillways have been constructed in either abutment. The present emergency spillway was constructed as a low area in the top of the dam. Flows exceeding the capacity of the service spillway and storage will flow over this low section near the left abutment. The entrance channel is the upstream slope approximately 3:1 and the control section is the paved road section across the top of the dam. The exit channel is the backslope of the dam would be subject to extreme erosion if used. The backslope in the vicinity of the spillway has already experienced a slippage failure. The vegetative cover is fescue and wild grass and it provides an ineffective cover against erosion. The emergency drawdown facility is a pipe in the intake structure with a gate valve. It is not believed the lake can be completely drained with this facility. The facilities were not operated during this inspection. The owner stated that the gate had been opened last year without difficulty.
