Phase I Inspection Report

Cortlandt Lake Dam

Lower Hudson River Basin, Westchester County, N.Y.

Inventory No. 85

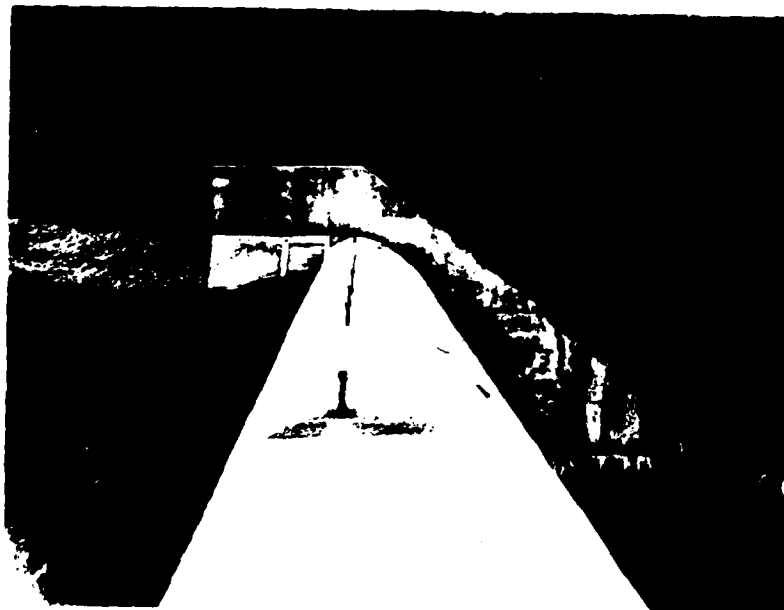
1959 PHOTO  
CREST OF SPILLWAY WITH FLASHBOARD PINS IN PLACE  
NOTE WOOD COVER OVER CIRCULAR HOLE IN WINGWALL
