Investigation of Cold Cathodes
for
Long Life CO₂ Waveguide Lasers

Annual Summary Report
for Contract N00014-79-C0312

U. Hochuli

November 1981

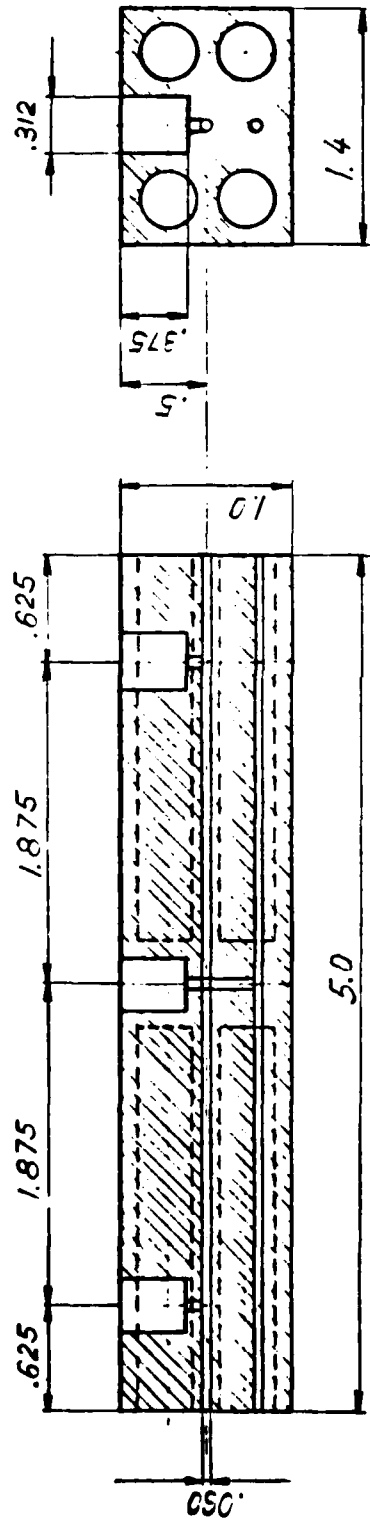
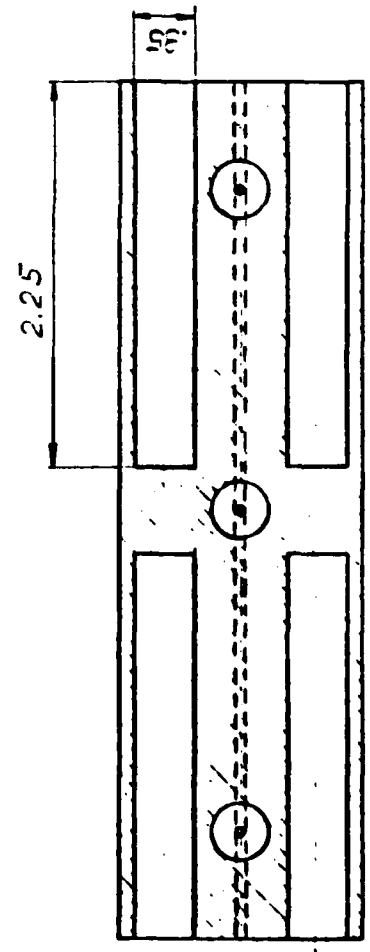
Fig. 1

Careful observations on the more than 50 different cathodes being tested indicate that semiconducting, sintered NiO is one of the better cathode materials. Such cathodes were actually used to generate the life test data with two of the BeO laser structures shown in Figure 1. Both of these lasers used three cathode type electrodes, one located 5/8" from each bore end and one near the bore center. Laser No 1 used both end electrodes as 2mA cathodes and the center electrode as the common 4mA anode. Laser No 2 worked with the end electrodes as 2mA anodes and used the center electrode as a common 4mA cathode. From the discharge tube results we know that the 4mA cathode is prone to considerably heavier sputtering than the 2mA cathode. Both lasers had indium "O" ring and indium film seals developed by us 11 years ago. All the seals on Laser No 1 were perfect but Laser No 2 had

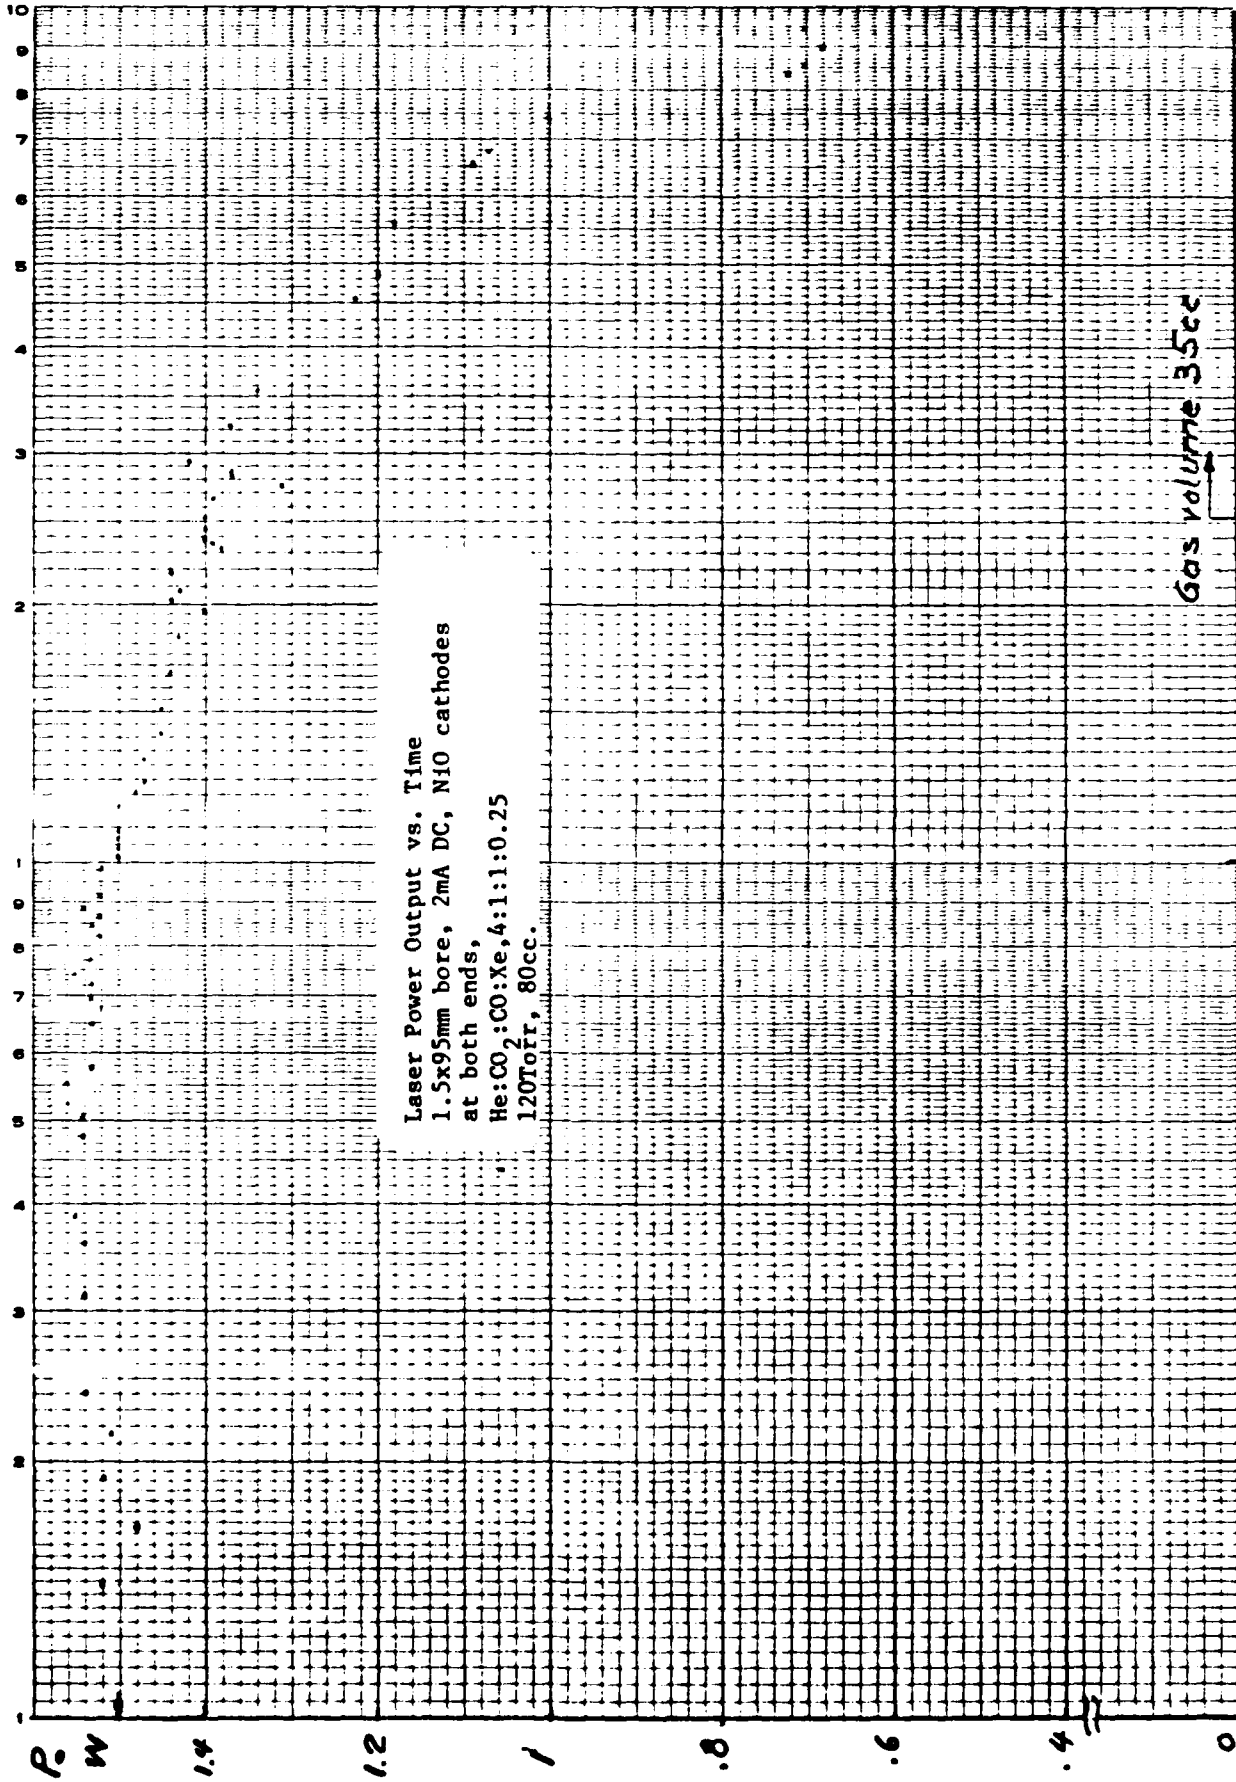
FIG. 2

The output power vs time curves for these two lasers are shown in Figures 2 and 3. These curves indicate a half power life of about 8000 hours for laser No 1 and about 4300 hours for laser No 2. Our results are quite an improvement when compared to the 750 to 1500 hour results we achieved a year ago. Probably an even longer life could have been achieved if the gas supplies for both lasers had not been reduced from 80cc to 35cc between 2500 and 3000 hours.

As Figure 2 shows the power output of this laser decreased from 1.54W to 0.7W after 9500 hours. Evacuation to 1 Torr and refilling restored the power to only 0.86W. Vacuum pumping and 100°C heating for two days, followed by refilling, restored the output power to 0.9W. Our laser structures use external windows (uncoated ZnSe, tilted 7° to avoid retroreflections) as vacuum seals behind the internal mirrors. Power supply failure over one weekend lowered the laser body temperature to the 15°C cooling water temperature.

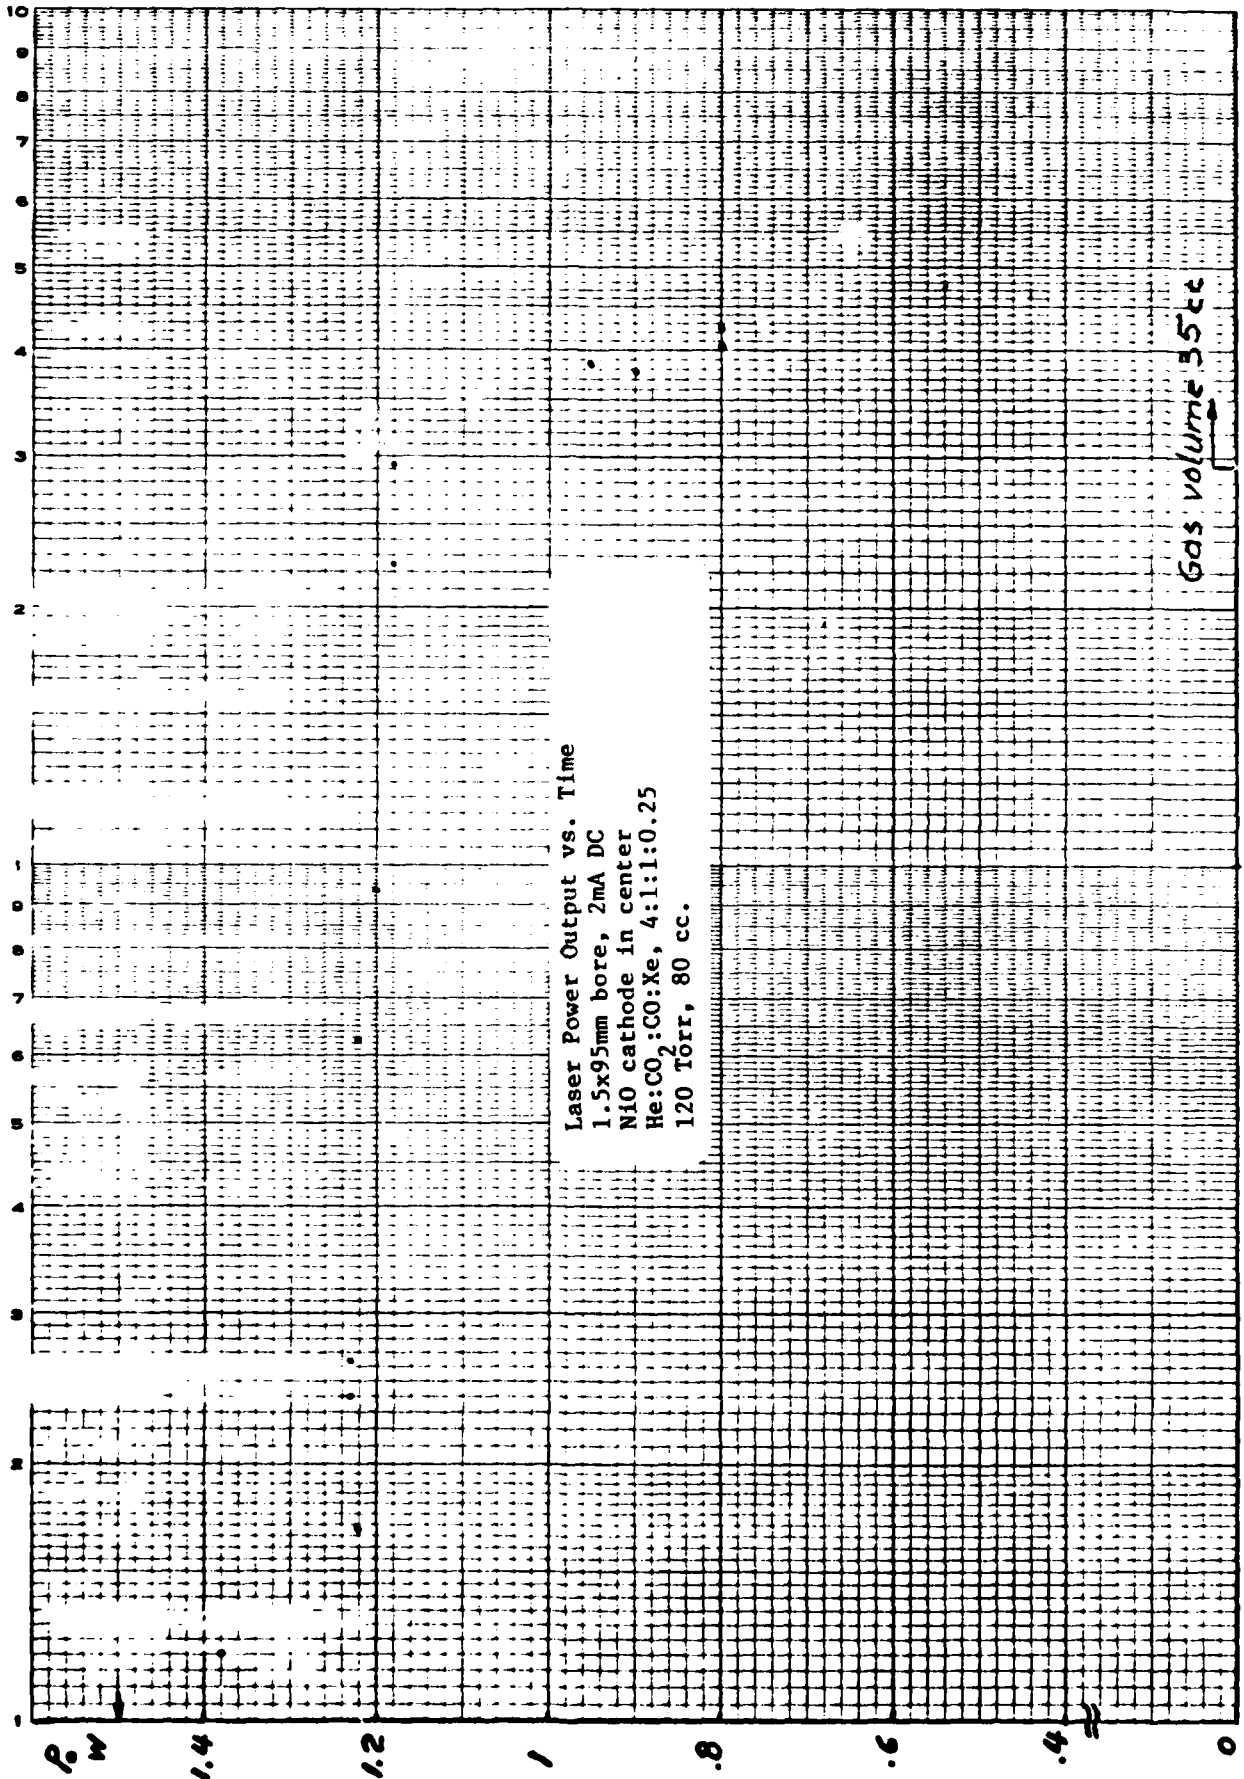
FIG. 3 10³ hours 10⁴

Figure 3 indicates a power drop from an initial 1.5W to 0.54W after 4750 hours. Increasing the gas volume again to 80cc, by reconnecting the laser to the same gas supply
