# BOMB CRATER REPAIR TECHNIQUES FOR PERMANENT AIRFIELDS

Report I

## SERIES I TESTS

David L. Cooksey

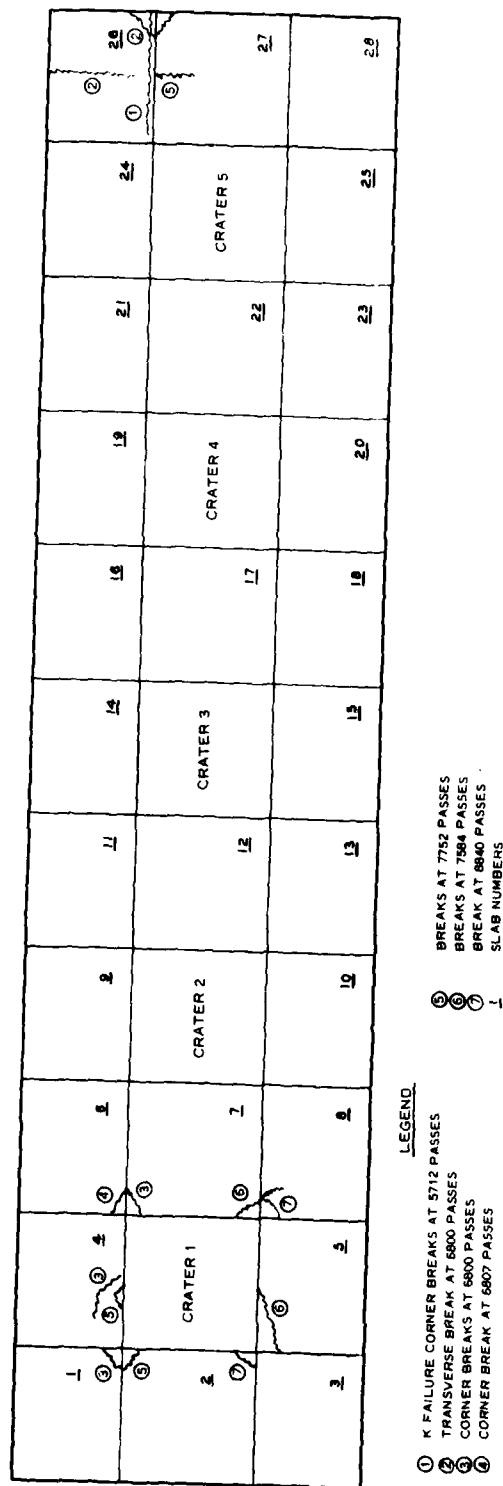
Figure 18. Breaks in asphalt-overlay pavement

elevation and thus problems arose as the load wheels tended to "ramp-up" onto the concrete slabs in the vicinity of crater 1 after 3400 passes of traffic. Also, transverse cracks developed in slabs 26 and 27. Probably the unevenness of the loose limestone in crater 1 contributed to the corner breaks and cracks around this crater by causing load shifting as the load wheels passed over the crater surface. However, after 5100 passes of traffic, there were no major cracks in the surface pavement due to traffic.

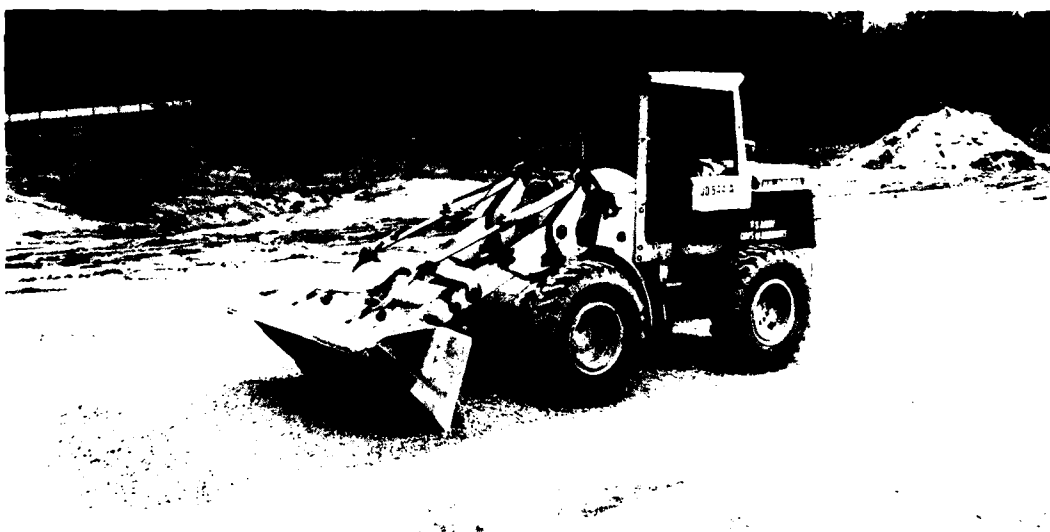
Photo 70. Maintenance being performed on limestone repair in crater 1

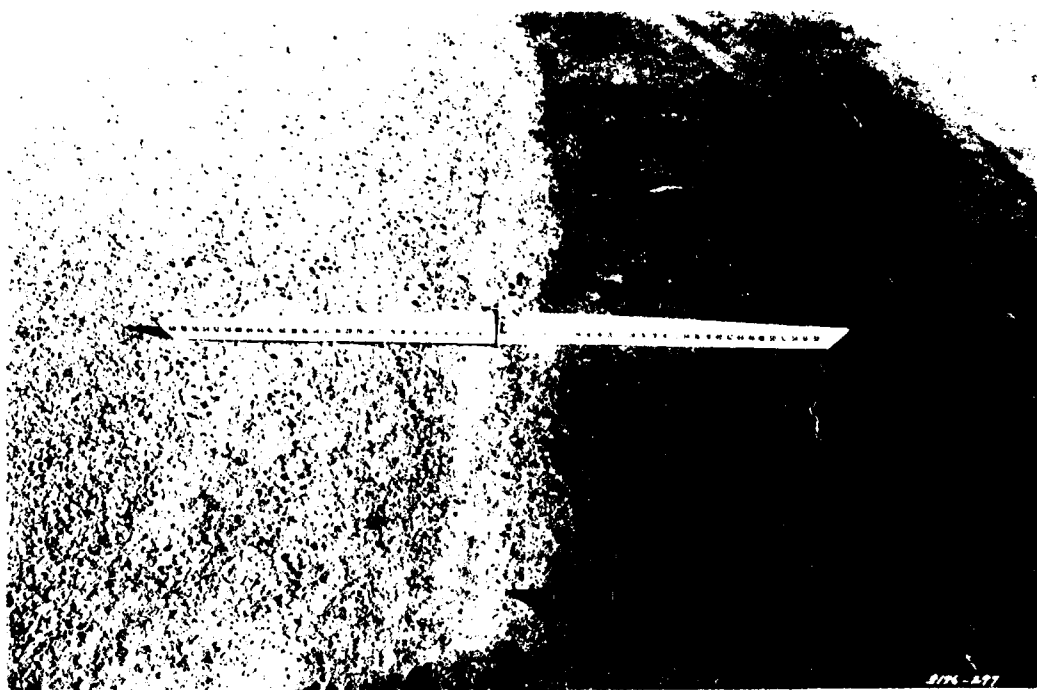
Photo 73. Repair surface of crater 1, lane 1, after 4692 passes of the C-141 load cart

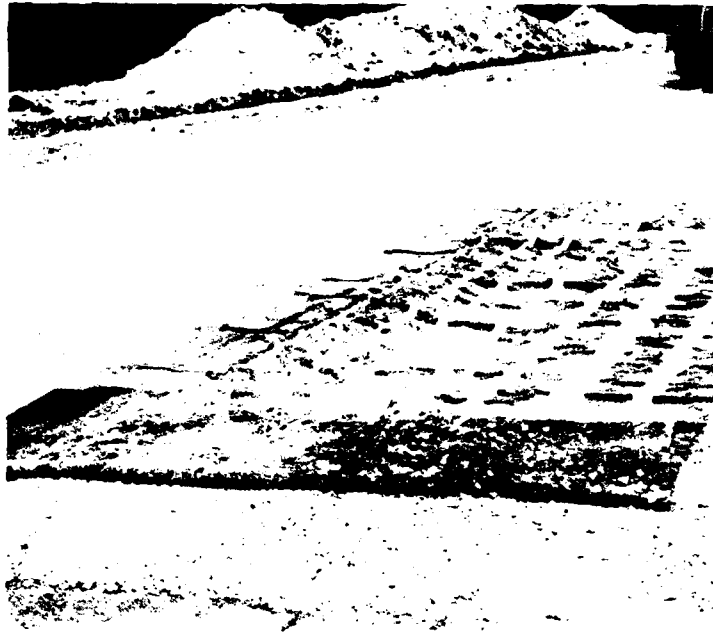
Photo 83. End of fabric rolled back to show condition of bottom surface after loss of bond
