BEL-AIR LAKE DAM

NDI I.D. PA-0066

PHASE I INSPECTION REPORT  
NATIONAL DAM INSPECTION PROGRAM

AUGUST 1981

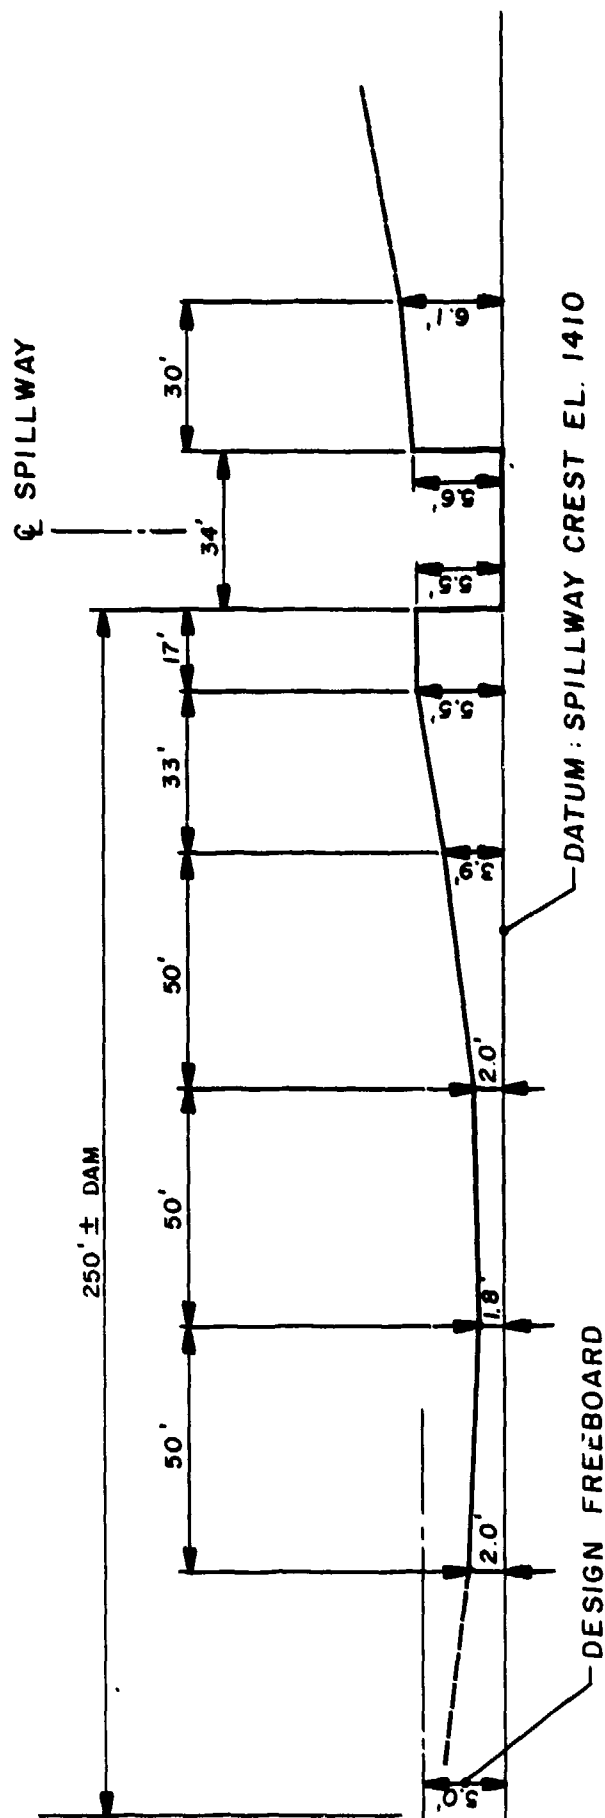
### DAM CREST PROFILE (LOOKING DOWNSTREAM)

In general, the condition of the embankment is considered to be fair. The most significant condition noted was that the center of the dam was significantly lower than the top of the spillway sidewalls, significantly reducing the potential discharge capacity of the spillway. By field survey, the available freeboard measured relative to the low section on the crest of the dam was only about 1.8 feet. Plate 6 shows the existing dam crest profile. The design drawings indicate that the design freeboard was five feet. Therefore, the center of the dam appears to have settled. At this time, no other indications of ongoing settlement were noted. The middle portion of the downstream face is covered with trees and brush.
