*2* BUZZARD SWAMP WATERFOWL AREA

*3* NO. 6 DAM

*8* PHASE I INSPECTION REPORT

*1* NATIONAL DAM INSPECTION PROGRAM

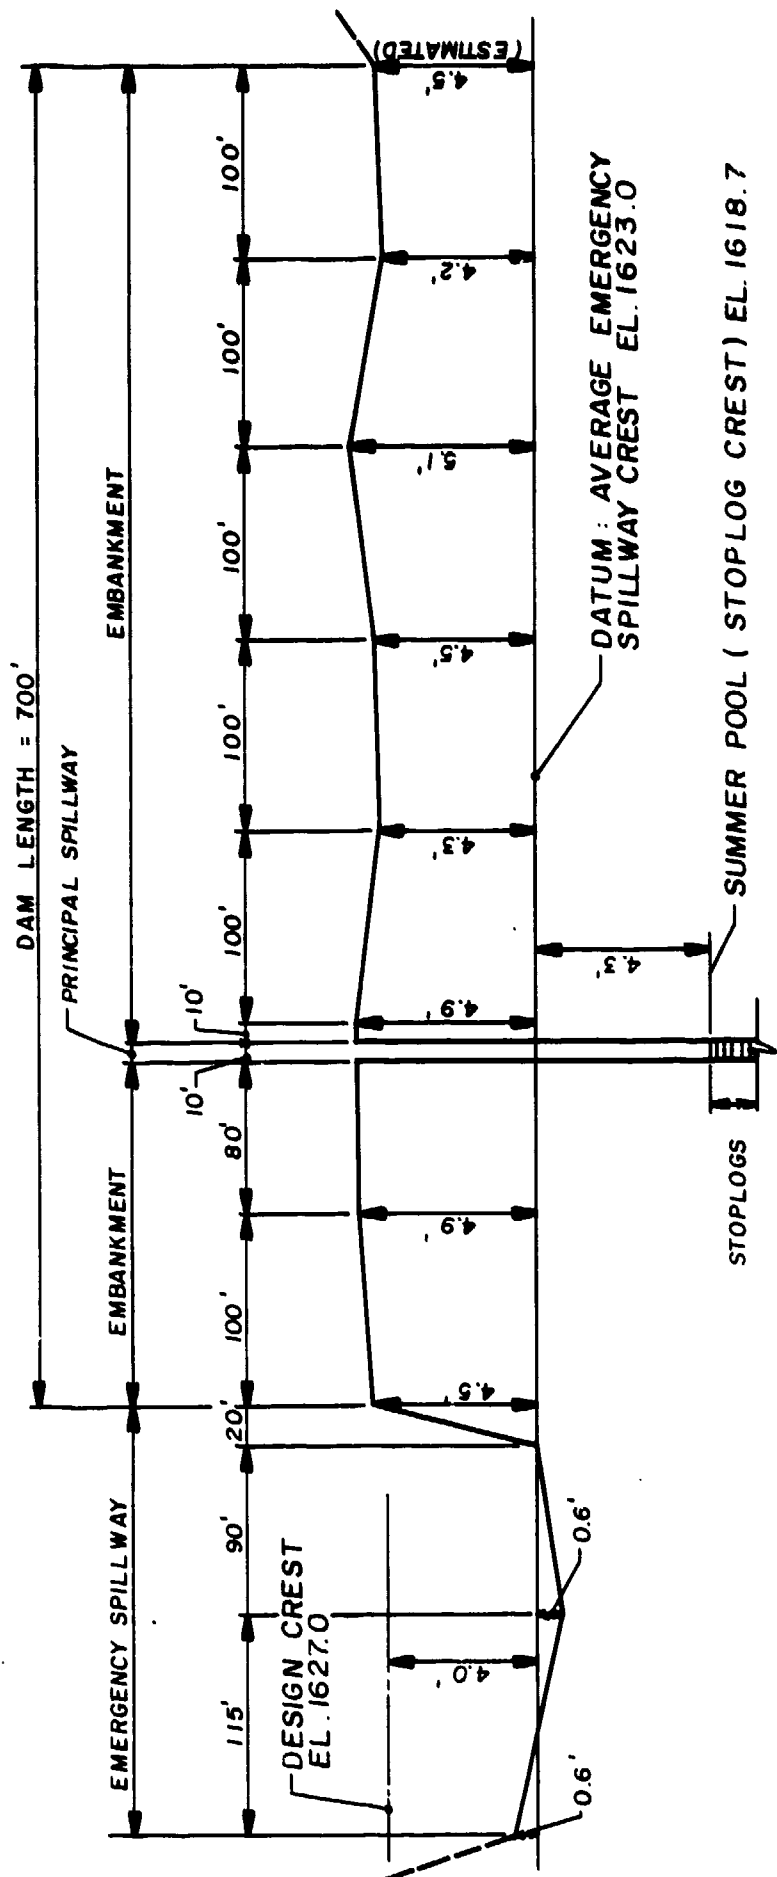
# **DAM CREST PROFILE** (LOOKING DOWNSTREAM)

The dam crest was surveyed relative to the emergency spillway crest elevation and was found to be at or above the design level. The lowest embankment area occurred at a section near the right abutment. The dam crest profile, according to field measurements, is illustrated on Plate 10.
