COLVER DAM

NDI I.D. PA- 0437

PHASE I INSPECTION REPORT  
NATIONAL DAM INSPECTION PROGRAM

AUGUST 1981

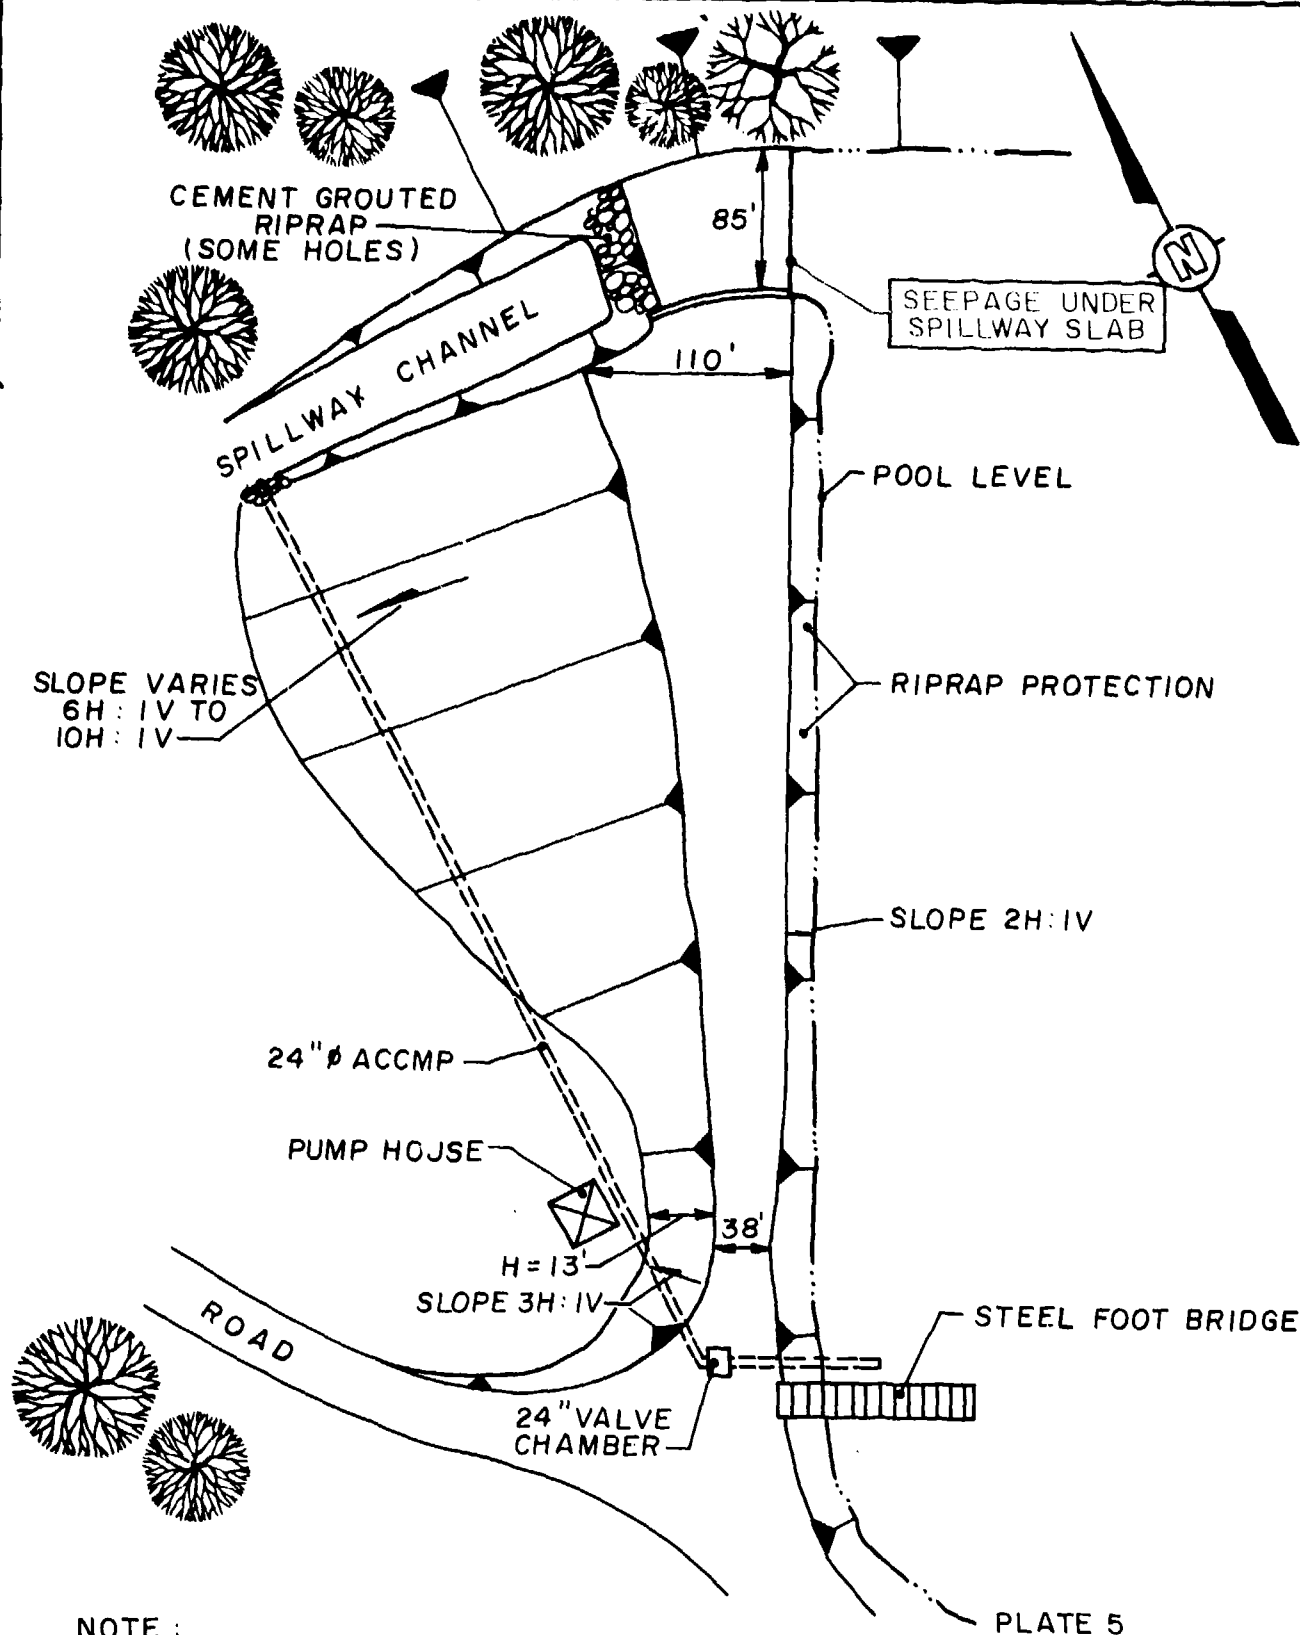
COLVER DAM  
 GENERAL PLAN  
 FIELD INSPECTION NOTES  
 FIELD INSPECTION DATE: JULY 16, 1981

The specific observations are illustrated on Plate 5.

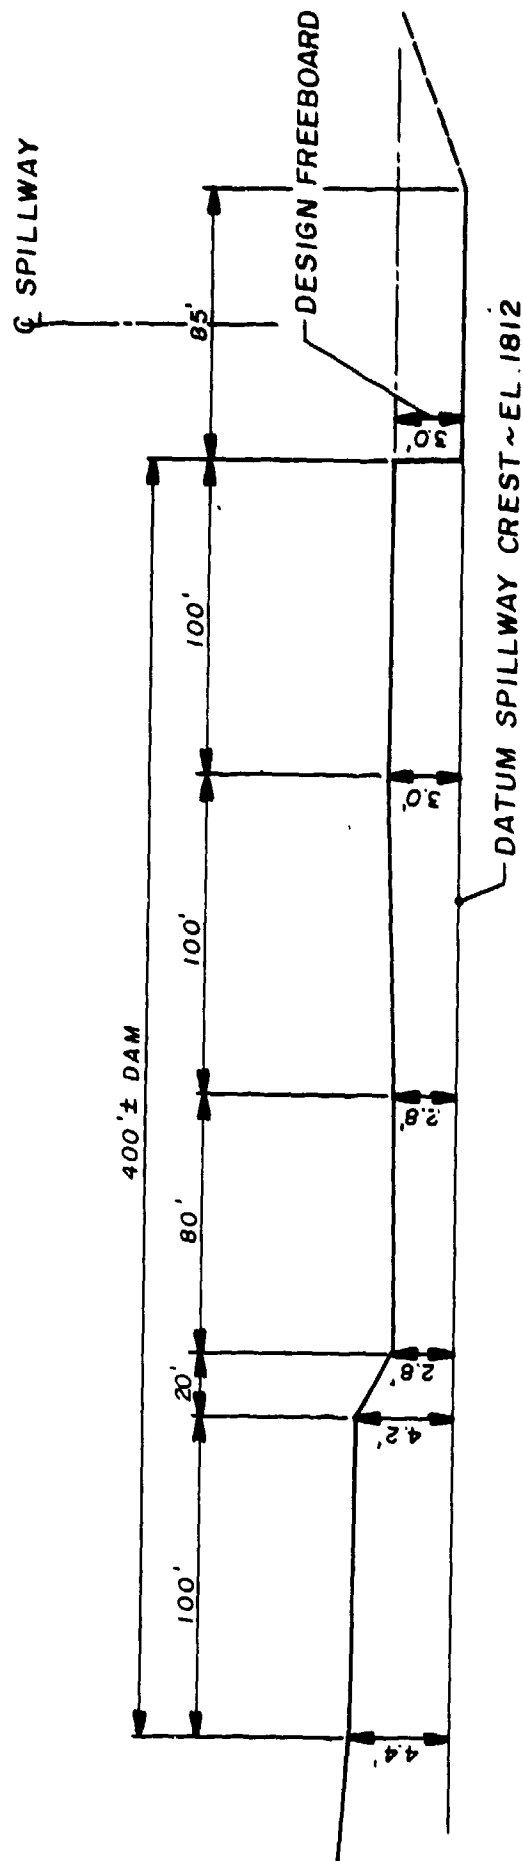
# DAM CREST PROFILE (LOOKING DOWNSTREAM)

The dam crest was surveyed relative to the spillway crest elevation and the lowest area was found to be within 0.2 foot of the design crest level. The dam crest profile, according to the field measurements, is illustrated in Plate 6.
