BIGBY RUN DAM

NDI ID NO. PA-226

PHASE I INSPECTION REPORT
NATIONAL DAM INSPECTION PROGRAM

NAME OF DAM	Bigby Run Dam
STATE LOCATED	Pennsylvania
COUNTY LOCATED	Somerset
STREAM	Bigby Run
DATES OF INSPECTION	November 6, 1980 and May 12, 1981
COORDINATES	Lat: 39° 51.6' Long: 79° 4.5'

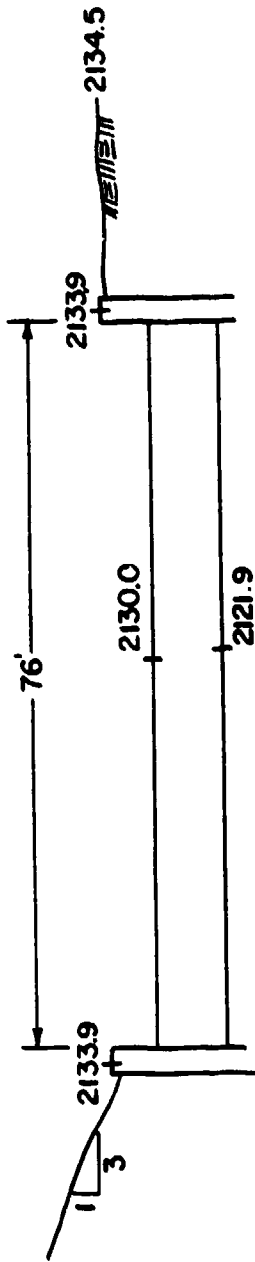
**SPILLWAY PROFILE
LOOKING UPSTREAM
SCALE: 1"=20'**

CONCRETE
DETERIORATING

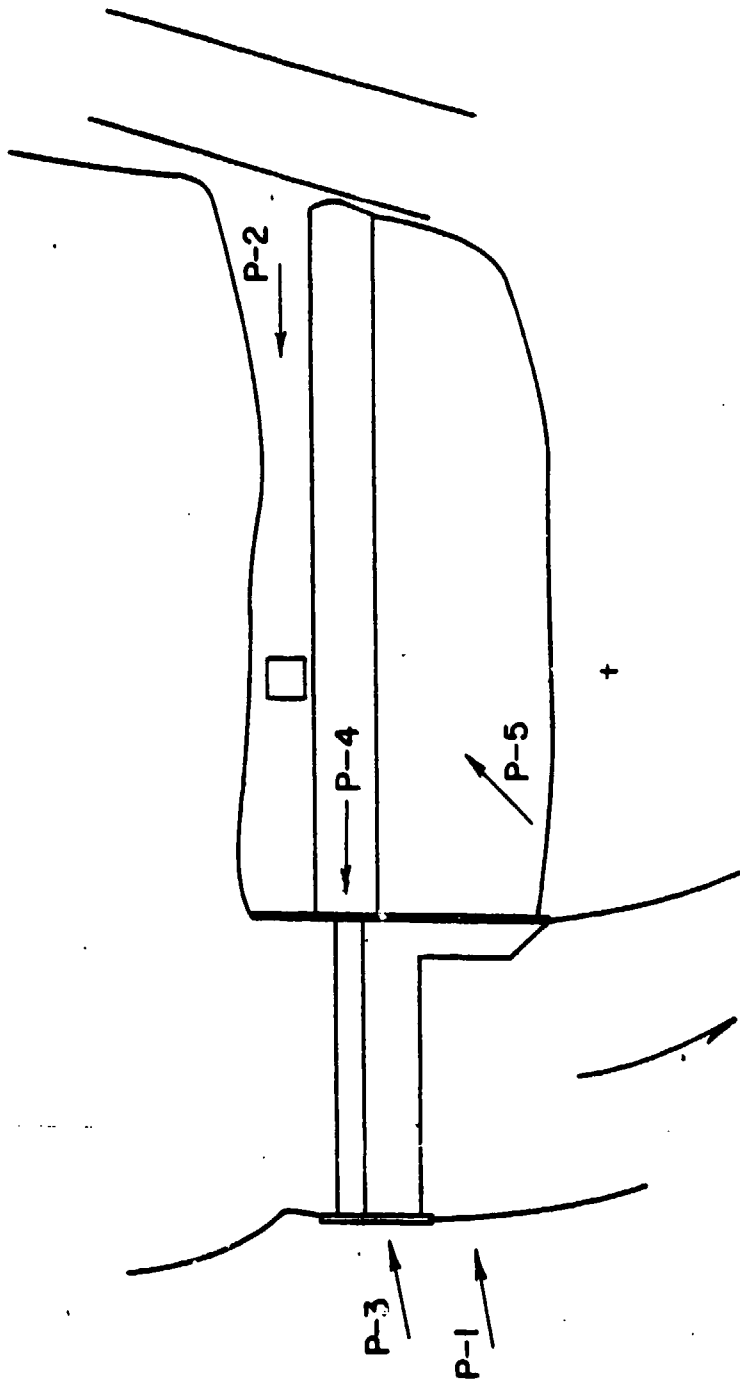
C-1

c. Appurtenant Structures. The spillway was observed to be a concrete ogee section. Field measurements taken during the inspection indicated that the length of the crest was approximately 76 feet. In general, the concrete in the spillway was in a deteriorating condition. Deterioration of the concrete was observed on the right spillway retaining wall. The discharge channel for the spillway consisted of an open cut channel in bedrock. No major deficiencies were observed in the area of the spillway which were considered capable of significantly affecting the discharge potential of the structure. A valve house was observed on the upstream slope of the dam.

4.5 Evaluation. Maintenance of the dam and operating facilities is considered fair. The concrete in the spillway is in a deteriorating condition. Marked deterioration was observed at the right spillway wingwall. The concrete should be repaired. Minor seepage was observed at the toe of the dam adjacent to the left abutment contact.

The spillway was in a visibly deteriorating condition. Deterioration was observed in the right spillway wingwall. During the May 12, 1981 inspection, the reduced level of the reservoir allowed a closer inspection of the ogee section. Soil was observed along the upstream face of the ogee section. This condition was not observed during the November 6, 1980 inspection due to discharges over the spillway at the time. It is possible that some of the material represents fill placed against the upstream face of the dam during construction of the dam. The fill material and silt slopes gently from the spillway crest to the reservoir at a slope of approximately 4H:1V.

1. Upper left - View of crest and downstream slope of dam. View towards the left abutment.
2. Upper right - View of upstream slope of dam. Note gate house on upstream slope.
3. Lower left - View of spillway.
4. Lower right - View of spillway crest. View towards the right abutment. Note deterioration of concrete on right spillway wall.

3. The concrete in the spillway should be repaired.
