2 **CAMP SINOQUIPE LAKE DAM**

NDI ID NO. PA-1058

8 PHASE I INSPECTION REPORT  
1 NATIONAL DAM INSPECTION PROGRAM

AUGUST 1981

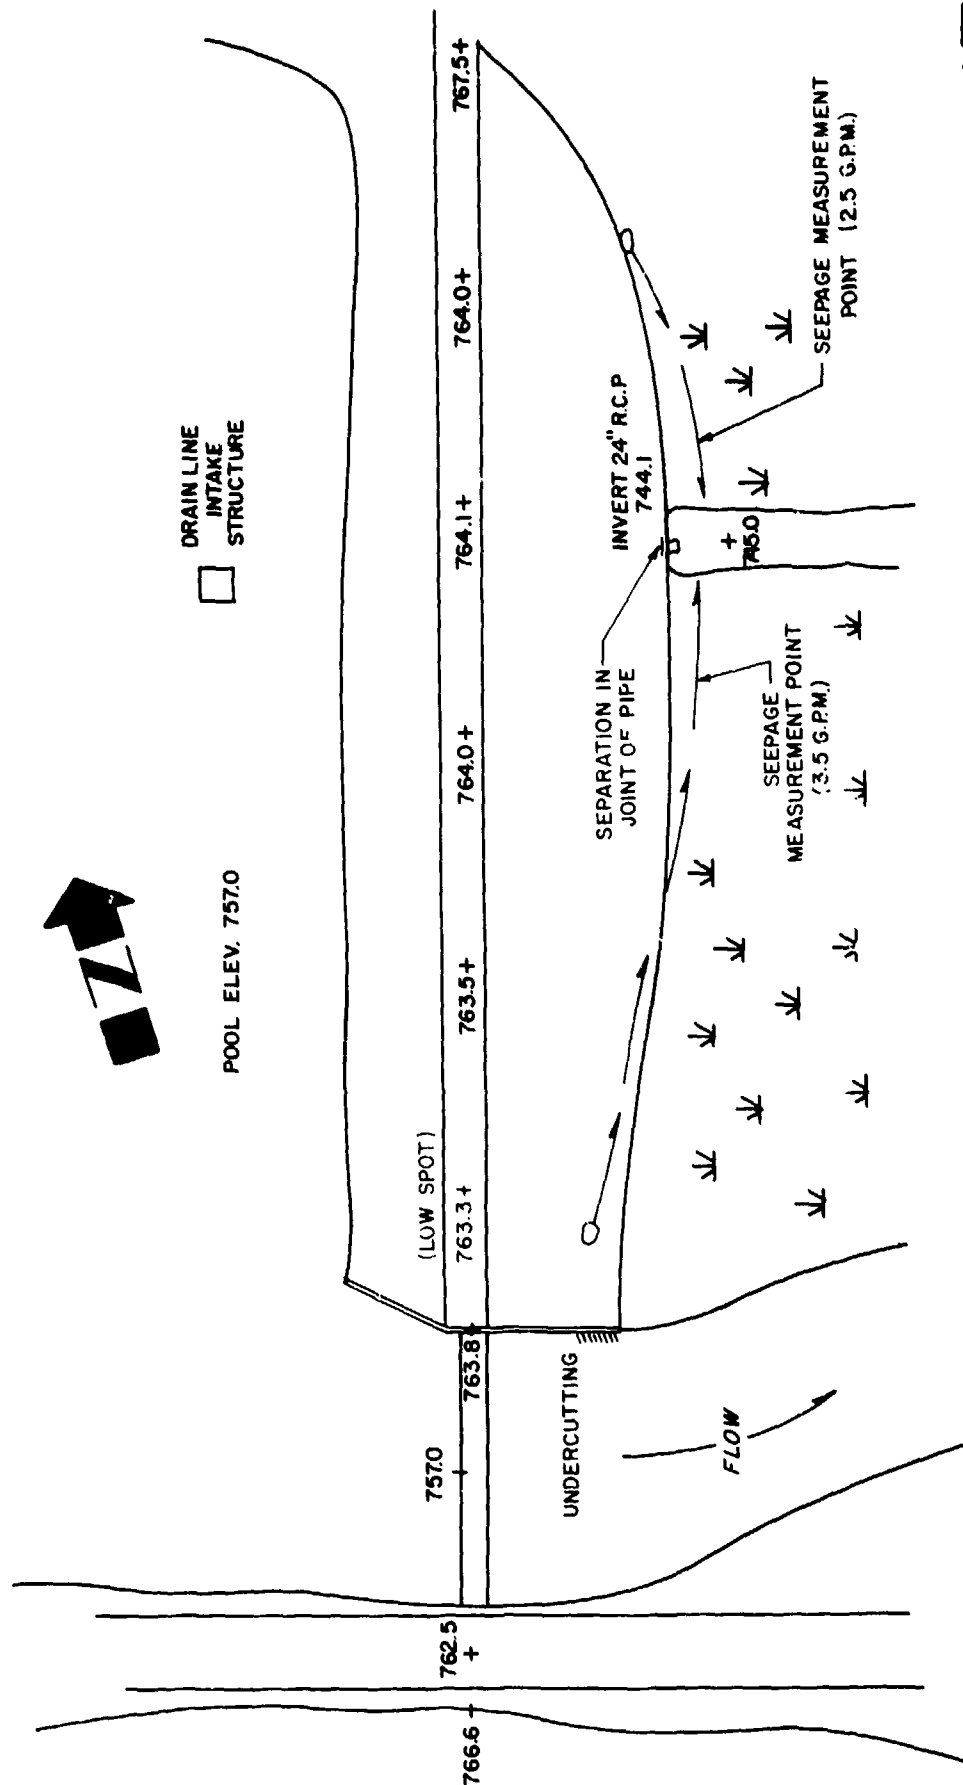
A-12

Two concentrated seepage points were observed during the inspection. One seepage point was located on the downstream slope of the dam adjacent to the left spillway wingwall. Seepage from this area flows along the downstream toe of the dam toward the outlet for the drainline. The seepage was measured to be 3.5 gallons per minute. The second seepage point was located at the toe of the dam adjacent to the left abutment contact. Seepage in this area was measured to be 2.5 gallons per minute. The seepage located adjacent to the spillway was noted as being clear. Seepage observed near the left abutment contact displayed a yellow-red coloring. No major erosion areas were observed during the inspection. No obvious signs of settlement of the embankment or sloughing of the embankment slopes were noted during the inspection. The observed seepage and saturated condition at and beyond the downstream toe are indicators of questionable long term stability.

| VISUAL EXAMINATION OF | OBSERVATIONS | REMARKS OR RECOMMENDATIONS |
|---|---|---|
| ANY NOTICEABLE SEEPAGE | Two seepage areas were observed during the inspection. See page A-12. | Seepage should be investigated. |
