**HORTON LAKE DAM**

NDI No. PA 00070  
PennDER No. 58-124  
Dam Owner: Harry Horton

**PHASE I INSPECTION REPORT**  
**NATIONAL DAM INSPECTION PROGRAM**

Horton Lake Dam, Susquehanna County, Pennsylvania  
NDI No. PA 00070, PennDER No. 58-124  
Sterling Brook  
Inspected 30 October 1980

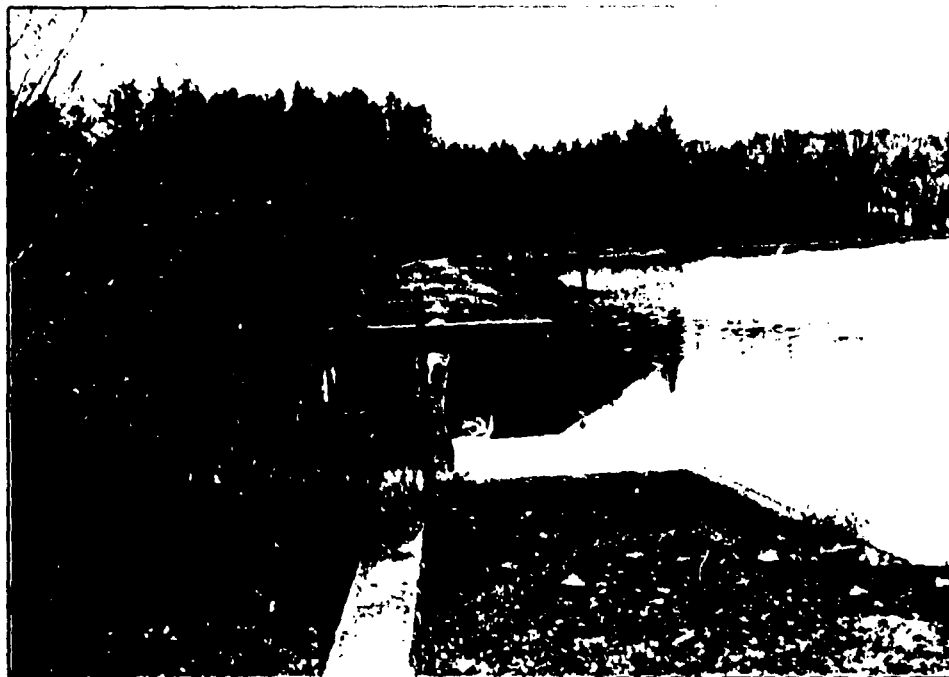
PHOTO 5. View Across Crest of Spillway
