**HATHAWAY POND DAM**

NDI No. PA 00050

**PHASE I INSPECTION REPORT**  
**NATIONAL DAM INSPECTION PROGRAM**

Hathaway Pond Dam, Susquehanna County, Pennsylvania  
NDI No. PA 00050, PennDER No. 58-06  
West Branch of Lackawanna River  
Inspected 30 October 1980

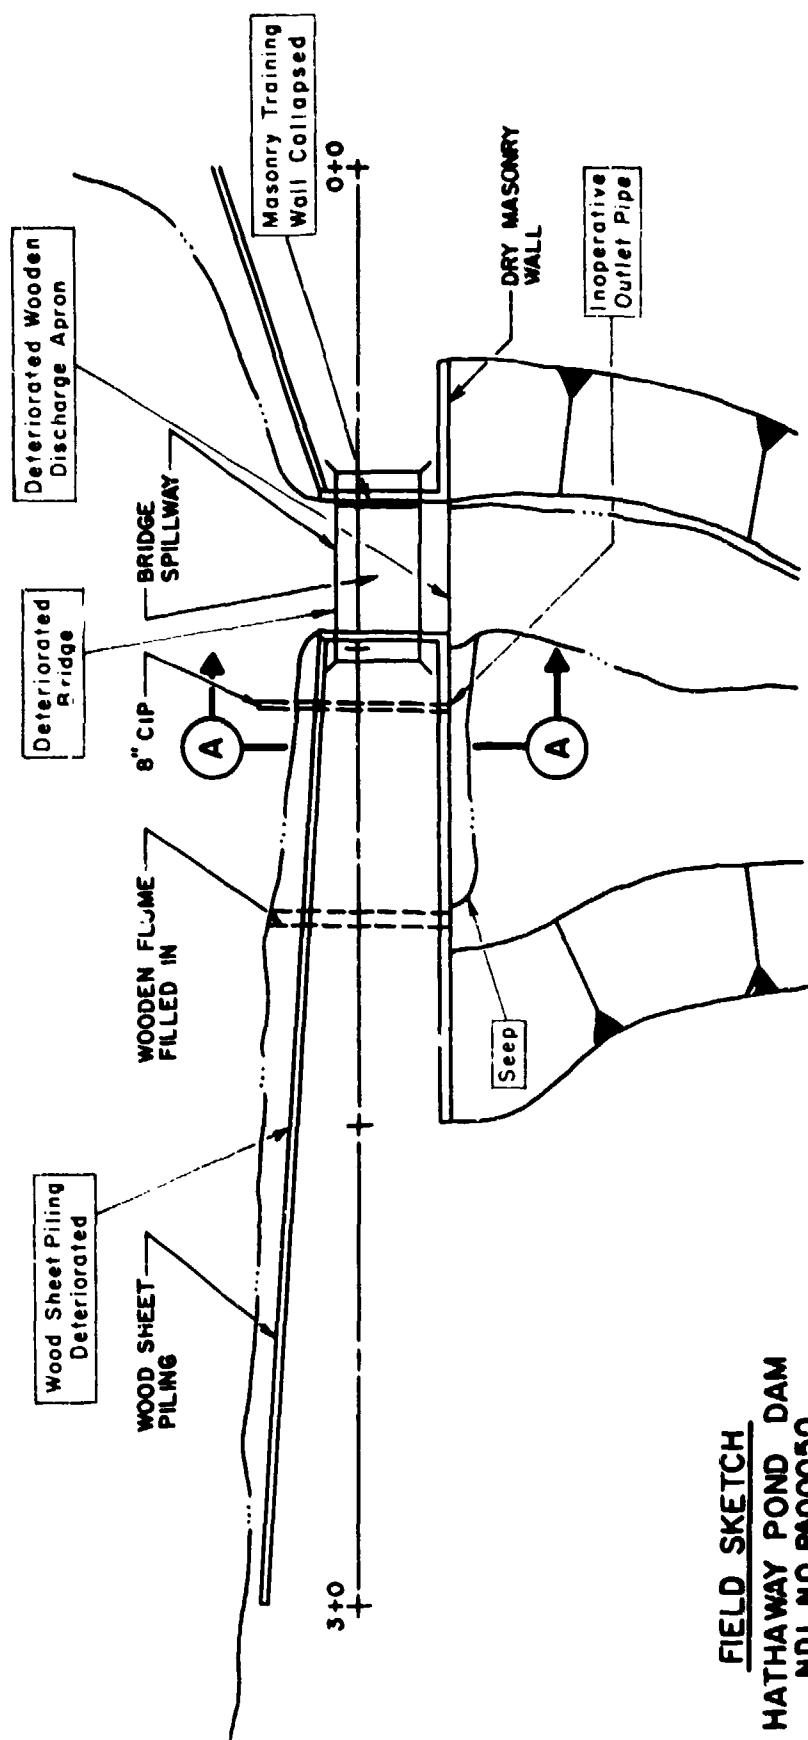
FIELD SKETCH  
HATHAWAY POND DAM  
NDI NO. PA00050  
Penn DER NO. 58-06  
SCHEMATIC - NOT TO SCALE

Note: Entire Embankment is  
Covered With Brush  
And Trees
