**MILLER'S POND DAM**

NDI No. PA 01004  
PennDER No. 8-27  
Dam Owner: Ernest Weaver

**PHASE I INSPECTION REPORT**  
**NATIONAL DAM INSPECTION PROGRAM**

Miller's Pond Dam, Bradford County, Pennsylvania  
NDI No. PA 01004, PennDER No. 8-27  
Miller Run  
Inspected 31 March 1981

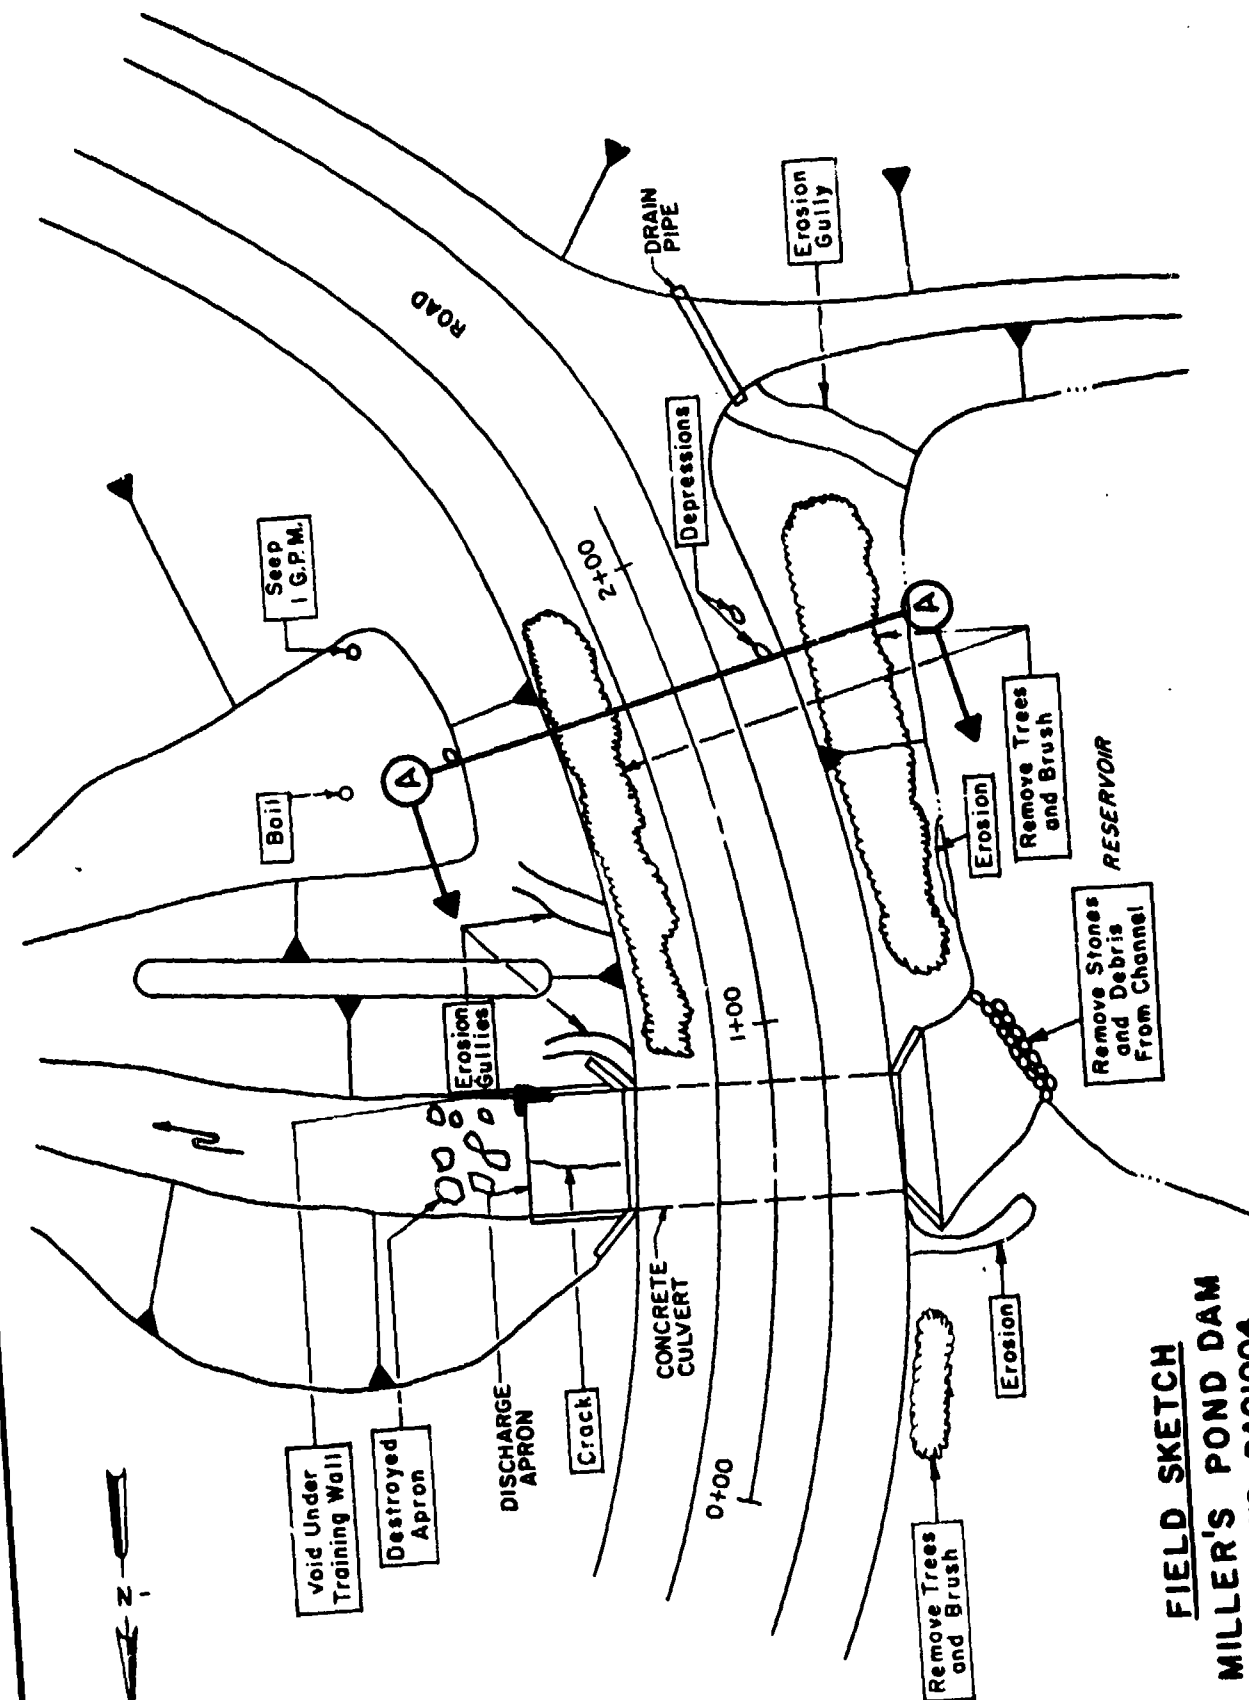
**FIELD SKETCH****MILLER'S POND DAM**

- b. Dam - Two seeps were observed at the downstream toe of the dam, and one boil was observed approximately 20 feet beyond the toe of the dam (see Field Sketch in Appendix A). A depression 3 feet in diameter and 2 feet deep and a 6-inch diameter depression were observed on the upstream crest. Trees and brush are growing on the upstream and downstream slopes of the embankment.

| VISUAL EXAMINATION OF | OBSERVATIONS | REMARKS OR RECOMMENDATIONS |
|---|---|---|
| ANY NOTICEABLE SEEPAGE | Two areas of seepage were observed<br>at the downstream toe near the right<br>abutment. One seep approximately<br>1 g.p.m., one seep approximately<br>5 g.p.m. There is a boil 20 ft.<br>below the toe of the embankment<br>below the larger seep. | Monitor these areas. |
