**SUSQUEHANNA RIVER BASIN  
SPRING GROVE DAM  
P. H. GLATFELTER COMPANY**

**NDI NO. PA-01028  
DER NO. 67-004**

**YORK COUNTY, PENNSYLVANIA  
PHASE I INSPECTION REPORT  
NATIONAL DAM INSPECTION PROGRAM**

Name of Dam: SPRING GROVE DAM  
State & State No.: PENNSYLVANIA, 67-004  
County: YORK  
Stream: CODORUS CREEK  
Date of Inspection: APRIL 27, 1981

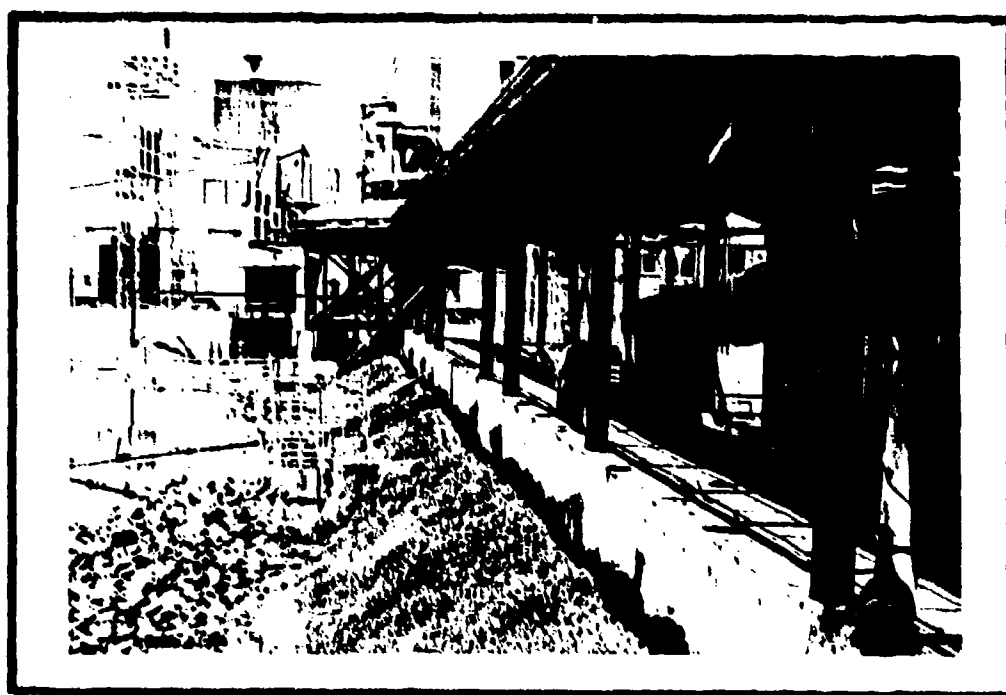
LEFT EMBANKMENT AND PARAPET WALL - NO. 3  
NOTE: BUILDING ON DOWNSTREAM SIDE

1. That the narrow crest between the parapet wall and the building be widened and the slope flattened.
2. That heavy rock for erosion protection be placed downstream of the spillway weir slab to prevent undermining of the slab.
3. That the flood control plan be expanded to include a downstream warning system.

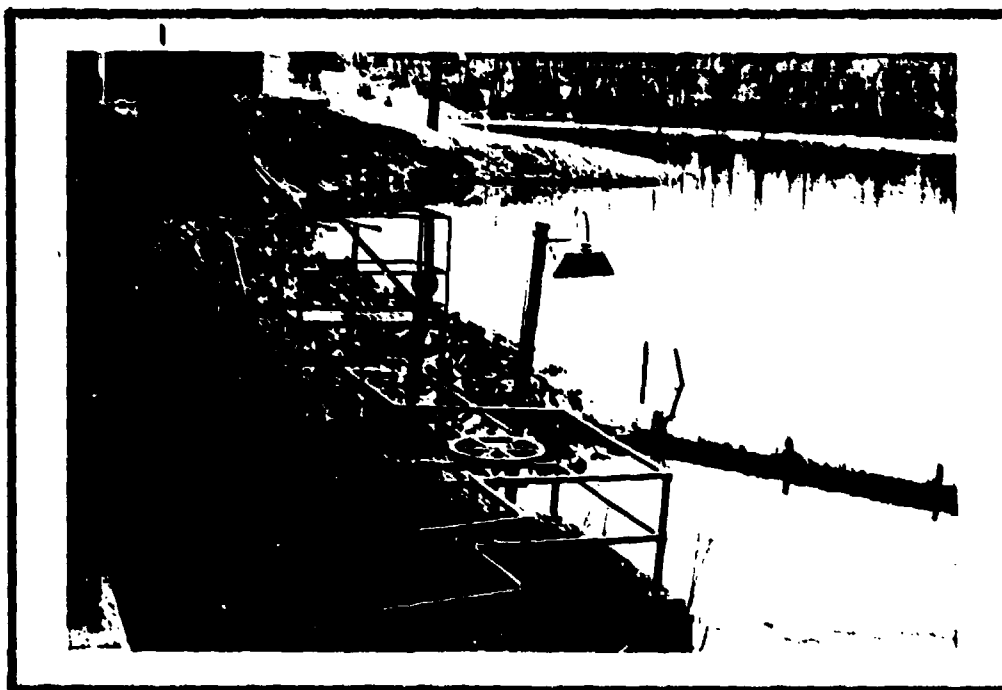
DETAIL OF VALVE CONTROLS - NO. 5

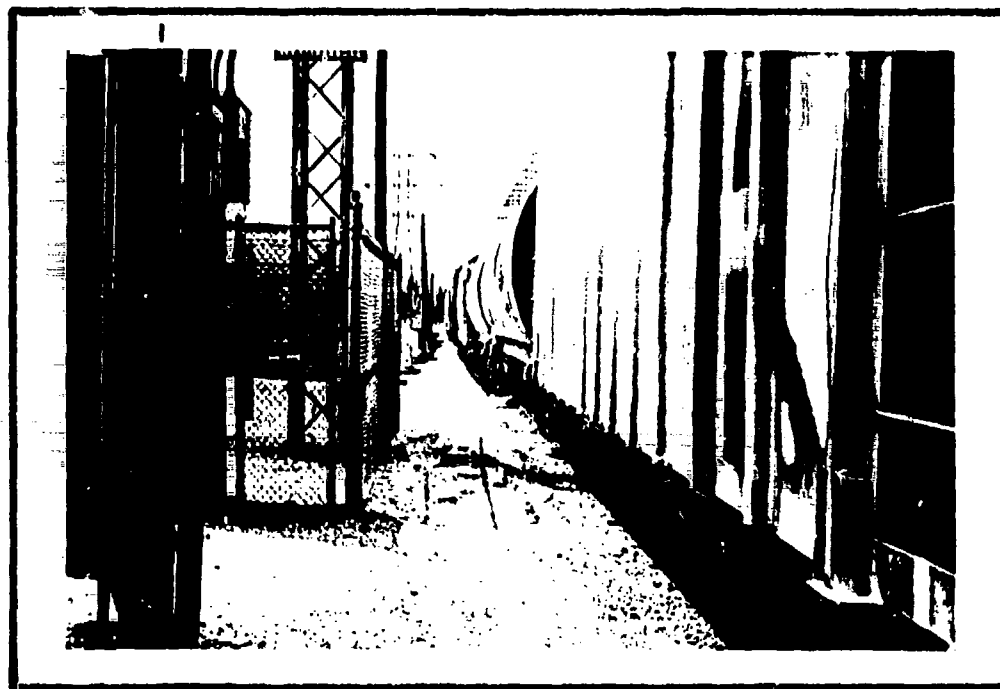
LOW AREA AT RAILROAD - NO. 8

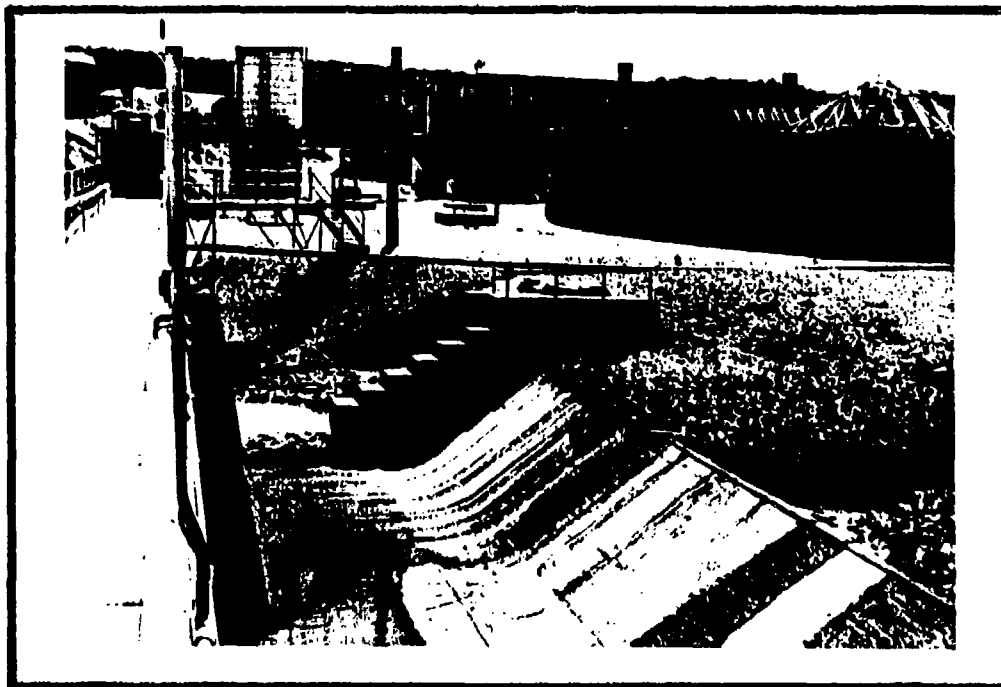
The spillway is located near the present right abutment of the embankment. The spillway abutment walls are massive concrete structures (Photographs No. 11 and 13). The left abutment has been tied into the new building with steel sheetpiling. The weir has a concrete surface and has deteriorated slightly (Photograph No. 14). At the downstream end of the concrete slab, there is a 2.0 to 2.5 foot deep pool. This pool is about 15 feet wide and has been caused by erosion during high discharges.

RIGHT ABUTMENT OF SPILLWAY - NO. 11

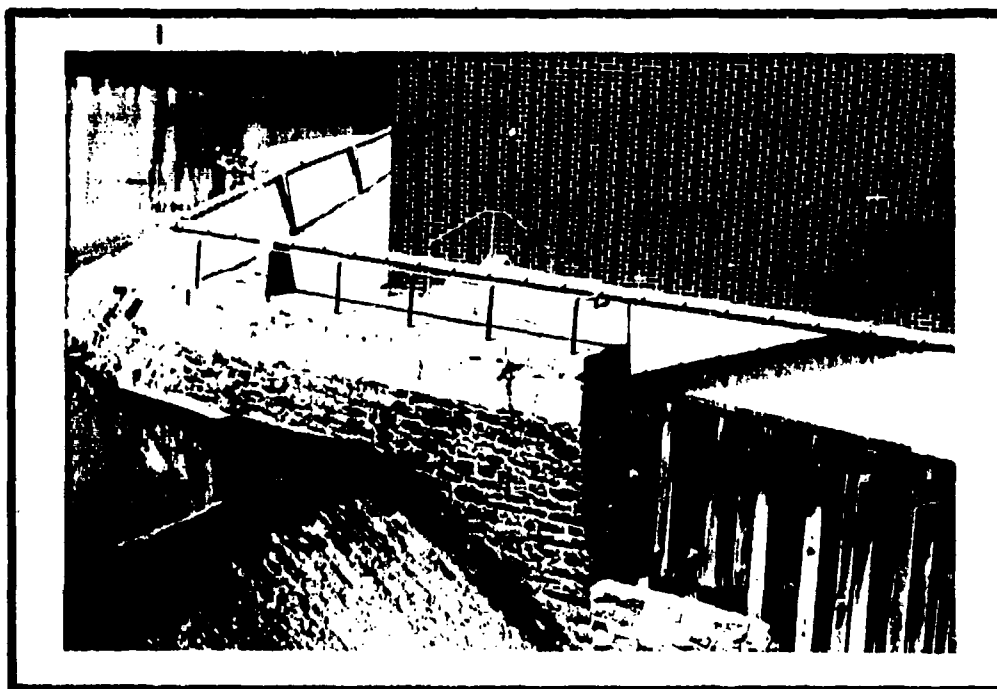
LEFT ABUTMENT OF SPILLWAY - NO. 13
