SUSQUEHANNA RIVER BASIN  
LAKE CONEWAGO DAM  
EASTERN ENTERPRISES, INC

NDI NO PA-00593  
DER NO 38-012

LEBANON COUNTY, PENNSYLVANIA  
PHASE I INSPECTION REPORT  
NATIONAL DAM INSPECTION PROGRAM

JULY 1981

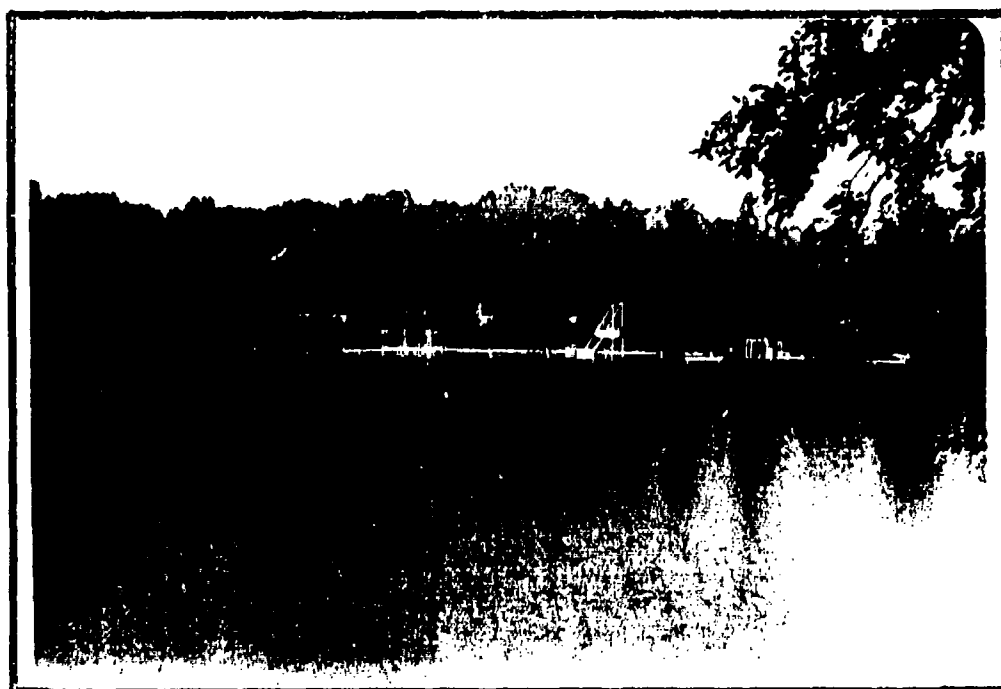
OVERVIEW OF RESERVOIR NO. - 11

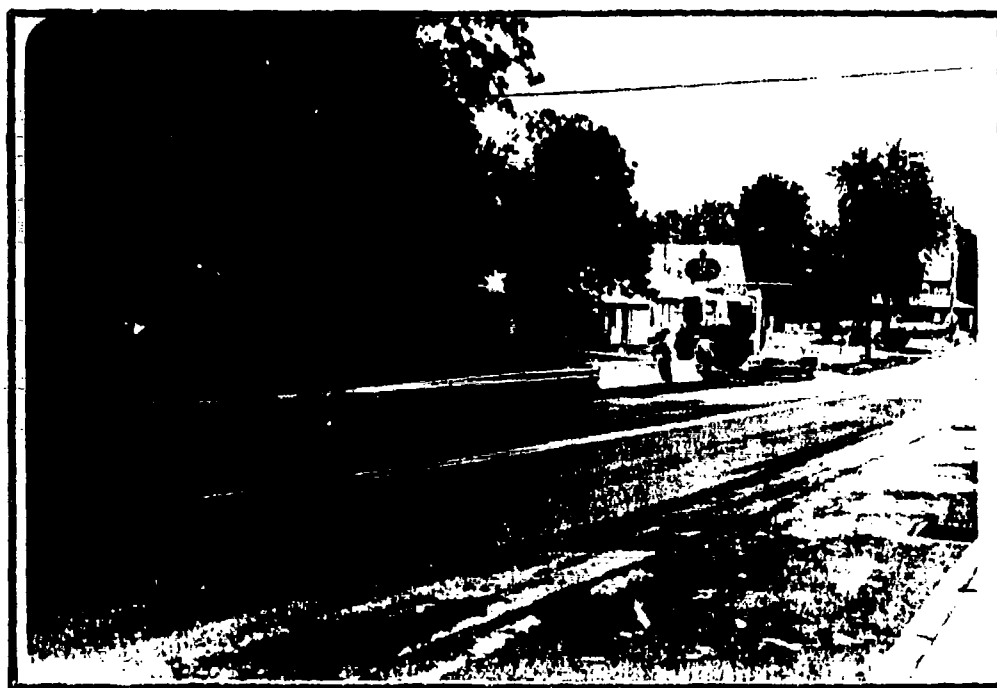
The immediate downstream channel of the spillway is a narrow channel with rock bottom and sides. A bridge with a waterway opening of 13.0 feet x 7.2 feet is located about 125 feet downstream. The Conewago Creek runs through a wooded area. A lumber company, two homes, a trailer, and a restaurant are located in the floodplain area about 2.5 miles downstream of the dam. A potential hazard to loss of life exists downstream if the dam fails. There is a possibility of the loss of a few lives. The hazard category is, therefore, considered to be "Significant."

OVERVIEW OF DAMAGE CENTER DOWNSTREAM LOOKING SOUTH NO. - 12
