PERCH POND DAM

NDI ID NO. PA-00135  
DER ID NO. 64-23

PHASE I INSPECTION REPORT  
NATIONAL DAM INSPECTION PROGRAM

AUGUST 1981

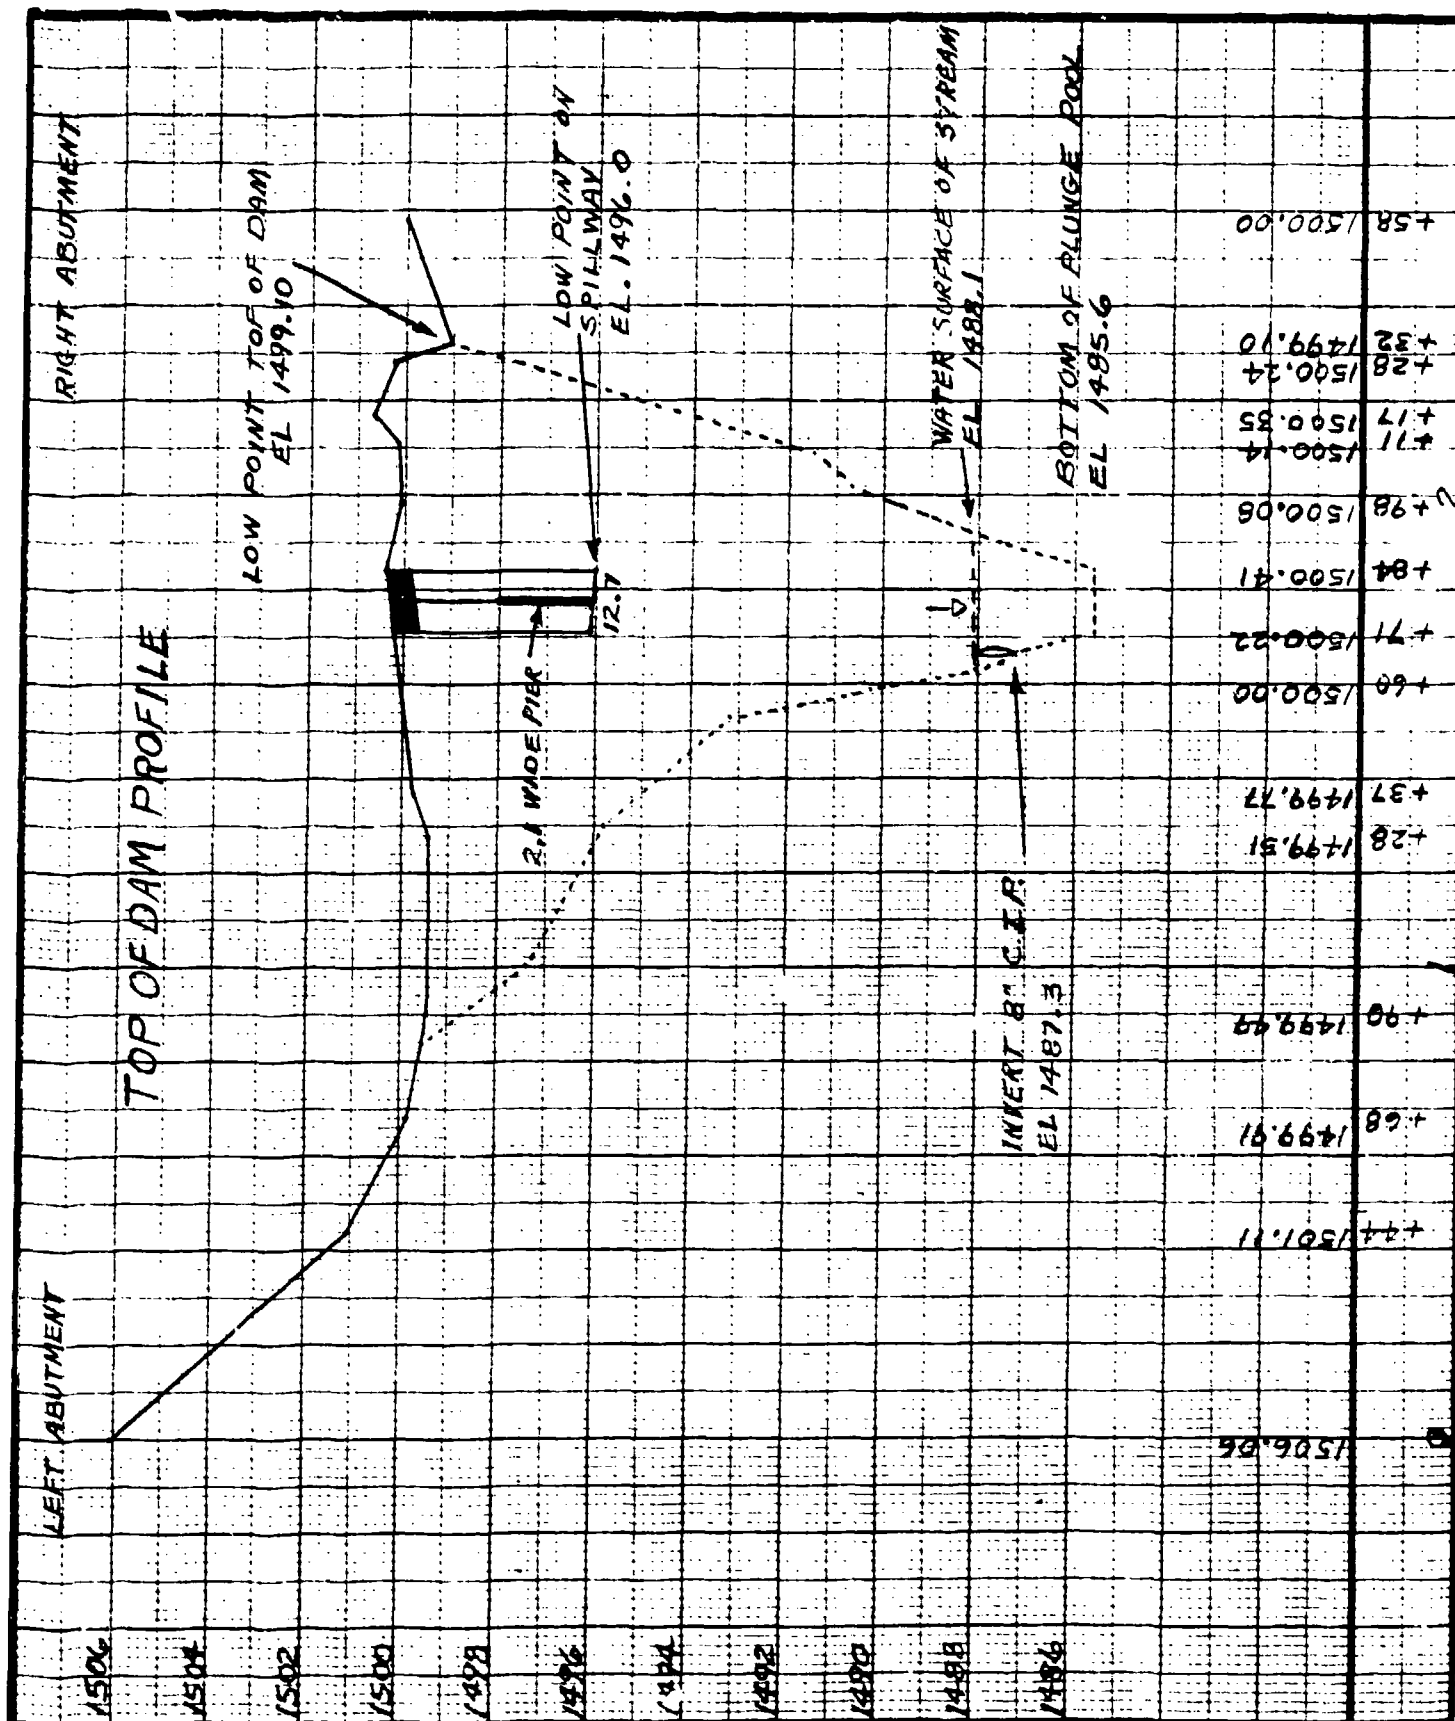
PERCH POND DAM  
GENERAL PLAN - FIELD INSPECTION NOTES

a. General: The overall appearance of the dam and appurtenances is fair. A plan of the dam and annotated field observations are shown on Exhibit A-1, Appendix A. Surveyed profiles and typical sections of the dam are presented in Exhibits A-2 and A-3. The survey datum for this inspection is based on the lake elevation shown on the USGS 7.5 Minute Quadrangle (see Exhibit E-1). Pertinent observed features are indicated on the photographs in Appendix C.
