MARSHALL LAKE DAM

NDI ID NO. PA-00985

PHASE I INSPECTION REPORT  
NATIONAL DAM INSPECTION PROGRAM

JULY 1981

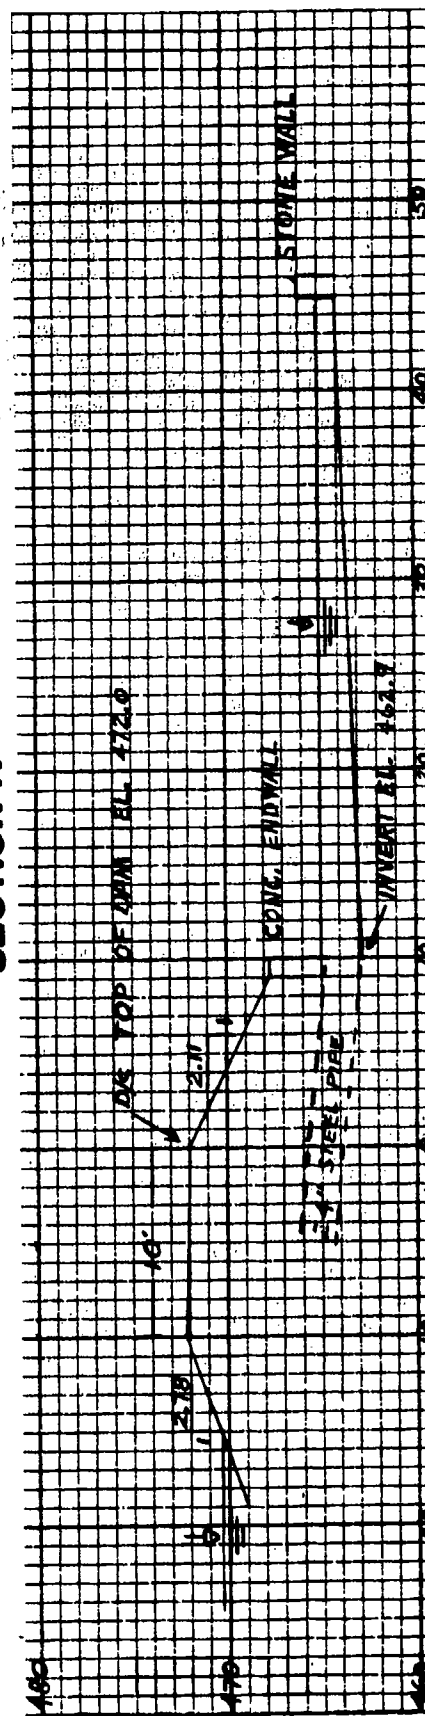
**OUTLET WORKS**

2. Outlet Works: The outlet works design features are described in paragraph 2.1b.(2)(b). The outlet of the 24-inch diameter steel pipe was submerged on the day of the inspection (see Outlet Works Section, Exhibit A-3 and Photograph 6, Appendix C). The concrete endwall terminal structure appears to be in good condition. There was no visible hoisting mechanism nor means of access to the reported upstream wooden gate at the inlet to the 24-inch diameter pipe.

(3) Locate and operate the submerged outlet works gate, or provide other emergency means of drawing down the reservoir. If the gate is operable, observe the conditions at the toe when the outlet pipe is subjected to pressure flow. Take appropriate action as necessary.
