SUSQUEHANNA RIVER BASIN  
DALTON RUN, LACKAWANNA COUNTY  
PENNSYLVANIA

GLENBURN POND DAM  
NDI ID NO. PA-00371  
DER ID NO. 35-1

PHASE I INSPECTION REPORT  
NATIONAL DAM INSPECTION PROGRAM

August 1981

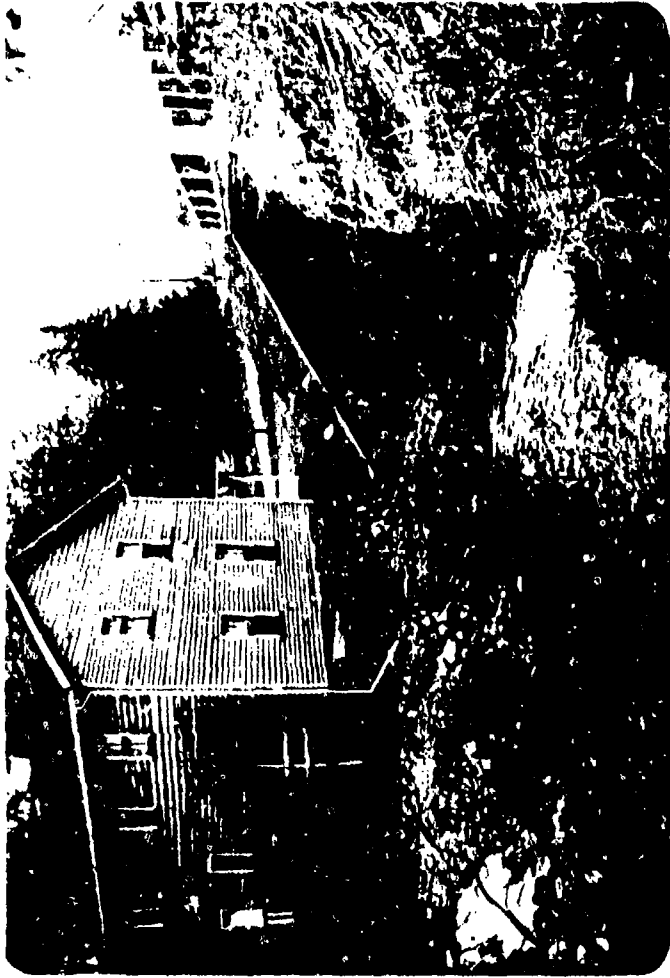
9. VIEW OF DUMPED STONE TO PROTECT HOME  
DOWNSTREAM OF HIGHWAY BRIDGE

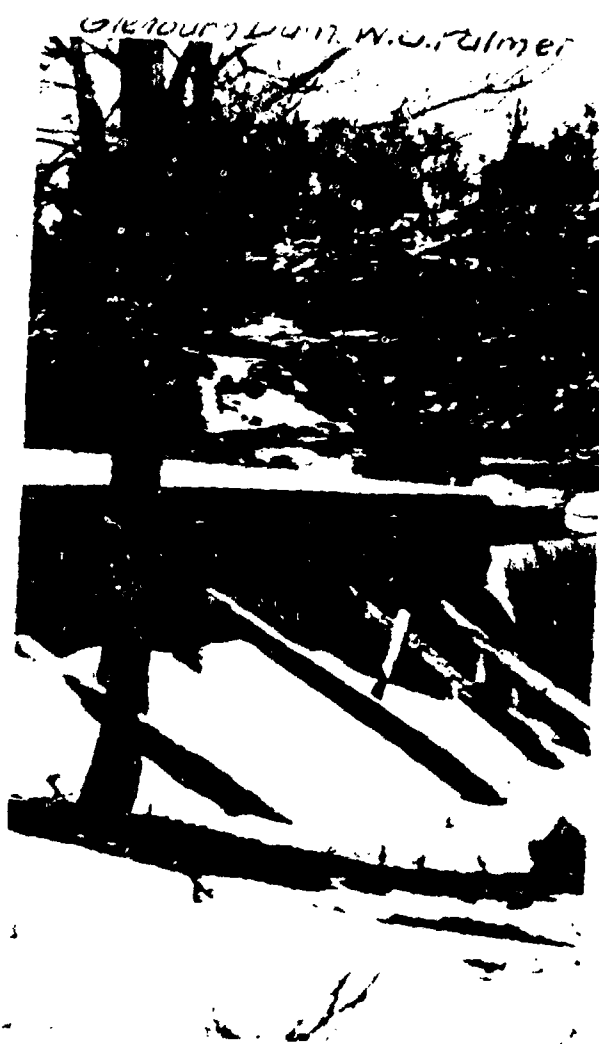
Construction of a temporary support (timber bracing) of the bulging right dry stone wall was necessitated prior to 1914. This temporary support was replaced by a dry stone buttress in 1926. Considerable leakage through the dam under the spillway weir was reported in 1956 and persists at the present time.

2. (1914 PHOTO) VIEW OF TEMPORARY SUPPORT OF RIGHT DRY STONE WALL
