NDI ID PA 00743

## NORTH ARROWHEAD LAKE DAM

PHASE I INSPECTION REPORT  
NATIONAL DAM INSPECTION PROGRAM

AUGUST 1981

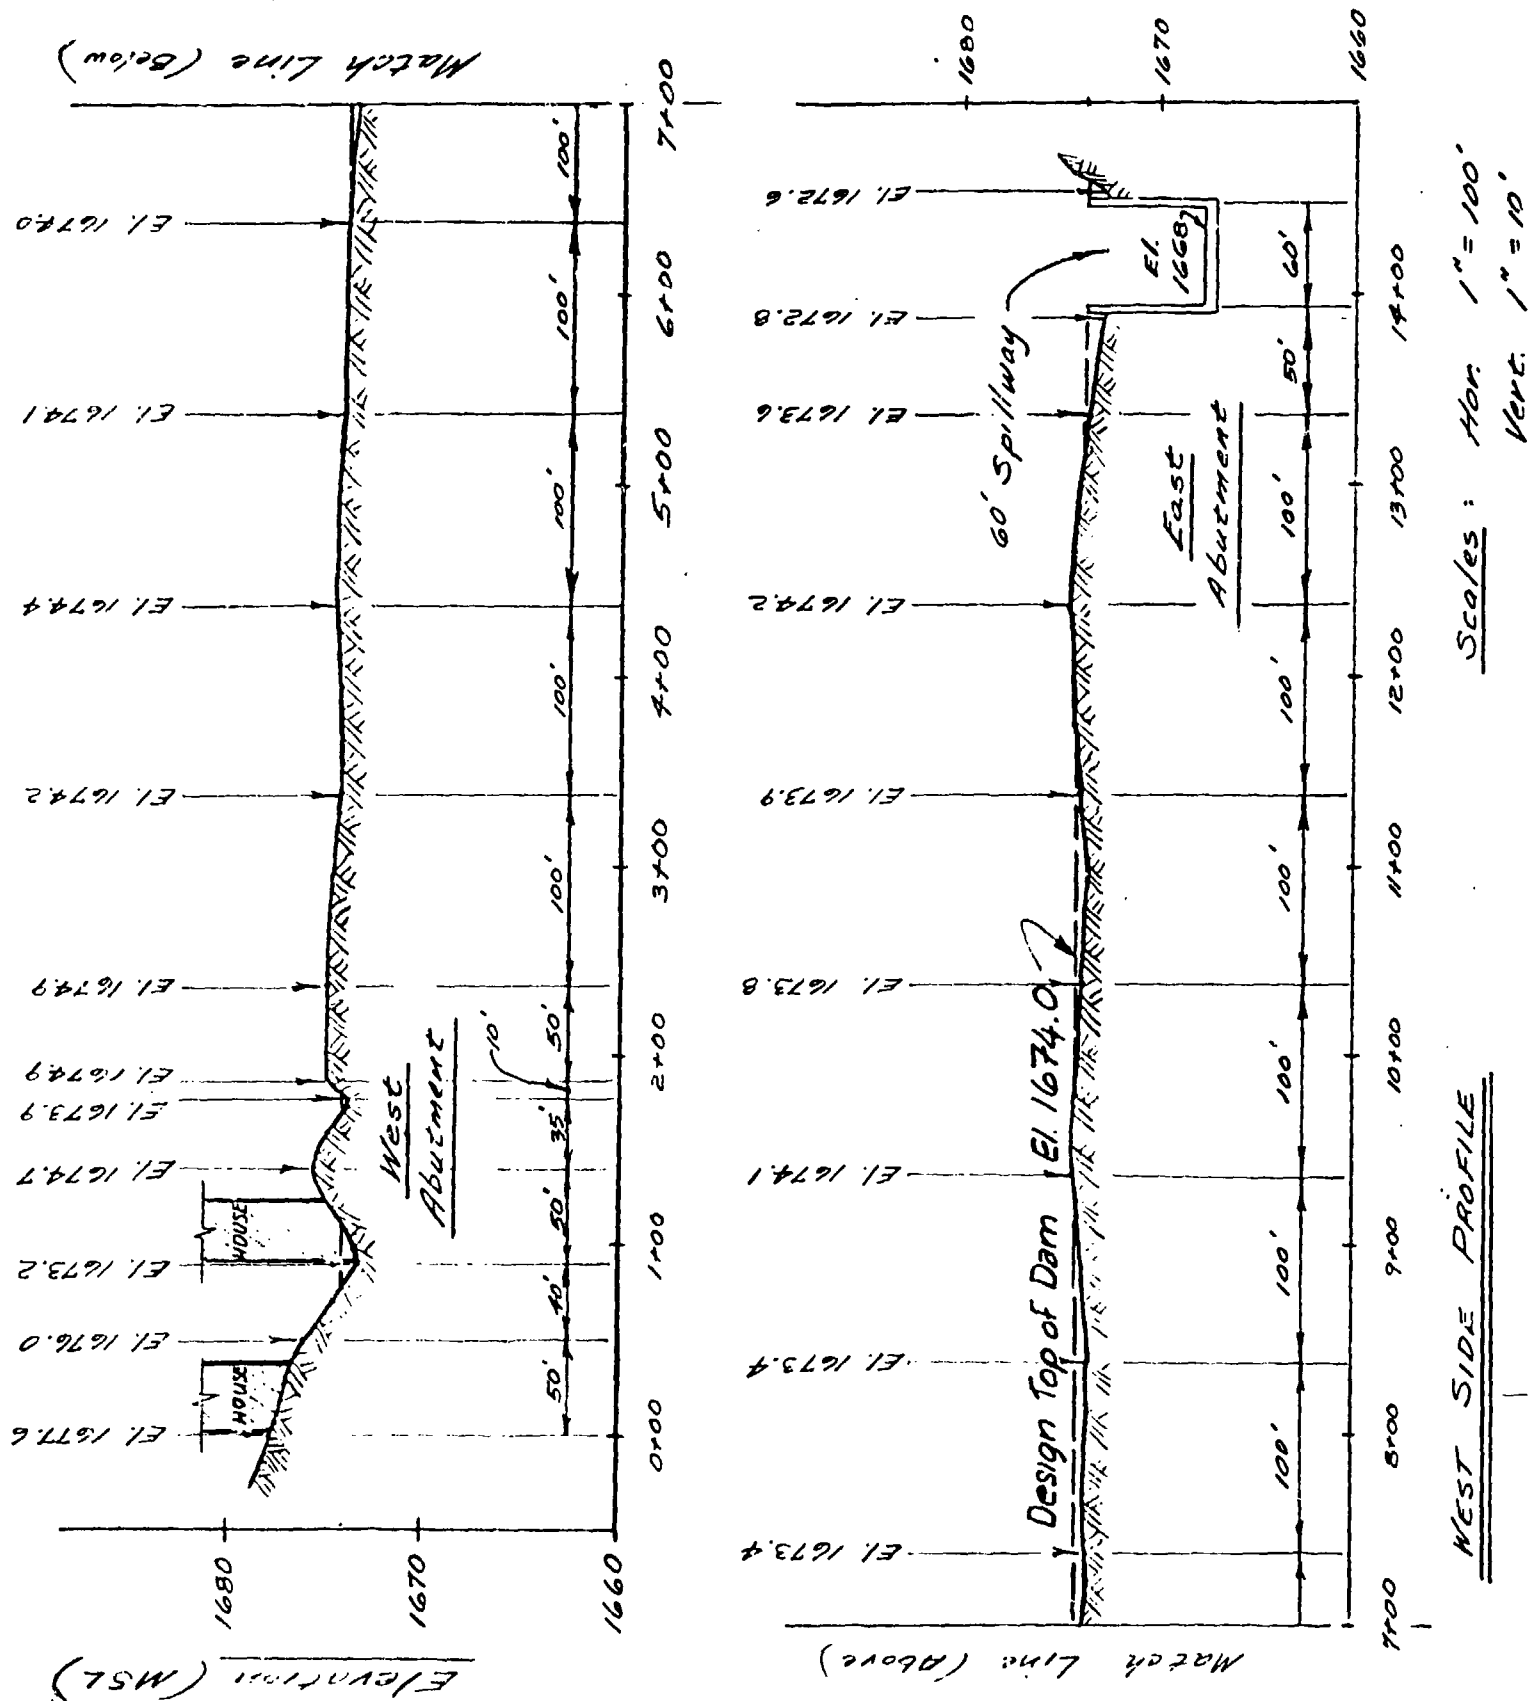
| Profile: N. Arrowhead Lake Dam | 11C | ADH | 4-30-81 | 1841.014 |

Low areas were observed near the west side  
abutment and on either side of the spillway  
inlet (see sheet 11C)
