DELAWARE RIVER BASIN  
SANDSPRING CREEK  
PENNSYLVANIA

## LAKE AKIBA DAM

### PHASE I INSPECTION REPORT NATIONAL DAM INSPECTION PROGRAM

AUGUST 1981

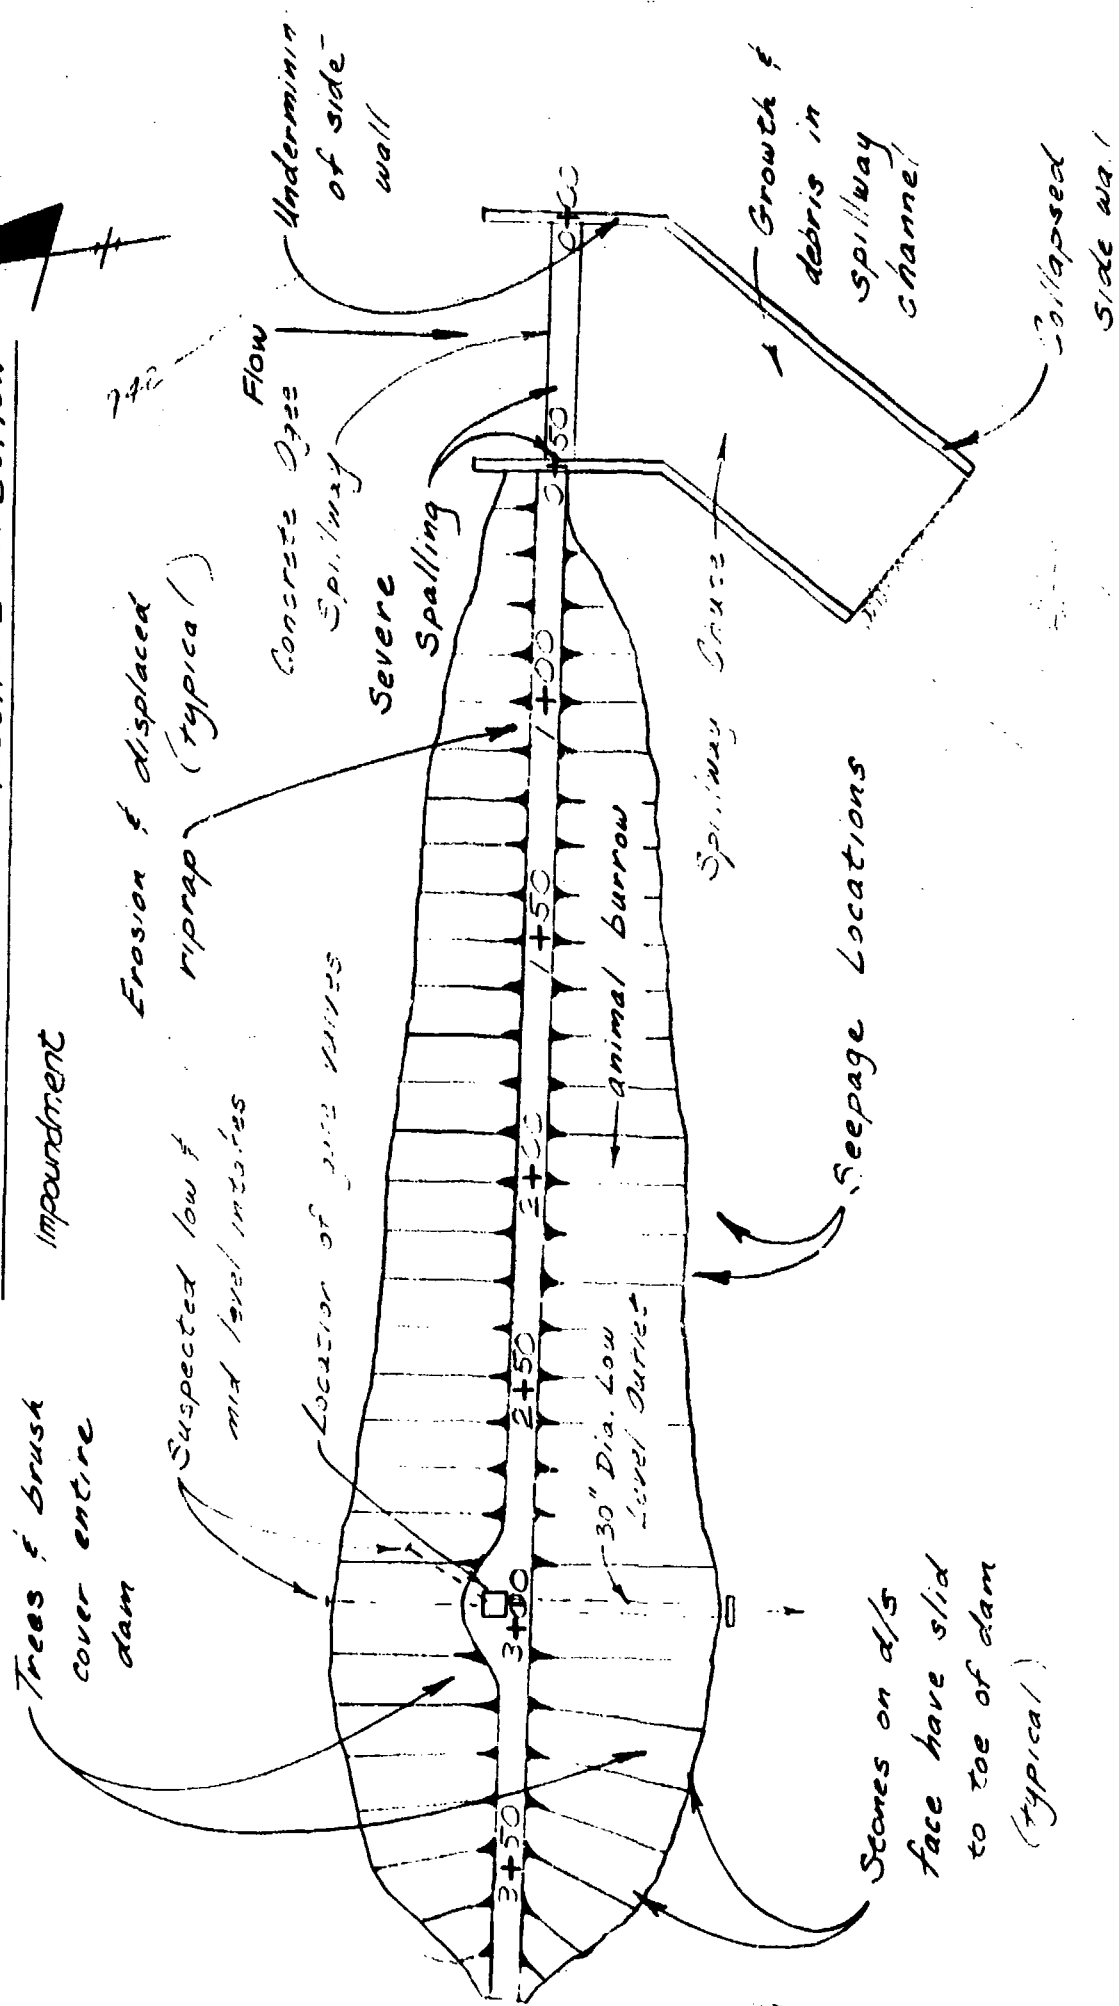
# LOCATION PLAN OF DEFICIENCIES OBSERVED DURING VISUAL INSPECTION

Seepage was found at two locations to the east of the outlet works (See sheet 11A of Appendix A). It was estimated to be approximately one gallon per minute at the western most location and no flow was observed at the other location (Photo 8, Appendix C).

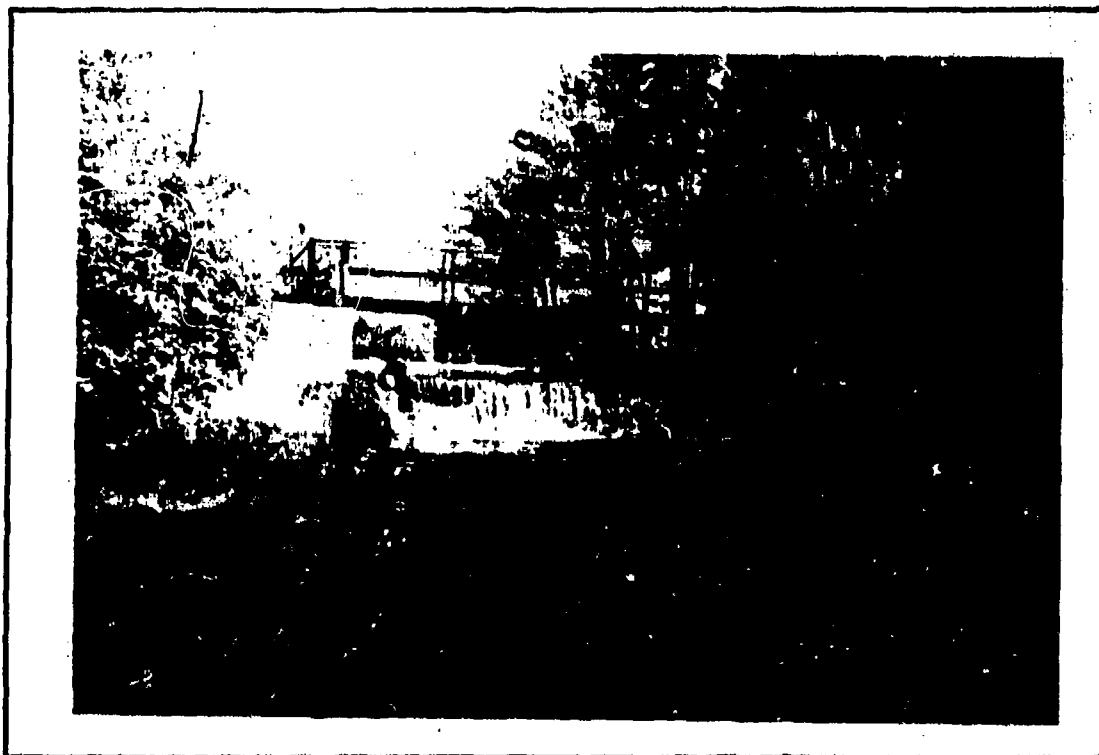
| <u>VISUAL EXAMINATION OF</u> | <u>OBSERVATIONS</u> | <u>REMARKS OR RECOMMENDATIONS</u> |
|---|---|---|
| DISCHARGE CHANNEL | <p>Channel sidewalls are overgrown and in poor structural condition. Much growth observed in channel. East side wall has collapsed. (Photos 4, 7, 10 and 11)</p> | <p>Replace sidewalls of channel.</p> <p>Clear invert of growth and miscellaneous debris.</p> |

4. LOOKING UPSTREAM OF THE SPILLWAY ADJACENT TO THE RIGHT  
ABUTMENT OF THE DAM. (5/20/81)
