NDI ID PA 00774  
PA DER 45-136

## HUNTER LAKE DAM

OWNED BY  
THE GOLDEN SLIPPER SQUARE CLUB  
PHASE I INSPECTION REPORT  
NATIONAL DAM INSPECTION PROGRAM

AUGUST 1981

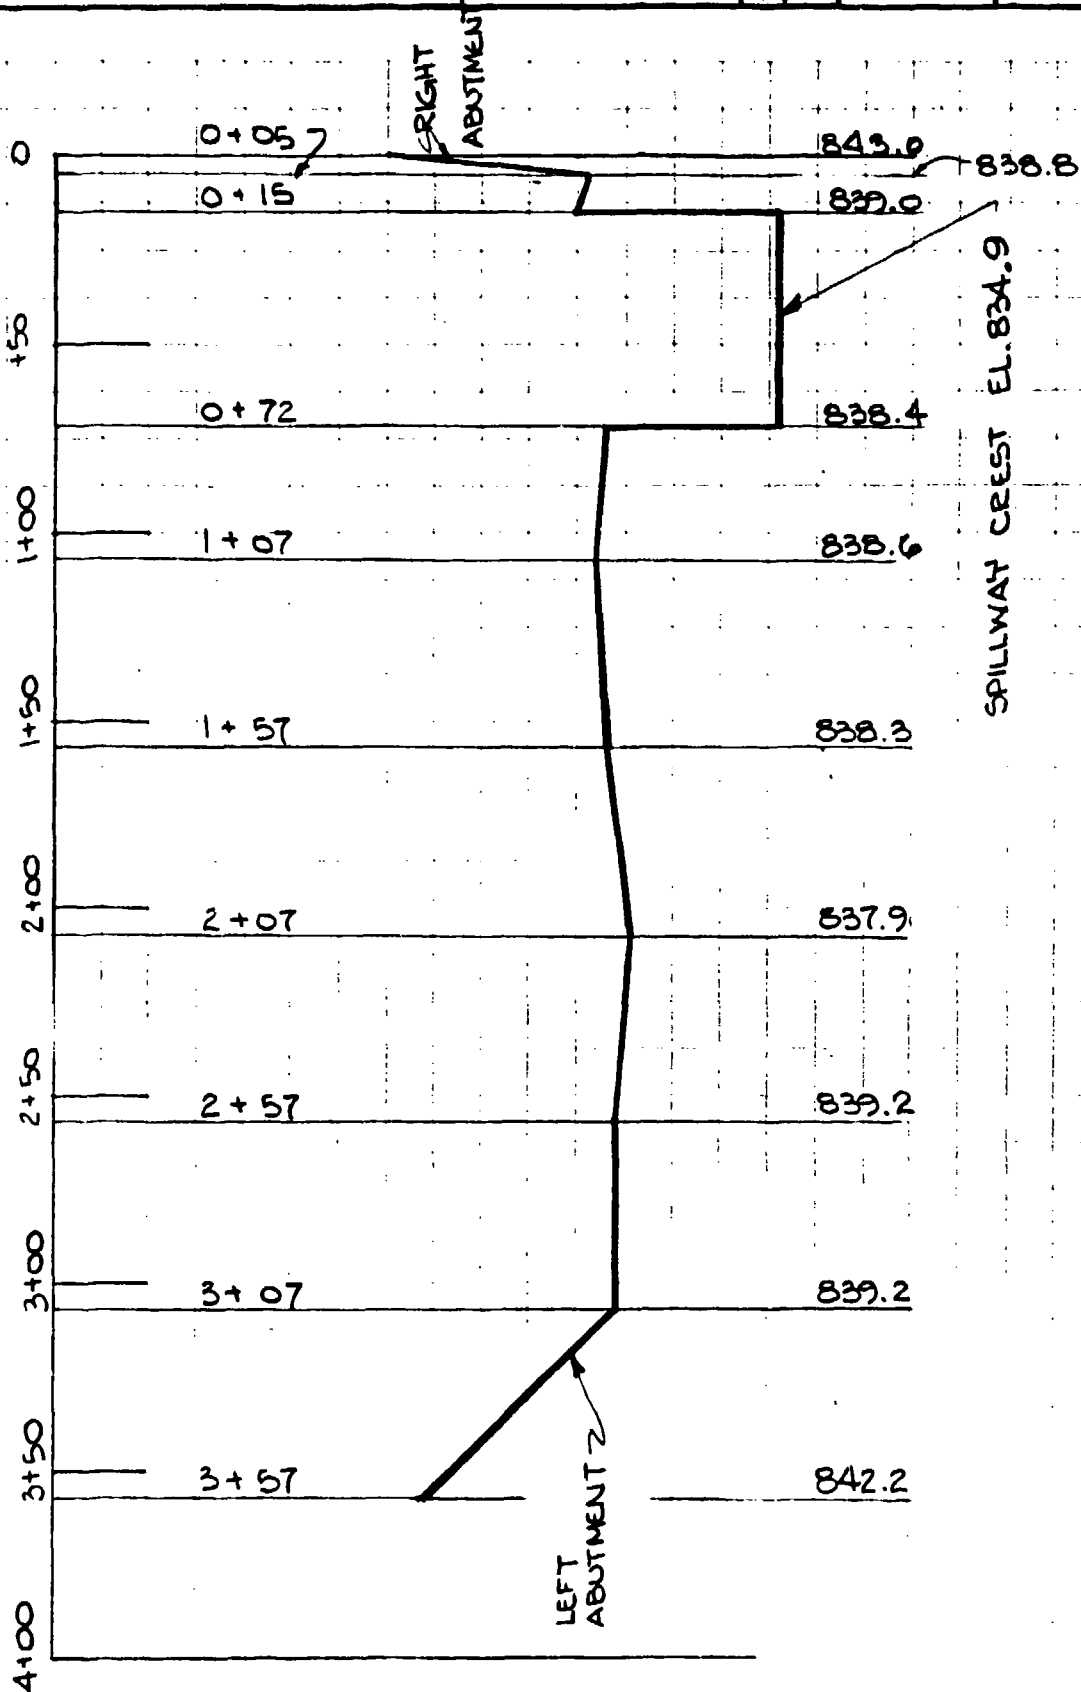
PROFILE CENTERLINE TOP OF DAM  
LOOKING DOWNSTREAM

The crest of the dam is covered with grass. No signs of settlement or misalignment were observed in the embankment. A survey along the centerline of the crest of the dam was made by the inspection team and is shown in Appendix A, Sheet 11B.
