SUSQUEHANNA RIVER BASIN  
LAKE STRAUSE DAM  
LAKE STRAUSE INCORPORATED

NDI NO. PA-01010,  
DER NO. 38-068

LEBANON COUNTY, PENNSYLVANIA  
PHASE I INSPECTION REPORT  
NATIONAL DAM INSPECTION PROGRAM

JULY 1981

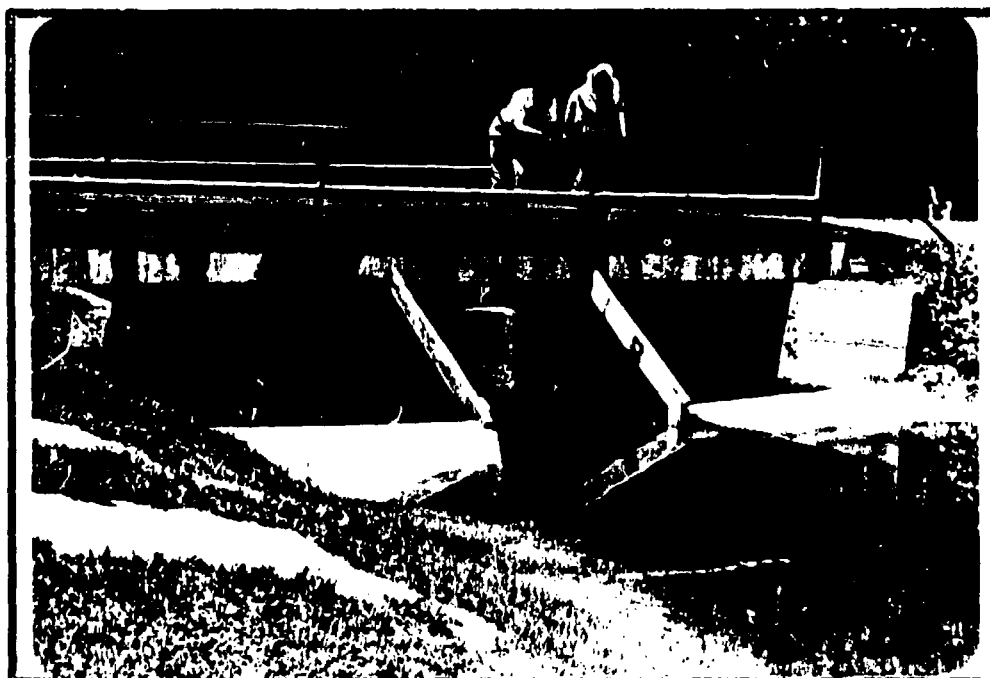
ends of the poles (Photograph No. 7). A two-span bridge with a center pier crosses the spillway. About 16 feet downstream of the bridge, the concrete discharge channel drops vertically 3.5 feet (Photograph No. 8), and from this point the channel is a rock lined channel. The concrete section, from the weir to the drop, is in fair condition with only minor deterioration.

It was noted that the wooden low flow diversion on the spillway was not secured tightly. The possibility exists that this device could break loose and obstruct the spillway.

The concrete, broad crested spillway appeared to be in good condition. The construction of the low flow diversion by placing the telephone poles does not affect the structural stability. The struts and loose poles could, however, restrict the waterway opening.

WEIR OF SPILLWAY AND ROADWAY BRIDGE NO. - 7

4. That the struts in the spillway be removed and that the wooden waterway diversion poles be secured by other means.
5. That a formal surveillance and downstream warning system be developed for use during periods of high or prolonged rainfall.
6. That an operation and maintenance manual be prepared for guidance in the operation of the dam during normal and emergency conditions, and that a schedule be developed for the annual inspection of the dam and its appurtenant structures.
