PENNSYLVANIA  
**BENTLEYVILLE DAM LEVEL II**

NDI ID NO. PA-1096

BENTLEYVILLE WATER AUTHORITY

PHASE I INSPECTION REPORT  
NATIONAL DAM INSPECTION PROGRAM

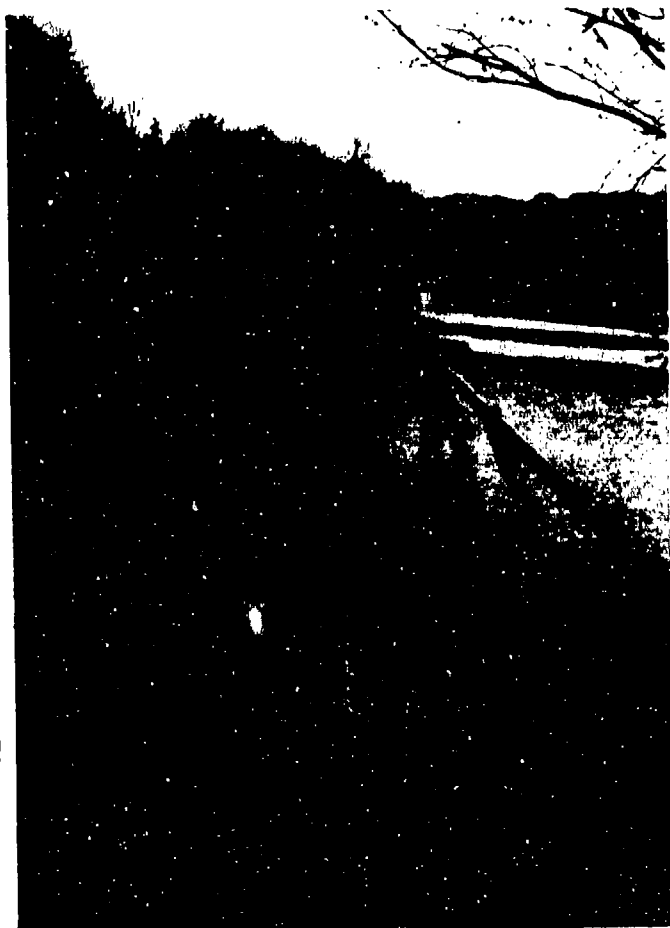
The drainline control structure located on the upstream slope of the dam was observed to be in a deteriorating condition. An abandoned foot bridge serves as access to the control structure. The control for the gate valve housed in the control structure was observed to be very badly rusted, and apparently not capable of serving to control the valve. The valve on the downstream end of the drainline was visible, and the valve was in the open position. No flow was observed discharging from the line.

1. It should be ascertained whether the upstream shutoff for the 12" cast iron pipe is operable. If it is found that the valve is not operable, it should be made operable or some other method devised to drain the reservoir. If the valve is operable, it should be operated and lubricated on a regular basis.
