**POND No.4 DAM**

ROCHESTER AND PITTSBURGH COAL COMPANY

**PHASE I INSPECTION REPORT  
NATIONAL DAM INSPECTION PROGRAM**

POND NO. 4 DAM  
INDIANA COUNTY, COMMONWEALTH OF PENNSYLVANIA  
NDI No. PA 00851  
PENN DER No. 32-81

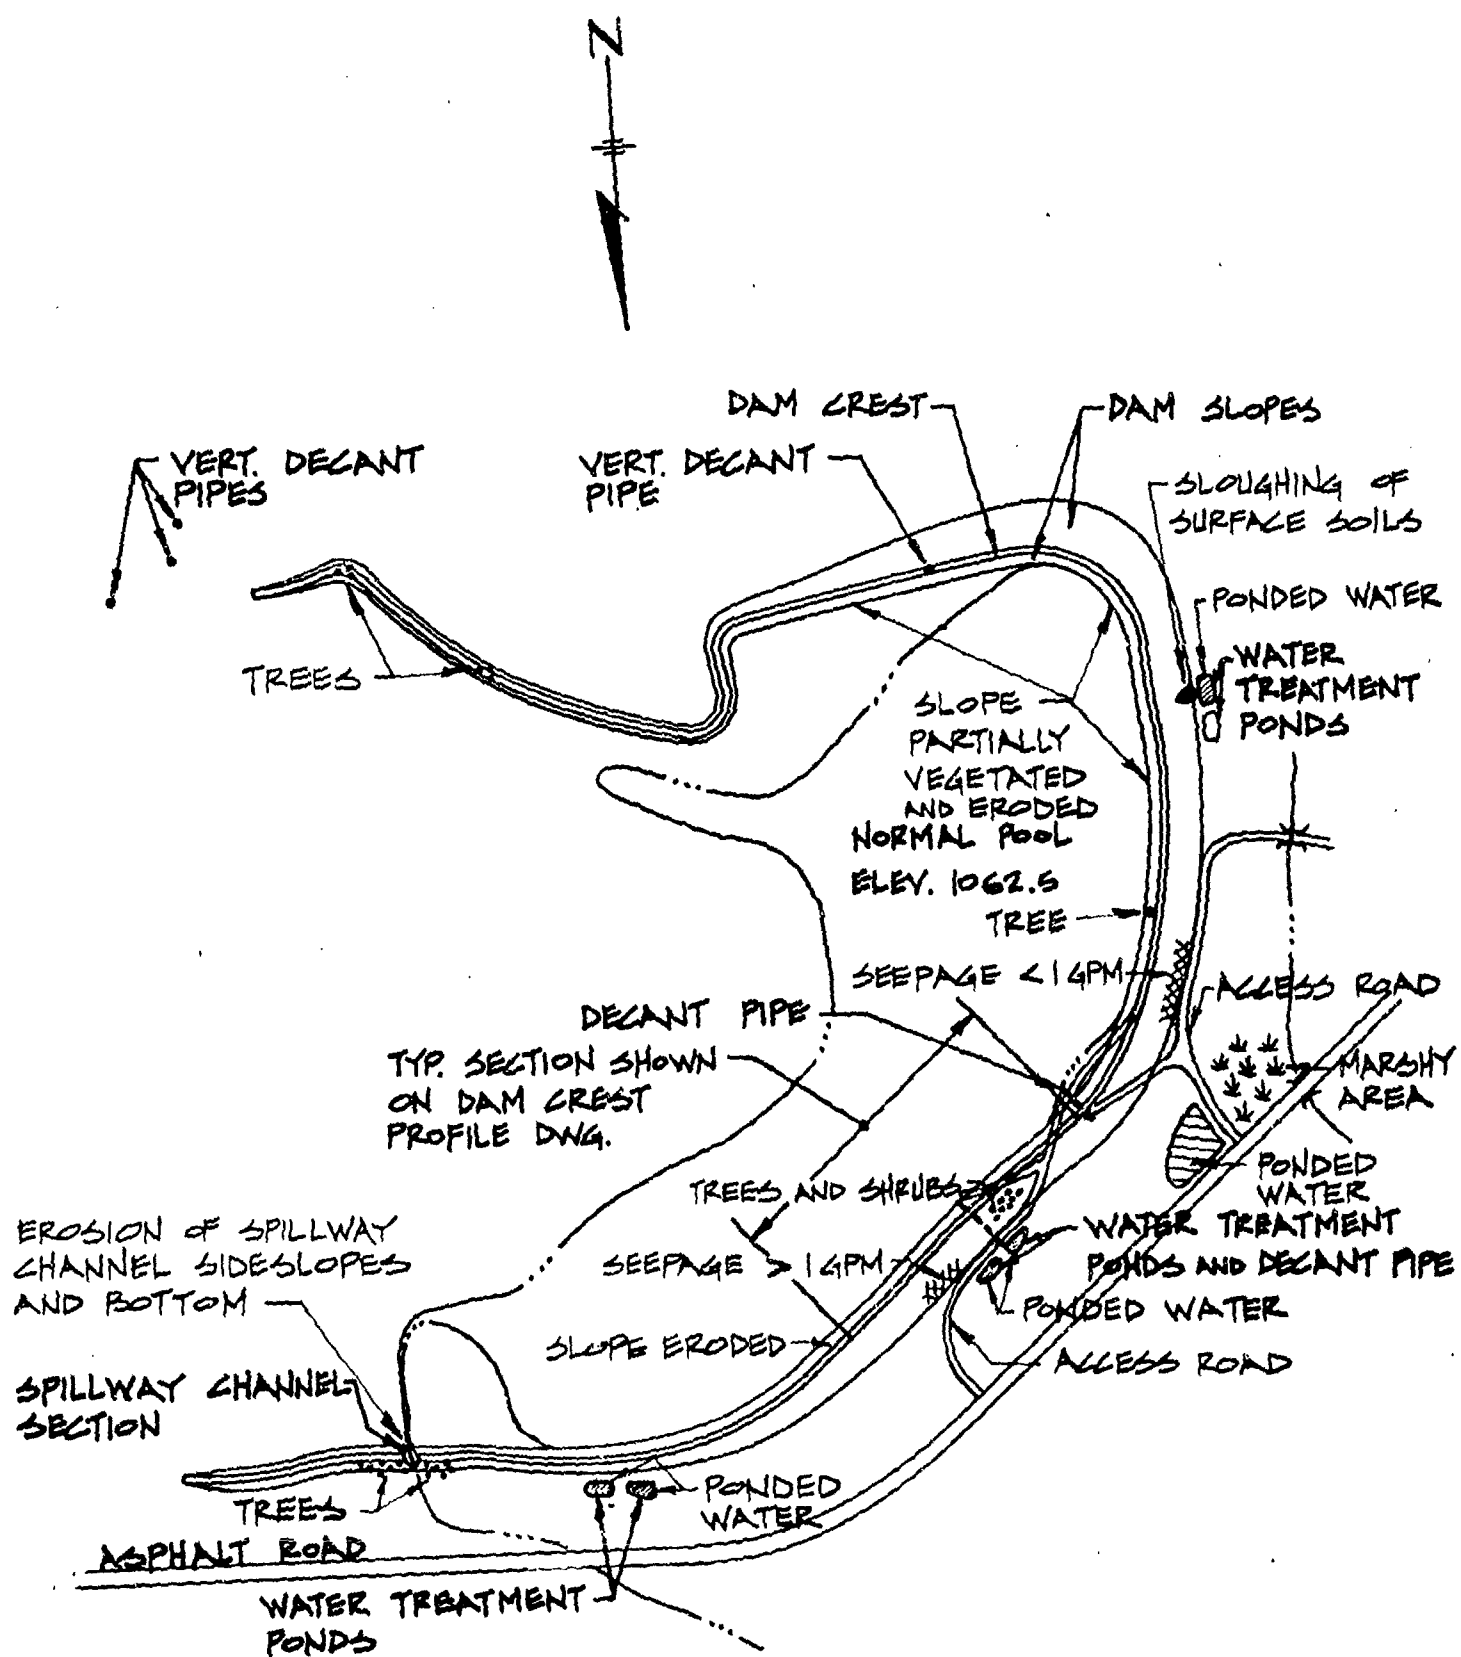
FIELD SKETCH  
POND No. 4 DAM

2. Seepage: Seepage zones were observed along the downstream embankment toe at the locations shown on the Field Sketch. The seepage zones were generally small in surface area and had estimated flow rates of about 1 gpm. There was no visible evidence of erosion channels or movement of soil fines at either discharge. However, the dense vegetation cover may have obscured the presence of soil fines or erosion. A notable increase in vegetation cover and growth was also observed at these areas and along the embankment toe.

1. Outlet Works: Four 6 inch diameter vertical decant pipes were observed at the locations shown on the Field Sketch. All vertical decant pipes were partially or fully clogged and buried within 2 to 3 feet of the capped top end section. None of the existing vertical decant pipes appeared functional. Refer to Photograph No. 6.

| <u>VISUAL EXAMINATION OF</u> | <u>OBSERVATIONS</u> | <u>REMARKS OR RECOMMENDATIONS*</u> |
|---|---|---|
| SLOUGHING OR EROSION OF EMBANKMENT AND ABUTMENT SLOPES | Minor sloughing of downstream embankment slope was evident at one location. Embankment erosion was also observed at several unprotected slope areas. Refer to Field Sketch. | |

| VISUAL EXAMINATION OF | OBSERVATIONS | REMARKS OR RECOMMENDATIONS |
|---|---|---|
| ANY NOTICEABLE SEEPAGE | Seepage observed along downstream embankment toe at several locations. Seepage observed clear, with flow rates of about 1 gpm. location of seeps. | Refer to Field Sketch for |
