MINE No. 51 - POND 3

BETHLEHEM MINES CORPORATION  
ELLSWORTH - BUTLER DIVISION

PHASE I INSPECTION REPORT  
NATIONAL DAM INSPECTION PROGRAM

JULY 1981

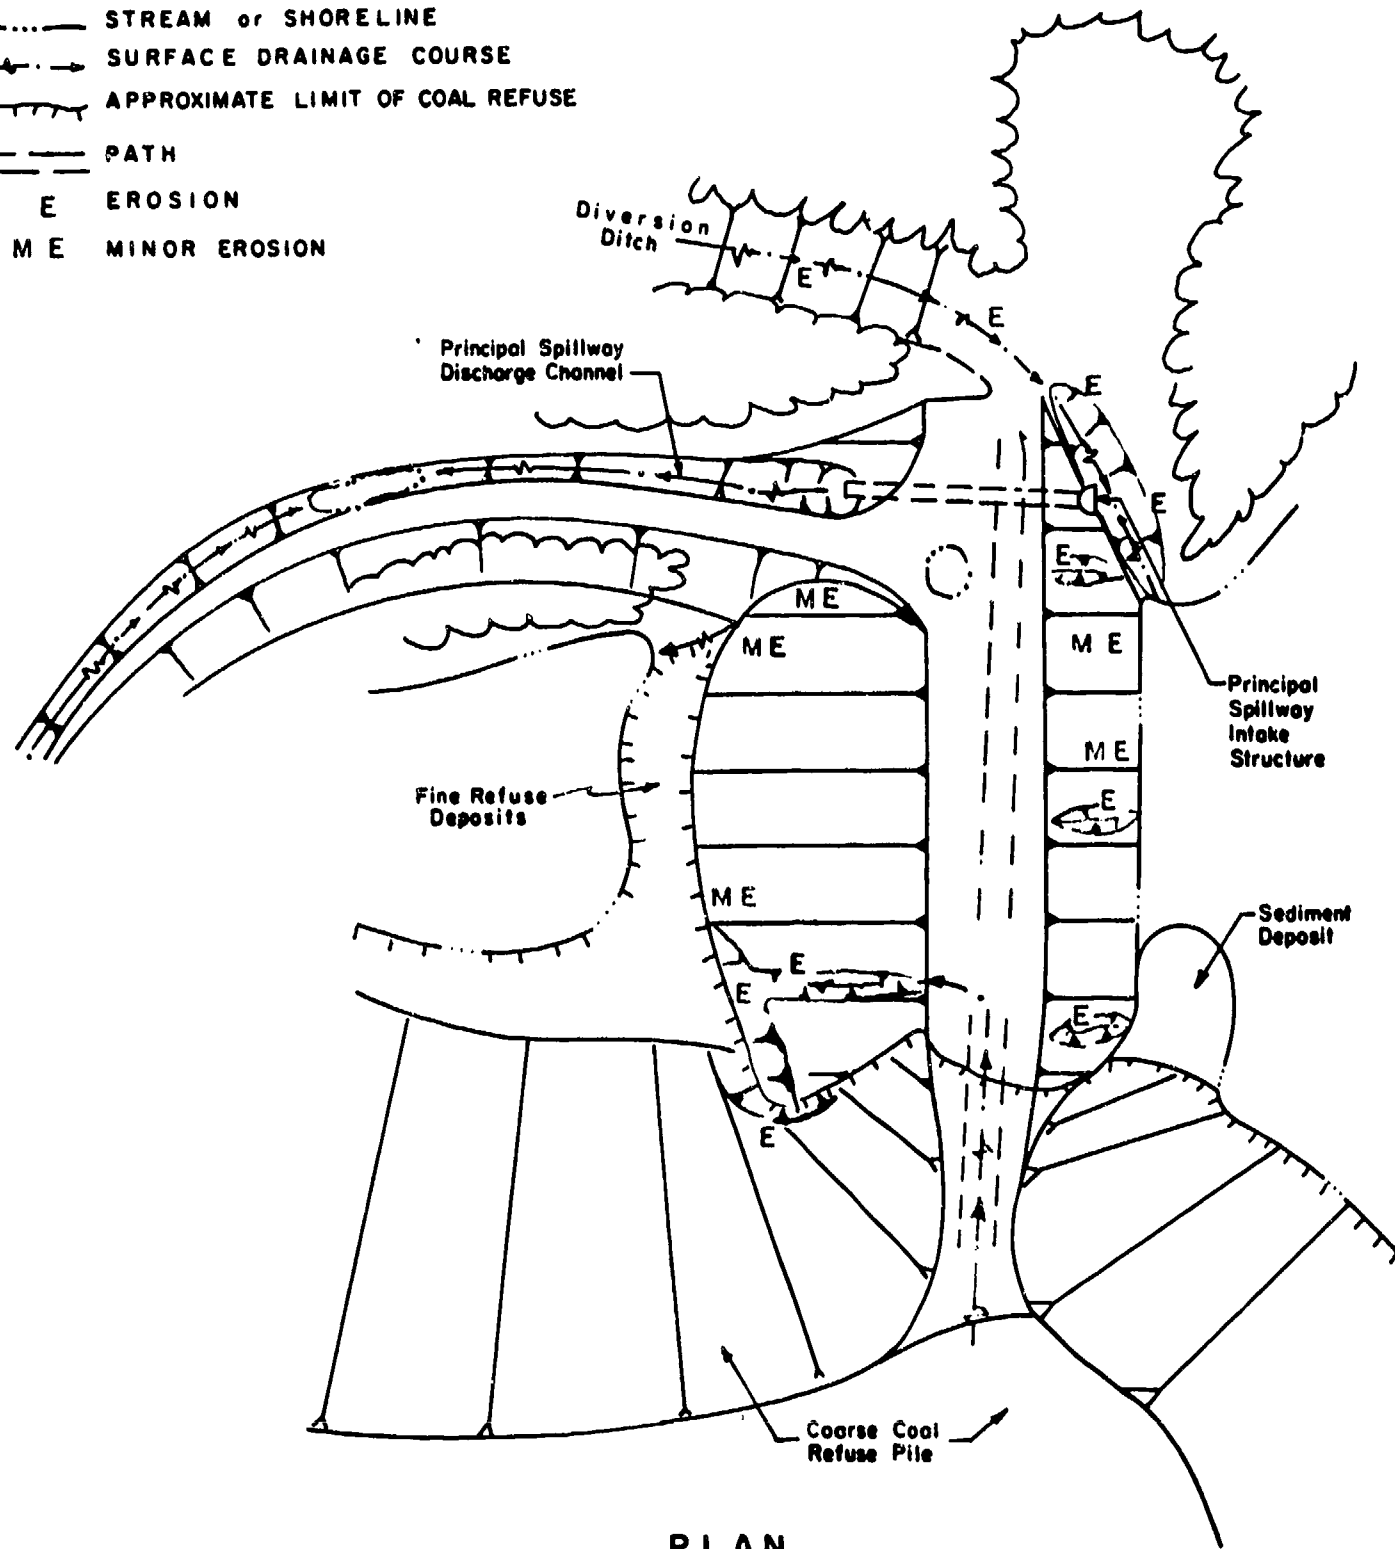
| DWG. NO. 80138H-1 | | |

- T IMPOUNDING EMBANKMENT SLOPE
- Y OTHER SLOPES
- STREAM or SHORELINE
- SURFACE DRAINAGE COURSE
- APPROXIMATE LIMIT OF COAL REFUSE
- PATH
- E EROSION
- M E MINOR EROSION
