NDI No. PA 00838  
PENN DER No. 2-50

## RENTON SLURRY POND 3

PHASE I INSPECTION REPORT  
NATIONAL DAM INSPECTION PROGRAM

JULY 1981

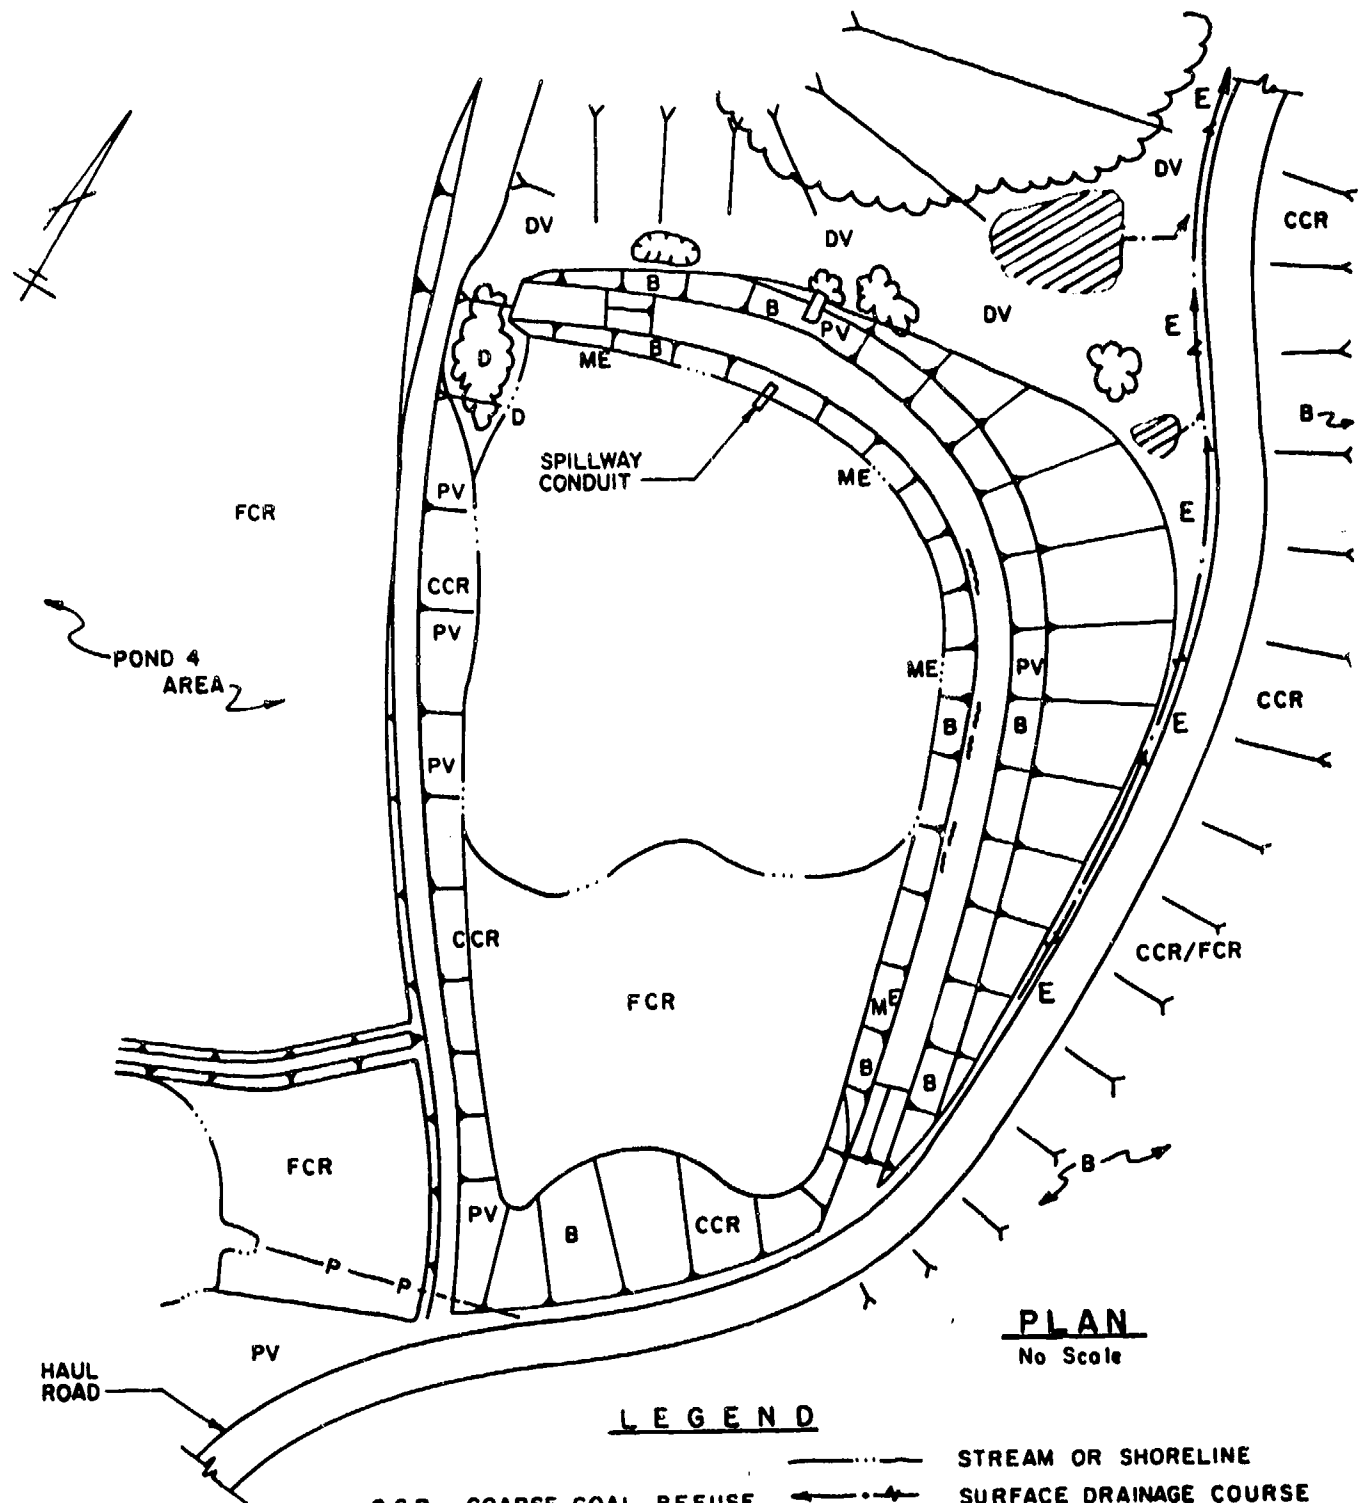
| <u>VISUAL EXAMINATION OF</u> | <u>OBSERVATIONS</u> | <u>REMARKS OR RECOMMENDATIONS</u> |
|---|---|---|
| <b>SURFACE CRACKS</b> | <p>Randomly oriented drying cracks observed on embankment crest. Cracks closed to very slight opening.</p> <p>Several minor tensional cracks were observed along the junction of the crest and the upstream and downstream slopes. All cracks appeared to be shallow and no scarps were observed.</p> | |

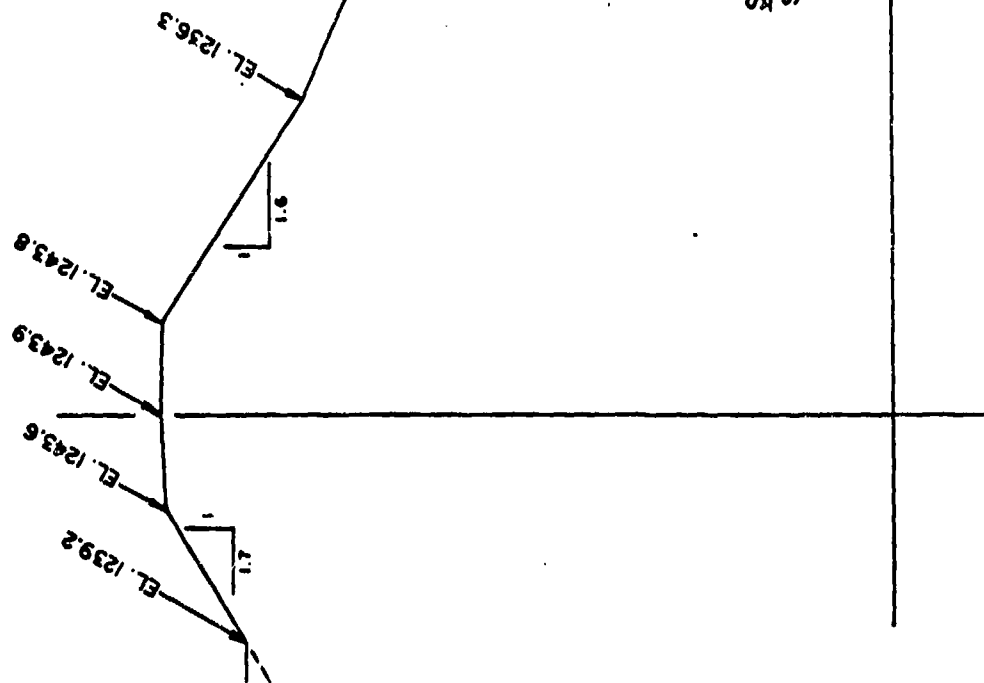
**SECTION A-A**

There were no observed indications of significant slope instability such as scarps or bulges. Several small tension cracks were observed near the crest in the recently placed earthen dike materials.
