RUSSELLTON SLURRY POND 3

REPUBLIC STEEL CORPORATION

PHASE I INSPECTION REPORT
NATIONAL DAM INSPECTION PROGRAM

RUSSELLTON SLURRY POND 3
ALLEGHENY COUNTY, COMMONWEALTH OF PENNSYLVANIA
NDI NO. PA 00839
PennDER NO. 2-52

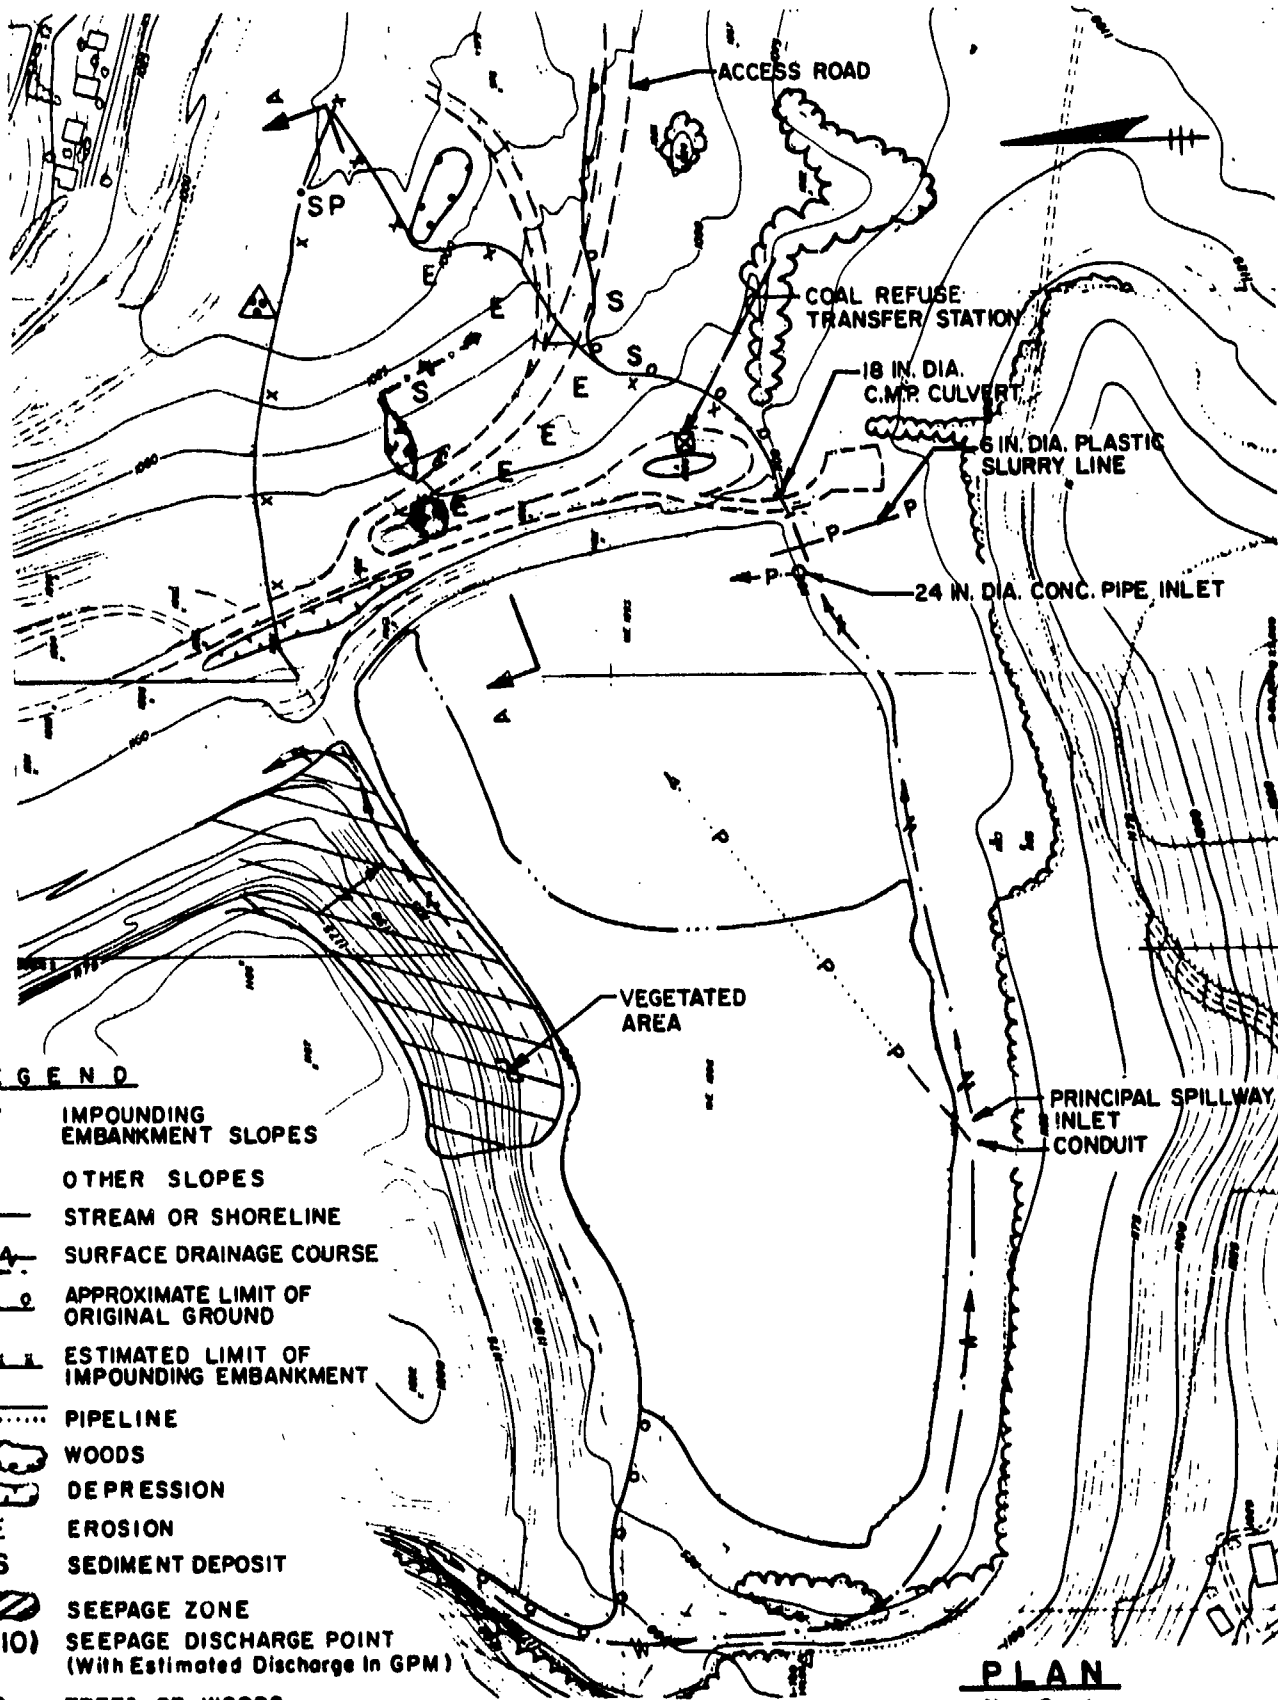
DATE: JULY 1981		RUSSELLTON SLURRY POND 3		FIELD SKETCH
SCALE: NONE		NATIONAL DAM INSPECTION PROGRAM		
DR: JF	CK:	ACKENHEIL & ASSOCIATES CONSULTING ENGINEERS		
DWG. NO. 80138L-1		GEO SYSTEMS, INC. 1000 BANKSVILLE RD./PITTSBURGH, PA. 15219		SHEET 1 of 2

Considerable erosion of the downstream slope has taken place as a result of surface runoff. Several deep gullies were observed that appeared to be local drainage channels. Sediment deposits resulting from embankment erosion were observed at several places. In general, the erosion, though significant in some places, did not appear to pose a threat to the embankment in terms of undercutting of slopes and erosion of embankment support.

A major seepage zone was observed in the downstream channel approximately 1,500 feet below the crest of the embankment. Several springs discharging up to 20 to 25 gpm were flowing approximately at the interface of the coarse coal refuse and the original ground surface. Considerable iron staining and some algae growth were observed immediately below the spring discharge points. Approximately 100 feet below, the spring flows entered a small depression that provided a sedimentation basin for channel flows. Considerable very fine, soft sediments were observed on the bottom of the depression. The origin of these materials could not be determined. Inflow to the sediment basin was generally clear, and discharge from the pond area was estimated at between 40 and 50 gallons per minute.

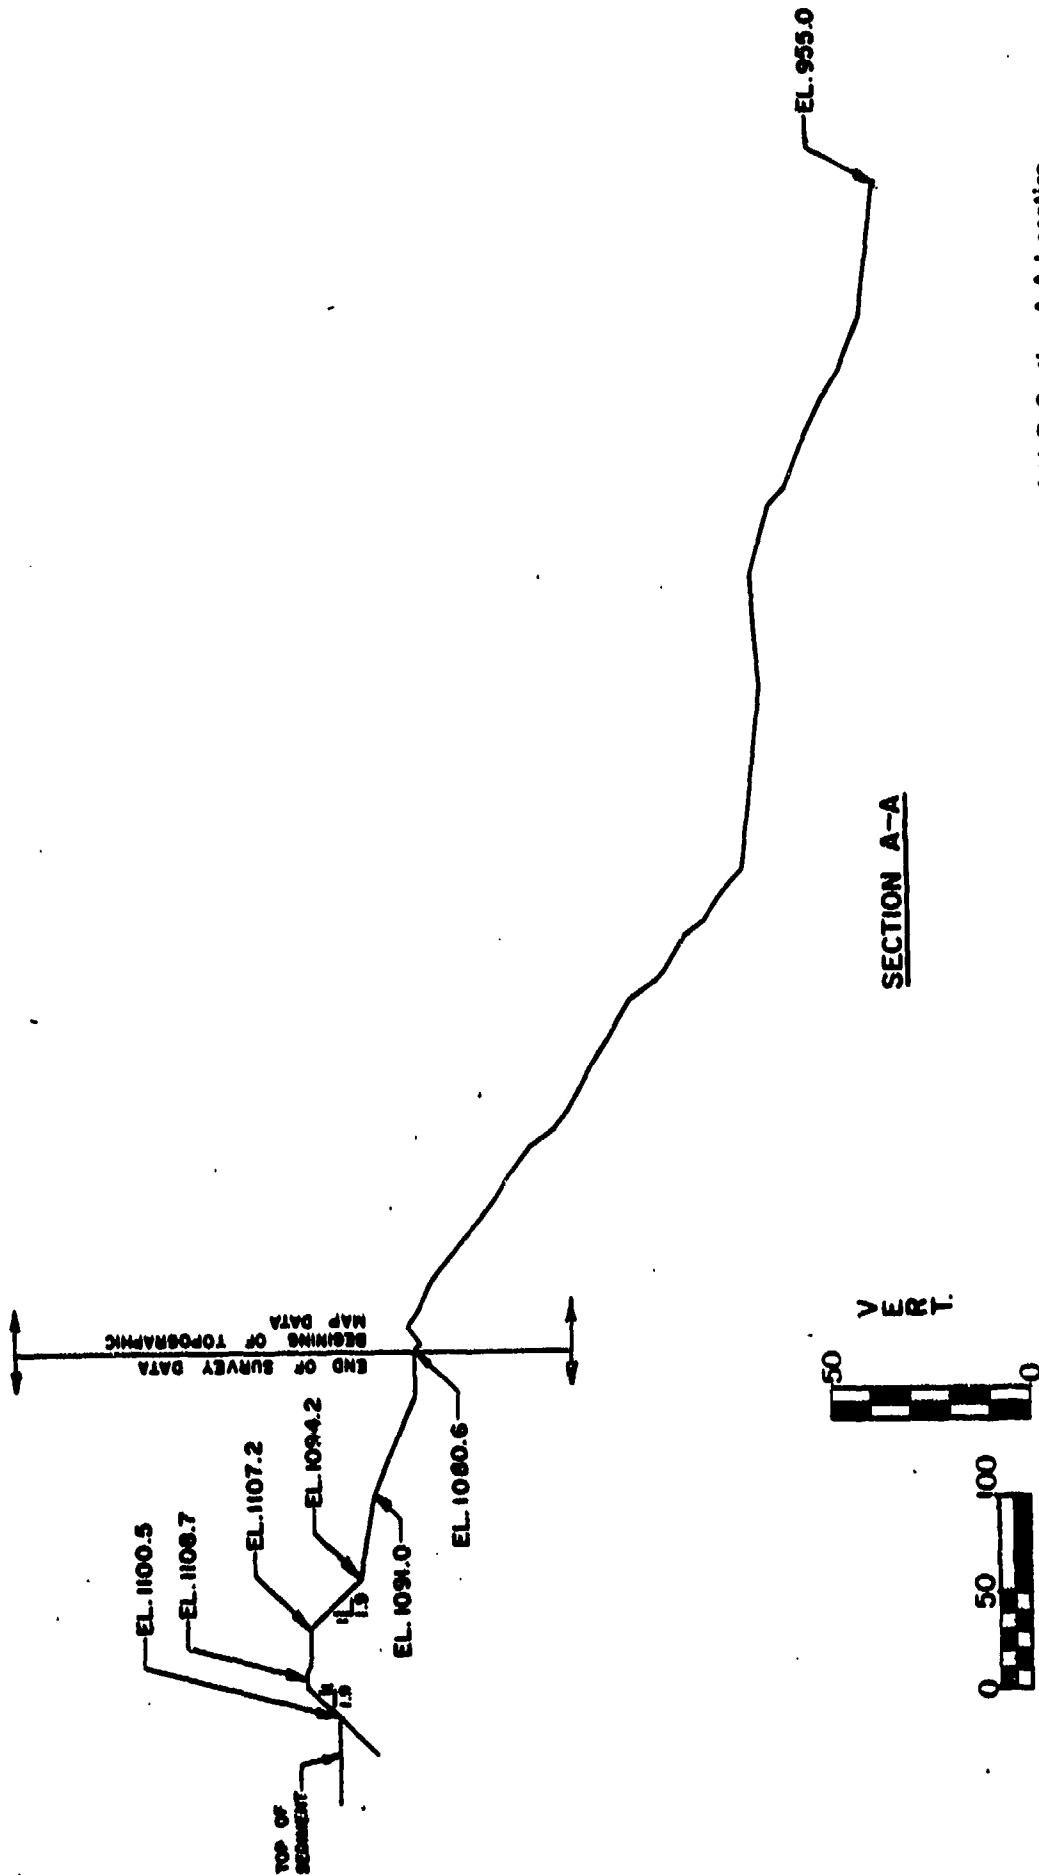
DATE: JULY 1981	RUSSELLTON SLURRY POND 3	FIELD SECTION
SCALE: AS SHOWN	NATIONAL DAM INSPECTION PROGRAM	
DR: JF	ACKENHEIL & ASSOCIATES CONSULTING ENGINEERS	
CK: JEB	1000 BANKSVILLE RD./PITTSBURGH, PA. 15216	
DWG. NO. 8038 L - 3

d. Visual Observations: The visual inspection disclosed that locally very steep slopes exist on the downstream face of the embankment, but little or no sloughing or slope instability was observed. There were no signs of cracks, scars, or anomalous bulges. The overall embankment slope is generally moderate to mild, as indicated by Field Section A-1.
