ROSNER POND DAM

NDI ID NO. PA-01111
DER ID NO. 64-190

PHASE I INSPECTION REPORT NATIONAL DAM INSPECTION PROGRAM

JUNE 1981

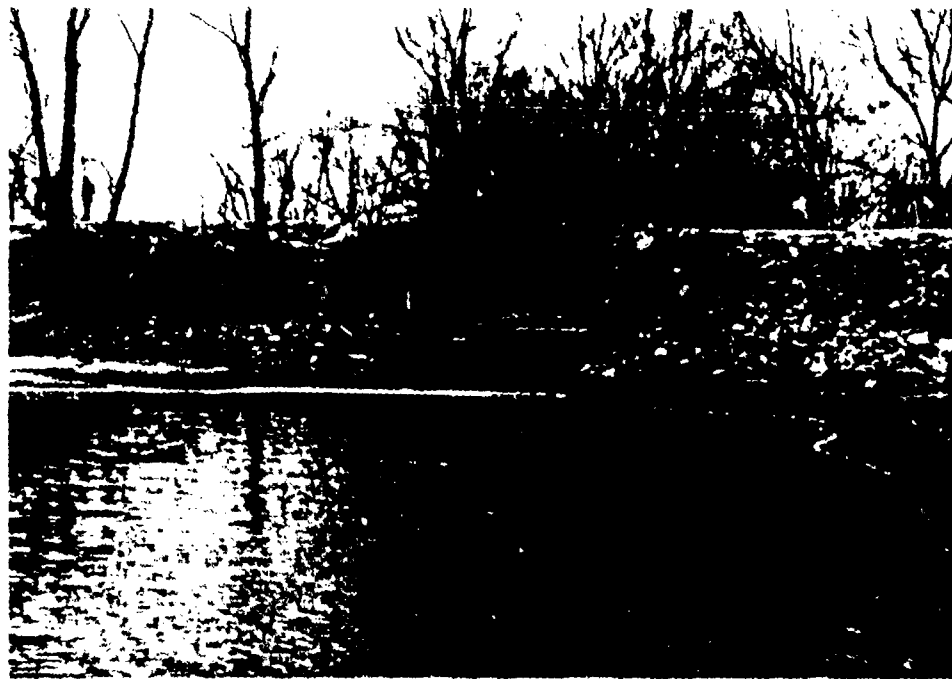
VIEW OF THE DAM FROM THE WEST
IN THE AFTERNOON

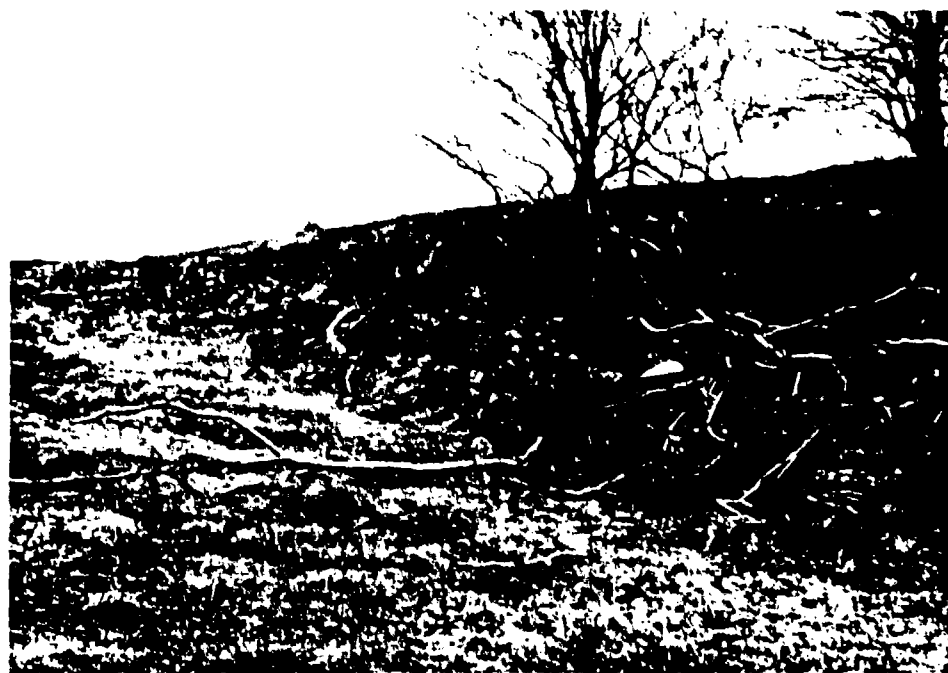
4. Downstream face of dam right abutment.

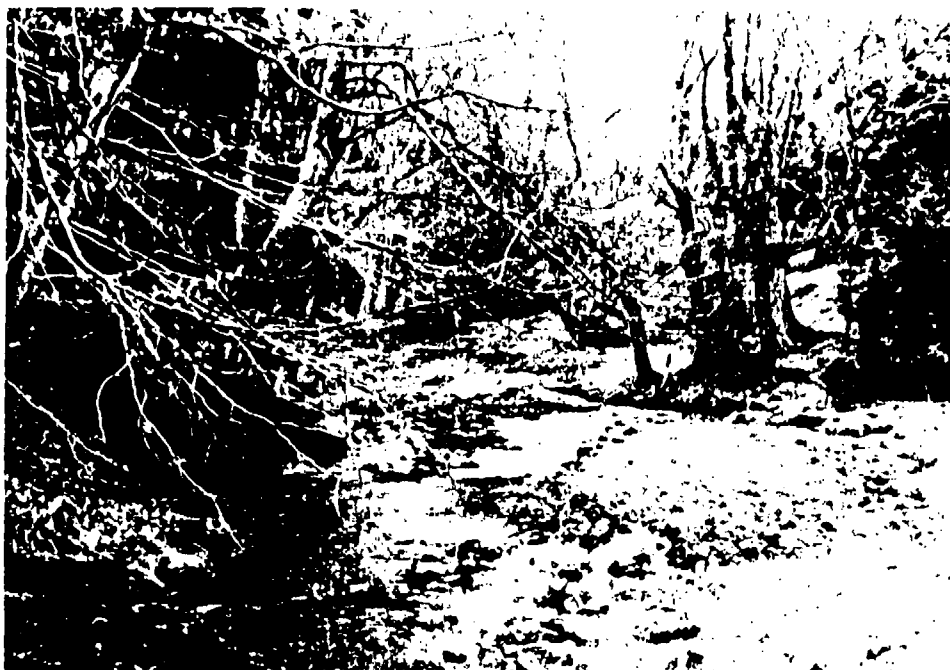
9. Downstream channel 100 feet beyond rock.

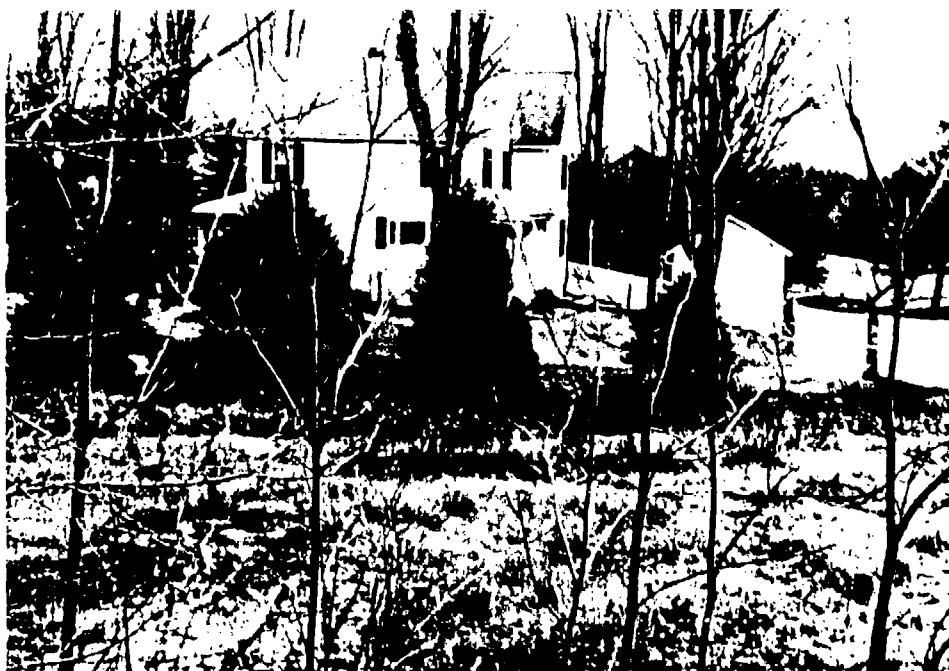
One home 1,600 feet below dam; within 50 feet of channel.
First floor 6 feet above streambed.

10. Downstream hazied. Streambed in foreground.

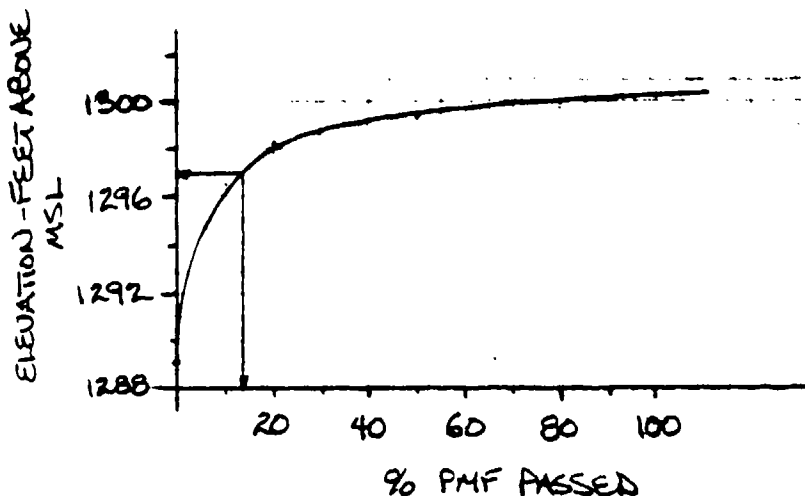
TOP OF DAM IS AT ELEVATION
1297.0

ROSWER POND DAM CAN PASS
11% OF THE PMF PRIOR TO
OVERTOPPING THE EMBANKMENT.

THIS FACILITY CAN CONTROL 11% OF THE PMF. AT THE SDF ($\frac{1}{2}$ PMF) THE DAM IS OVERTOPPED TO A MAXIMUM HEIGHT OF 2.2 FEET FOR A TOTAL DURATION OF ≈ 8.3 HOURS. SINCE IT IS FELT THAT AT 50% OF THE PMF, THE DAM WOULD FAIL DUE TO OVERTOPPING; THEREFORE, A BREACH ANALYSIS IS REQUIRED.
