ELK LAKE DAM

NDI ID No. PA-01102  
DER ID No. 64-4

PHASE I INSPECTION REPORT  
NATIONAL DAM INSPECTION PROGRAM

JULY 1981

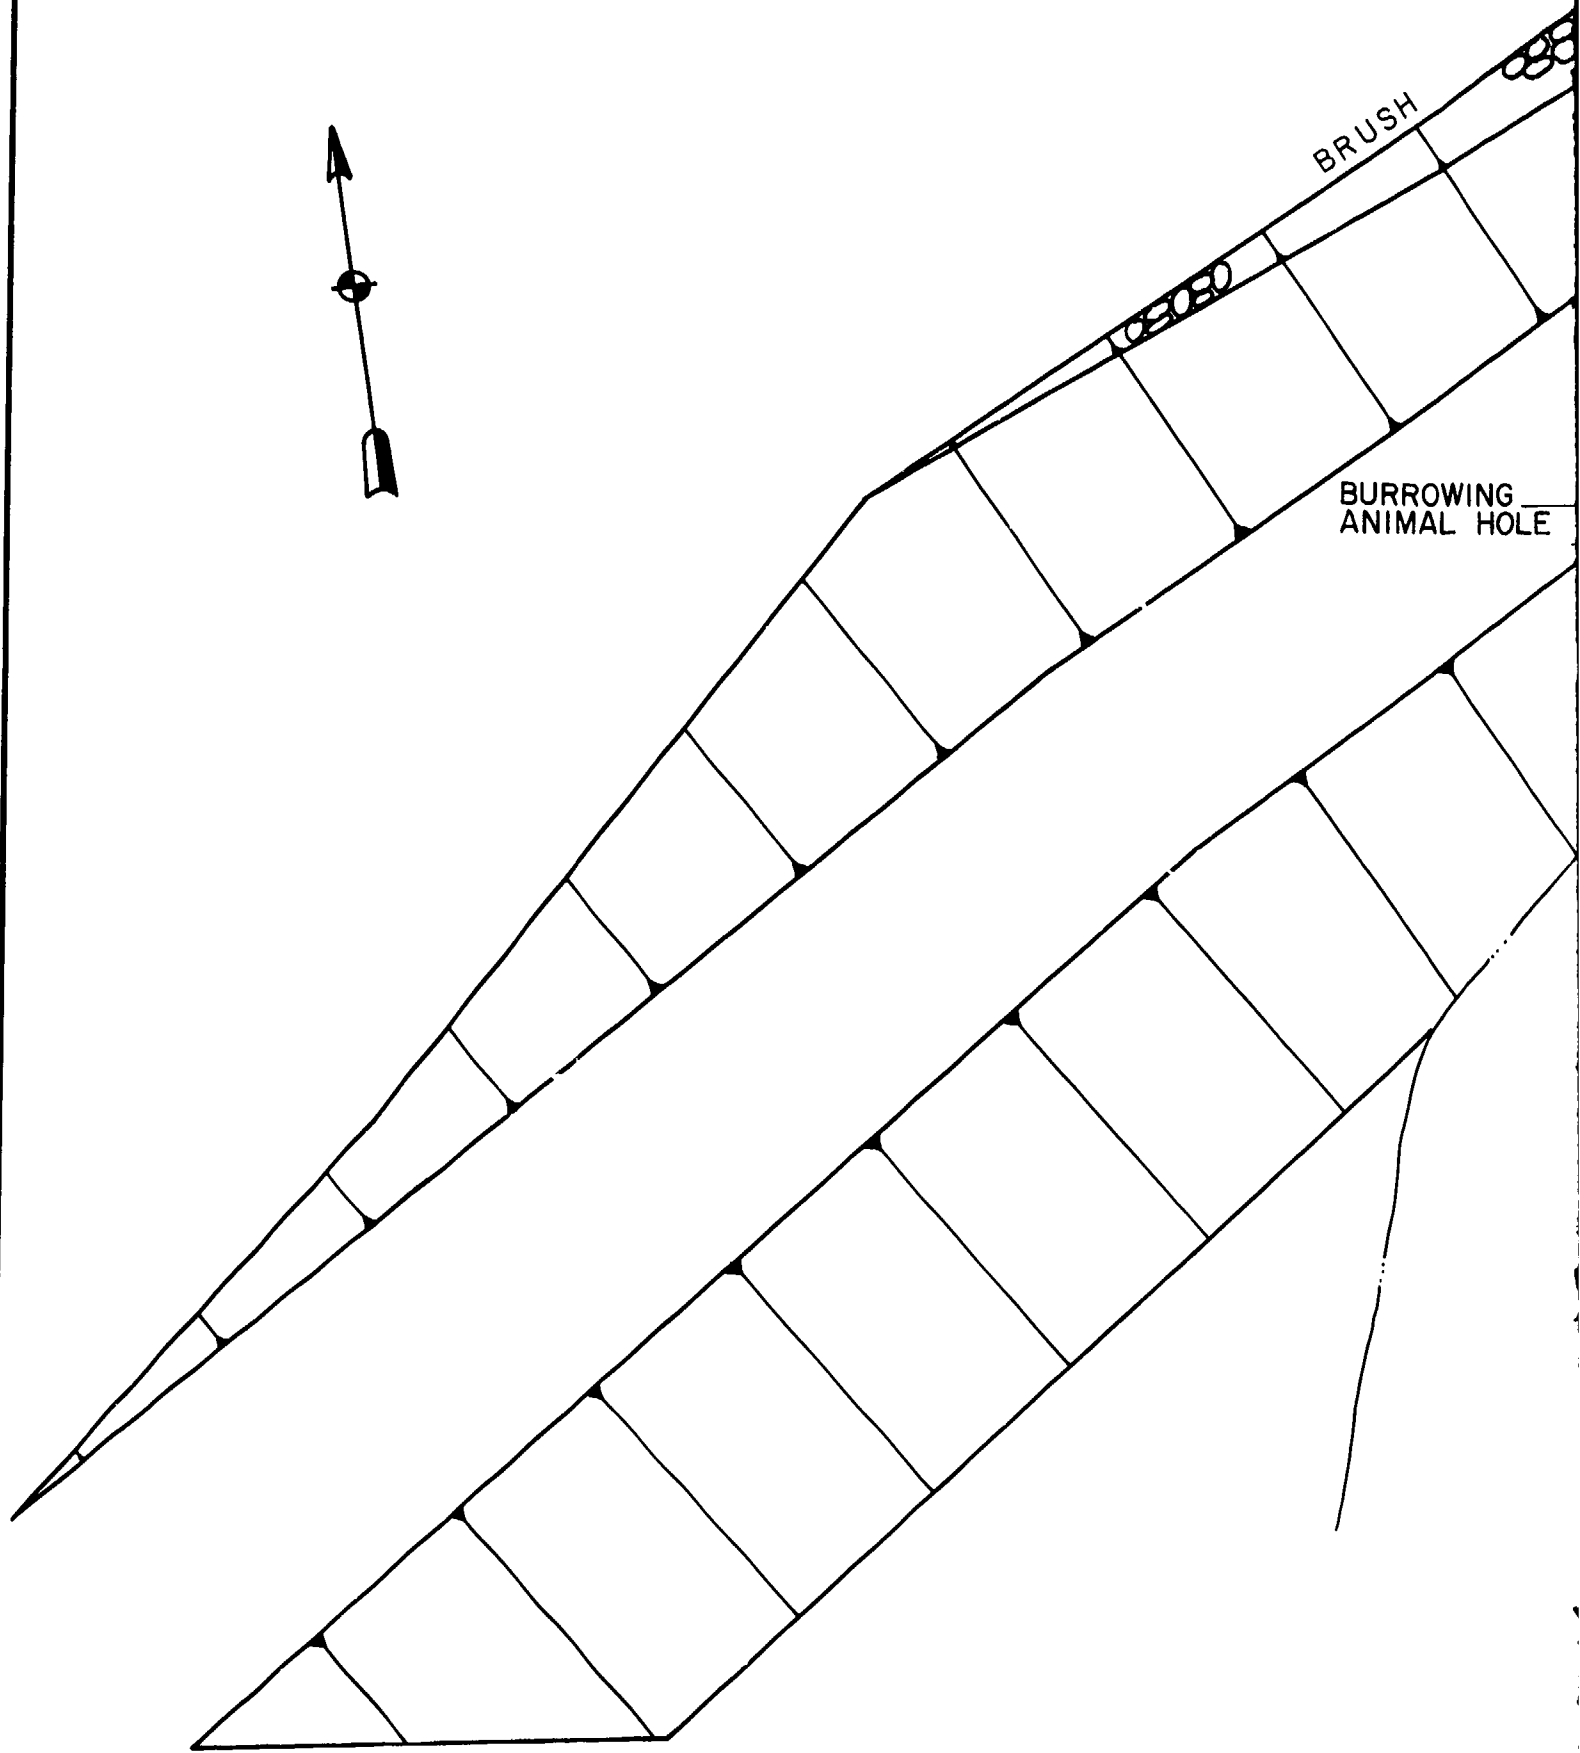
BRUSH

BURROWING  
ANIMAL HOLE

(4) Fill the burrowing animal hole adjacent to the spillway with suitable impervious material.
