UNGER DAM

NDI I.D. NO. PA-01090  
PENNDER I.D. NO. 64-208

PHASE I INSPECTION REPORT  
NATIONAL DAM INSPECTION PROGRAM

SEPTEMBER 1981

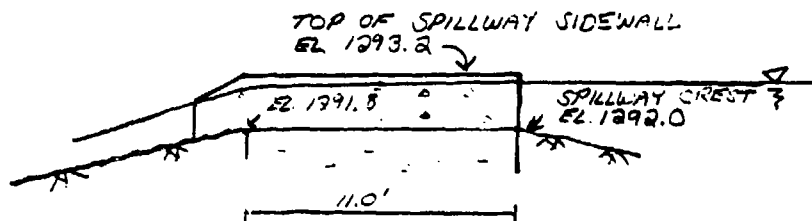
## SPILLWAY CAPACITY

IN COMPARING THE 100-YEAR FREQUENCY FLOOD PEAK (870 CFS)  
WITH THE MAXIMUM SPILLWAY CAPACITY (80 CFS), IT IS SEEN THAT THE  
DAM WILL BE OVERTOPPED UNDER THE 100-YEAR EVENT. IT WAS ASSUMED  
HERE THAT THERE WOULD BE NO SIGNIFICANT ATTENUATION OF THE  
PEAK INFLOW. THEREFORE, THE SPILLWAY IS CONSIDERED TO BE INADEQUATE.
