## CONTEE MAIN SETTLING POND DAM

CONTEE SAND AND GRAVEL COMPANY

PHASE I INSPECTION REPORT  
NATIONAL DAM INSPECTION PROGRAM

CONTEE MAIN SETTLING POND DAM  
PRINCE GEORGES COUNTY, MARYLAND  
NDI I.D. No. MD 81

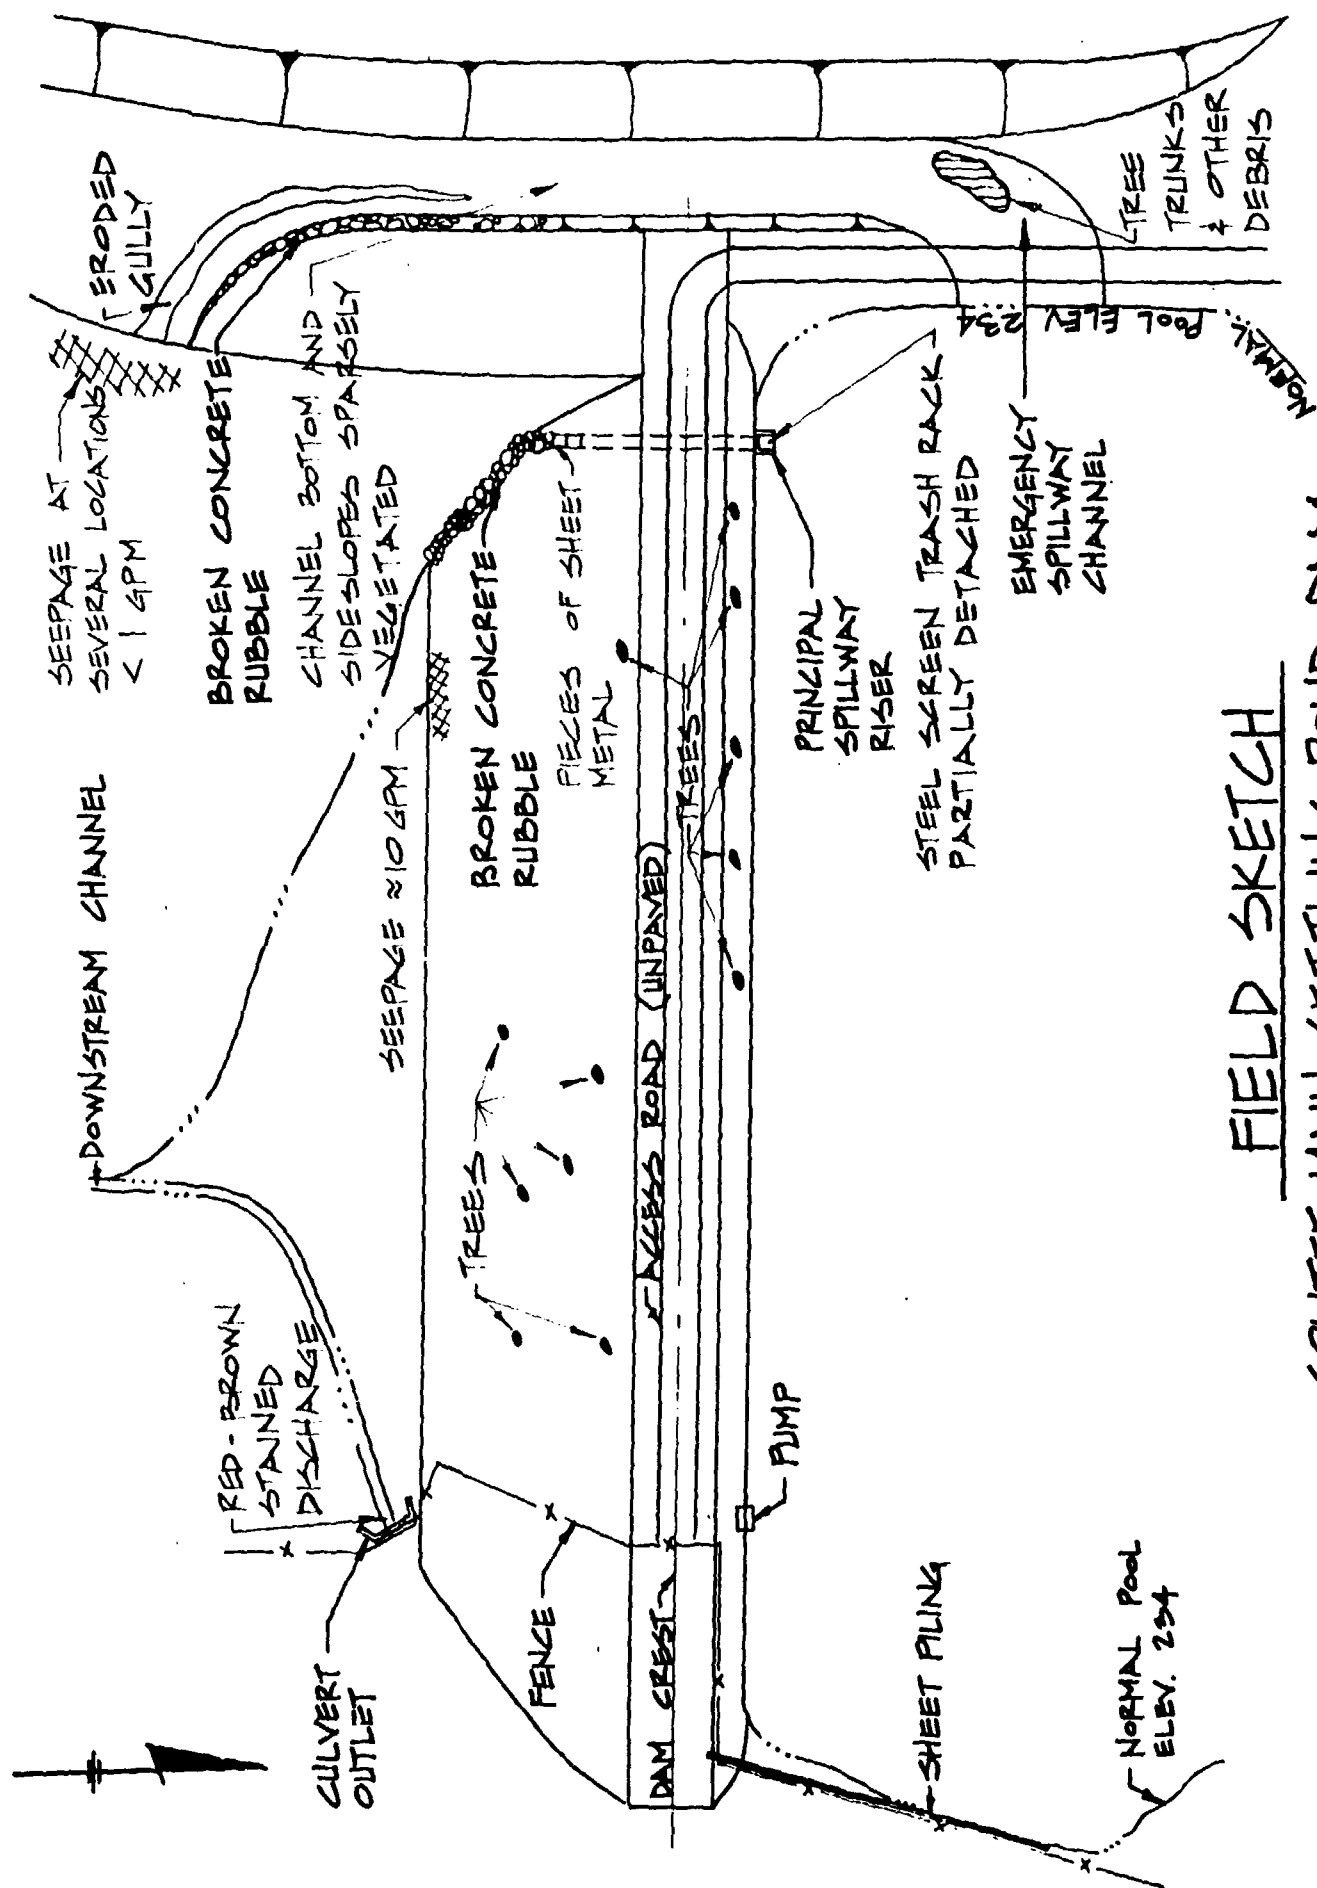
FIELD SKETCH  
CONTEE MAIN SETTLING POND DAM

1. Surficial: No significant structural deficiencies of the embankment were discernible. The embankment slopes are covered with grass and brush as well as several small trees (Photo No. 1). The crest of the embankment is unvegetated and is used as an access road (Photo No. 2).
2. Seepage: Seepage was observed emanating near the toe of the downstream embankment slope approximately 100 feet left of the right abutment. The flow rate of this seep was estimated to be about 10 gpm. There was no visible evidence of erosion channels or movement of soil fines. However, a dark red iron precipitate covered the seepage area and may have obscured the presence of soil fines or erosion. The immediate discharge area was saturated and very soft.

Several seeps were also noticed emanating from the right abutment at the outfall of the emergency spillway channel (See field sketch). The seepage flow from these seeps was also iron stained. The flow rate of each seep was estimated to be less than 1 gpm. No movement of soil fines or erosion channels were observed at the location of the seeps.

Seepage observed emanating from downstream embankment slope, approximately 100 feet left of the right abutment. Seepage flow was observed free of soil fines, but did include dark red iron precipitate particles. Flow rate was estimated at 10 gpm. Iron stained water was also observed in the spillway waste channel. Several individual discharges were observed to emanate from the hillside. These discharges were free of soil fines and had estimated flow rates of less than 1 gpm. During the June 3, 1981 inspection, the discharge from the culvert that outlets near the downstream embankment toe at the left abutment was also stained by a dark red iron precipitate. At the culvert inlet on the northbound side of Route 95, the water was clear and the flow rate was much less.

2. Monitor the seep located at the downstream embankment toe (See Field Sketch). If increased flow quantity or evidence of erosion is observed, the Maryland Water Resources Administration, Dam Safety Division should be notified immediately, and necessary corrective repairs made.

2. Monitor the seep located at the downstream embankment toe. If increased flow quantity or evidence of piping is observed, the Maryland Water Resources Administration, Dam Safety Division should be notified immediately, and necessary corrective repairs made.

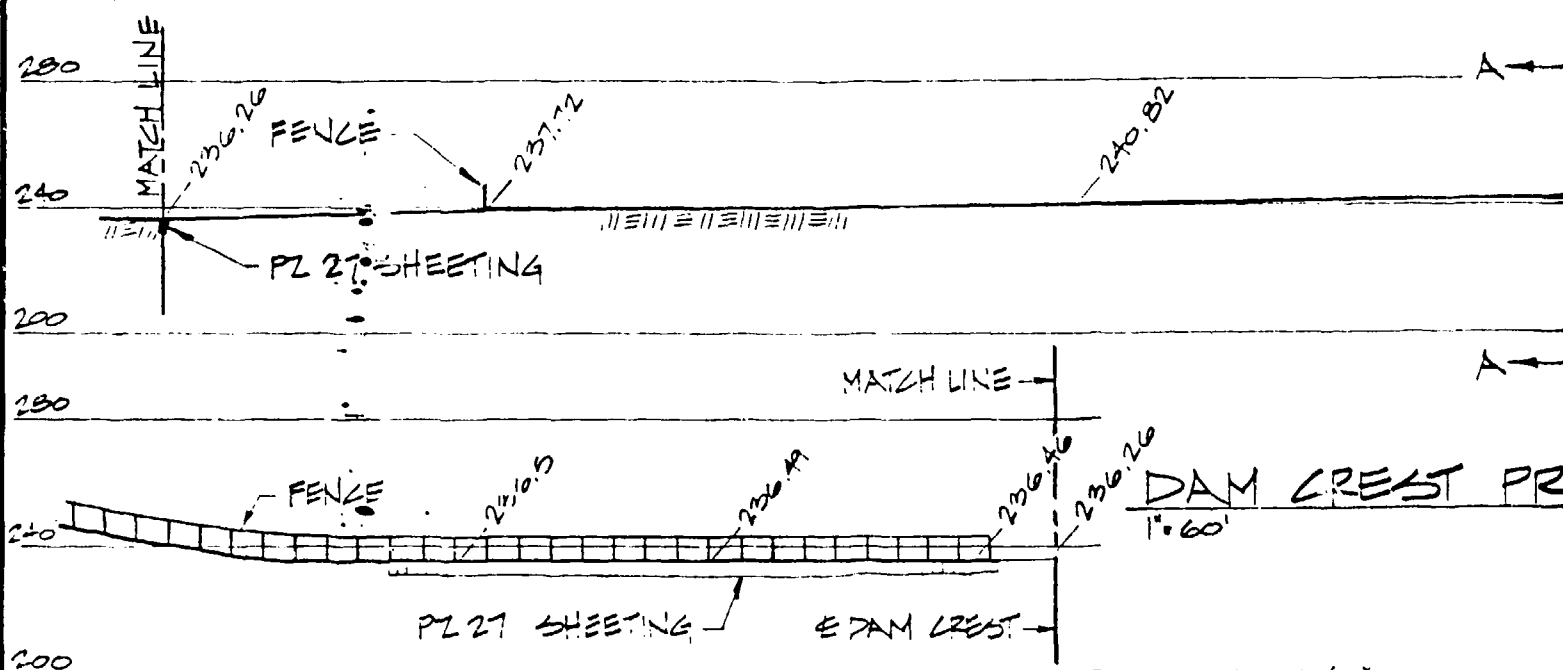
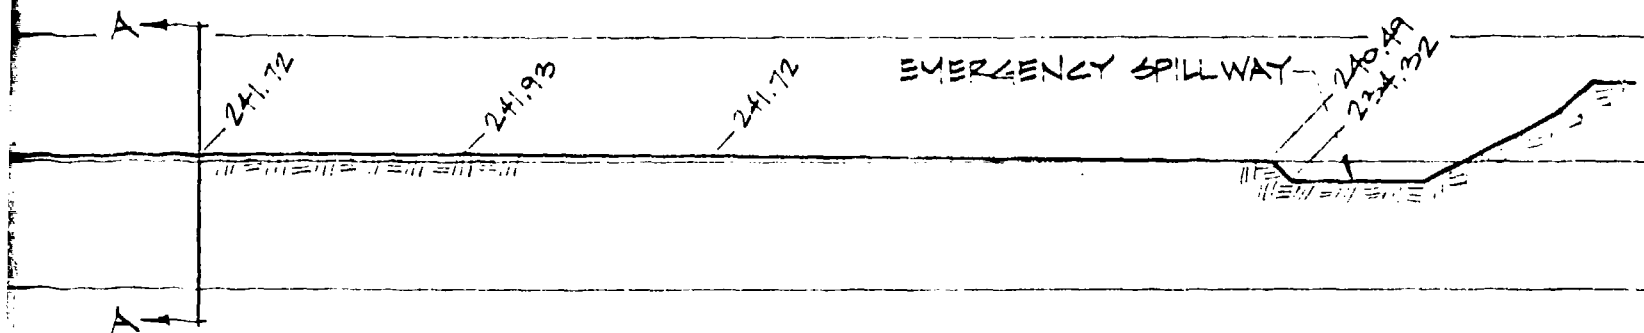
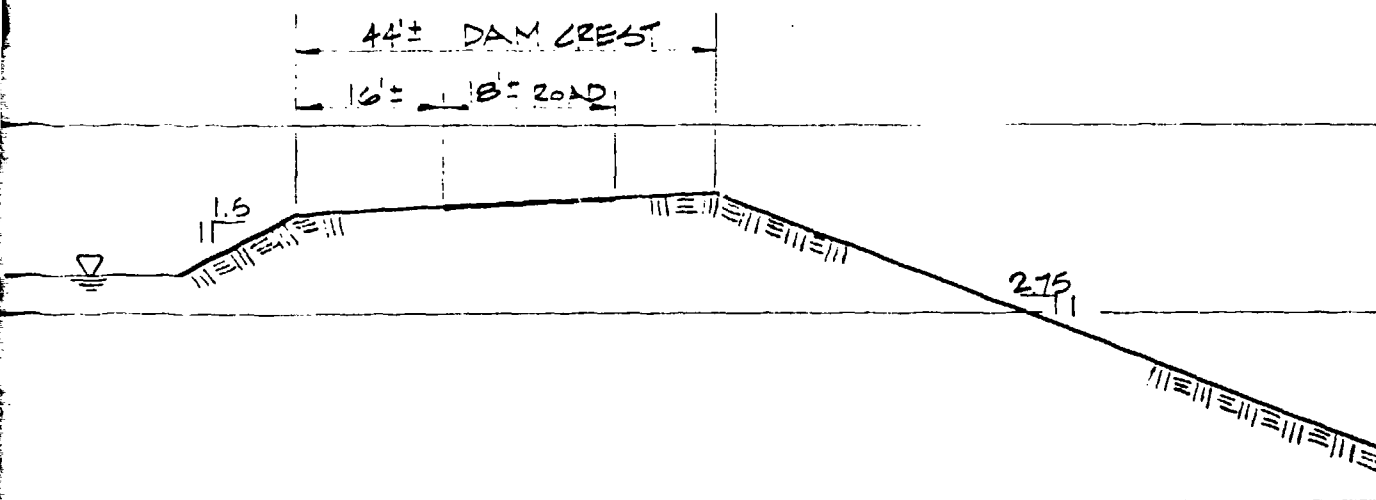
| DATE: JUNE 29, 1981 | CONTEE MAIN SETTLING POND DAM | DAM CREST<br>PROFILE AND<br>SECTION |

- C. VISUAL OBSERVATIONS: Except for fallen trees and other debris in the emergency spillway channel, no deficiencies were observed that would prevent the principal and emergency spillways from functioning as intended. The transit survey of the embankment crest and left abutment indicated that the lowest point on the embankment crest is at the left abutment junction near Interstate Route 95.

| VISUAL EXAMINATION OF | OBSERVATIONS | REMARKS OR RECOMMENDATIONS* |
|---|---|---|
| VERTICAL AND HORIZONTAL ALIGNMENT OF THE CREST | Transit survey indicated that dam crest varies from El 236.3 to El. 241.9. No significant horizontal misalignment noted. | |
