PHASE I INSPECTION REPORT  
NATIONAL DAM SAFETY PROGRAM  
ED PYLKAS DAM  
N.Y. 355  
DEC I.D. NO. 67-2067  
SUSQUEHANNA RIVER BASIN  
TIOGA COUNTY, NEW YORK

PHASE I INSPECTION REPORT  
NATIONAL DAM SAFETY PROGRAM

Name of Dam: Ed Pylkas Dam  
N.Y. 355

Date of Inspection: March 25, 1981 and April 30, 1981

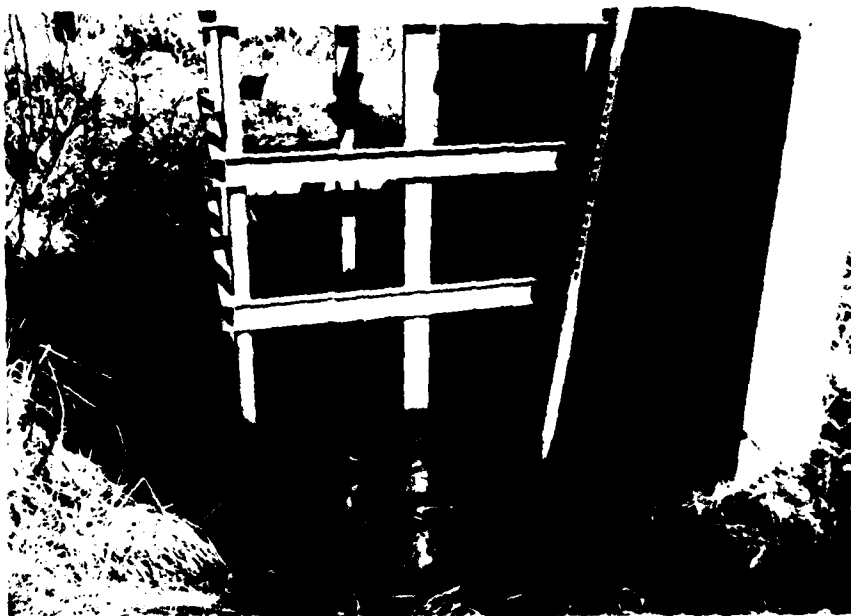
PHOTOGRAPH NO. 4  
Primary Spillway Inlet Structure

- a. Concrete Surfaces The only concrete structure is the  
principal spillway drop inlet structure. Concrete is in  
good condition.
- b. Structural Cracking None
- c. Movement - Horizontal & Vertical Alignment (Settlement)  
N/A
- d. Junctions with Abutments or Embankments   
N/A
- e. Drains - Foundation, Joint, Face   
N/A
- f. Water Passages, Conduits, Sluices   
N/A
- g. Seepage or Leakage   
N/A
