LITTLE CHOCONUT WATERSHED SITE 2C DAM

BROOME COUNTY, NEW YORK  
INVENTORY NO. NY, 722

**PHASE I INSPECTION REPORT  
NATIONAL DAM SAFETY PROGRAM**

**AUGUST 1981**

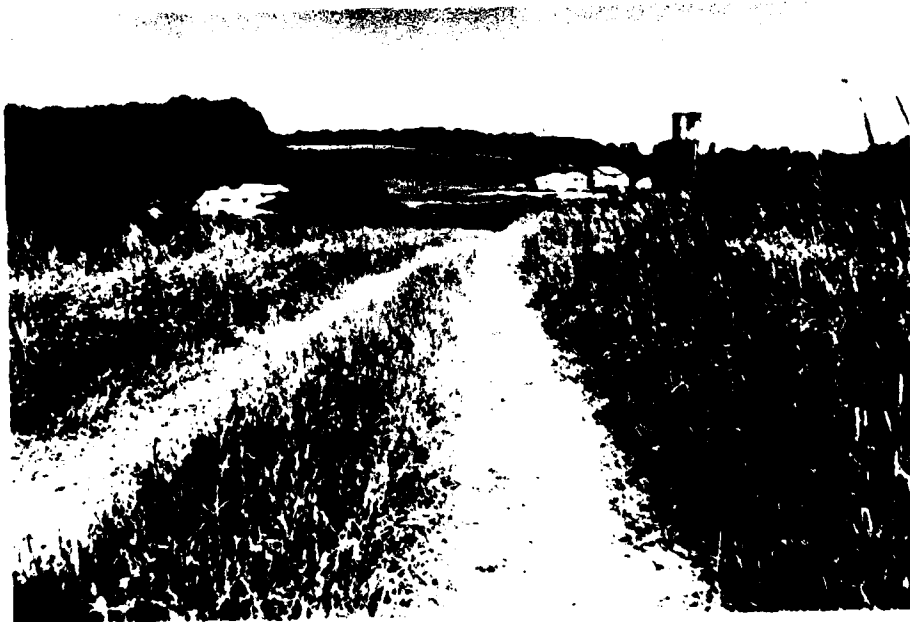
TOP OF DAM AND TIRE TRACKS

- (1) Vertical Alignment GOOD
- (2) Horizontal Alignment CURVED
- (3) Surface Cracks NONE
- (4) Miscellaneous TIRE TRACKS ALONG CREST
