Special Report 81-31

December 1981

ROOF MOISTURE SURVEY: RESERVE CENTER  
GARAGE, GRENIER FIELD, MANCHESTER, N.H.

W. Tobiasson, B. Coutermarsh and A. Greateorex

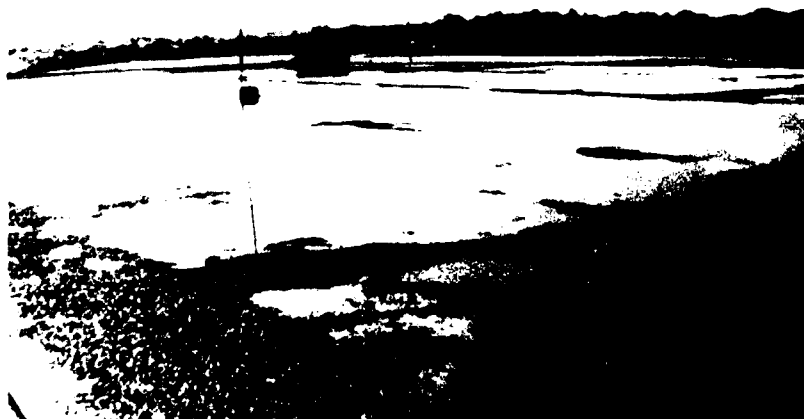
The garage roof at the Grenier Field Reserve Center had leaked since new insulation and a new membrane were installed there during the summer of 1979. We surveyed that roof with an infrared camera about 14 months later to determine how much insulation was wet, and to develop recommendations for corrective action. Two prior attempts to survey this roof in June and November 1979 could not be conducted because of ponded water (Fig. 1).

Figure 1. Ponds on the flat roof of the Reserve Center garage, June 1979.

The lack of internal drains on the main roof and the apparent lack of slope to drain cause water to pond over most of the roof, as shown in Figure 1. When water is allowed to pond on a roof the risk of premature failure is greatly increased. If this roof had been sloped to drain, much less water would have entered the insulation through membrane and flashing flaws.

1. Remove the existing membrane and insulation.
2. Repair the existing vapor retarder or install a new one towards the warm side of the roofing system.
3. Install internal drains on the main roof. Internal drains are expensive in a retrofit operation, but they are much preferred to over-the-eaves drainage for low-slope roofs in areas where it snows. Ice dams at the eaves can cause significant ponding loads on low-slope roofs in such areas.
4. On the main roof provide a positive slope to drain, of about 1/4 in./ft, using either tapered insulation or a wet fill. Use crickets in valleys to assure lateral flow of water to the drains.
5. Install curbs on which the antenna and guy wire anchors can be located, or side-mount the antenna on an exterior wall.
6. Install new insulation and a new membrane.
