**FINAL ENGINEERING REPORT
IMPROVEMENT PROGRAM FOR THE
C-141 NAVIGATION SELECTOR PANEL**

January 1982

Henry L. Riser, Jr.

ARINC Research Corporation
a Subsidiary of Aeronautical Radio, Inc.
2551 Riva Road
Annapolis, Maryland 21401
Publication 2315-11-1-2635

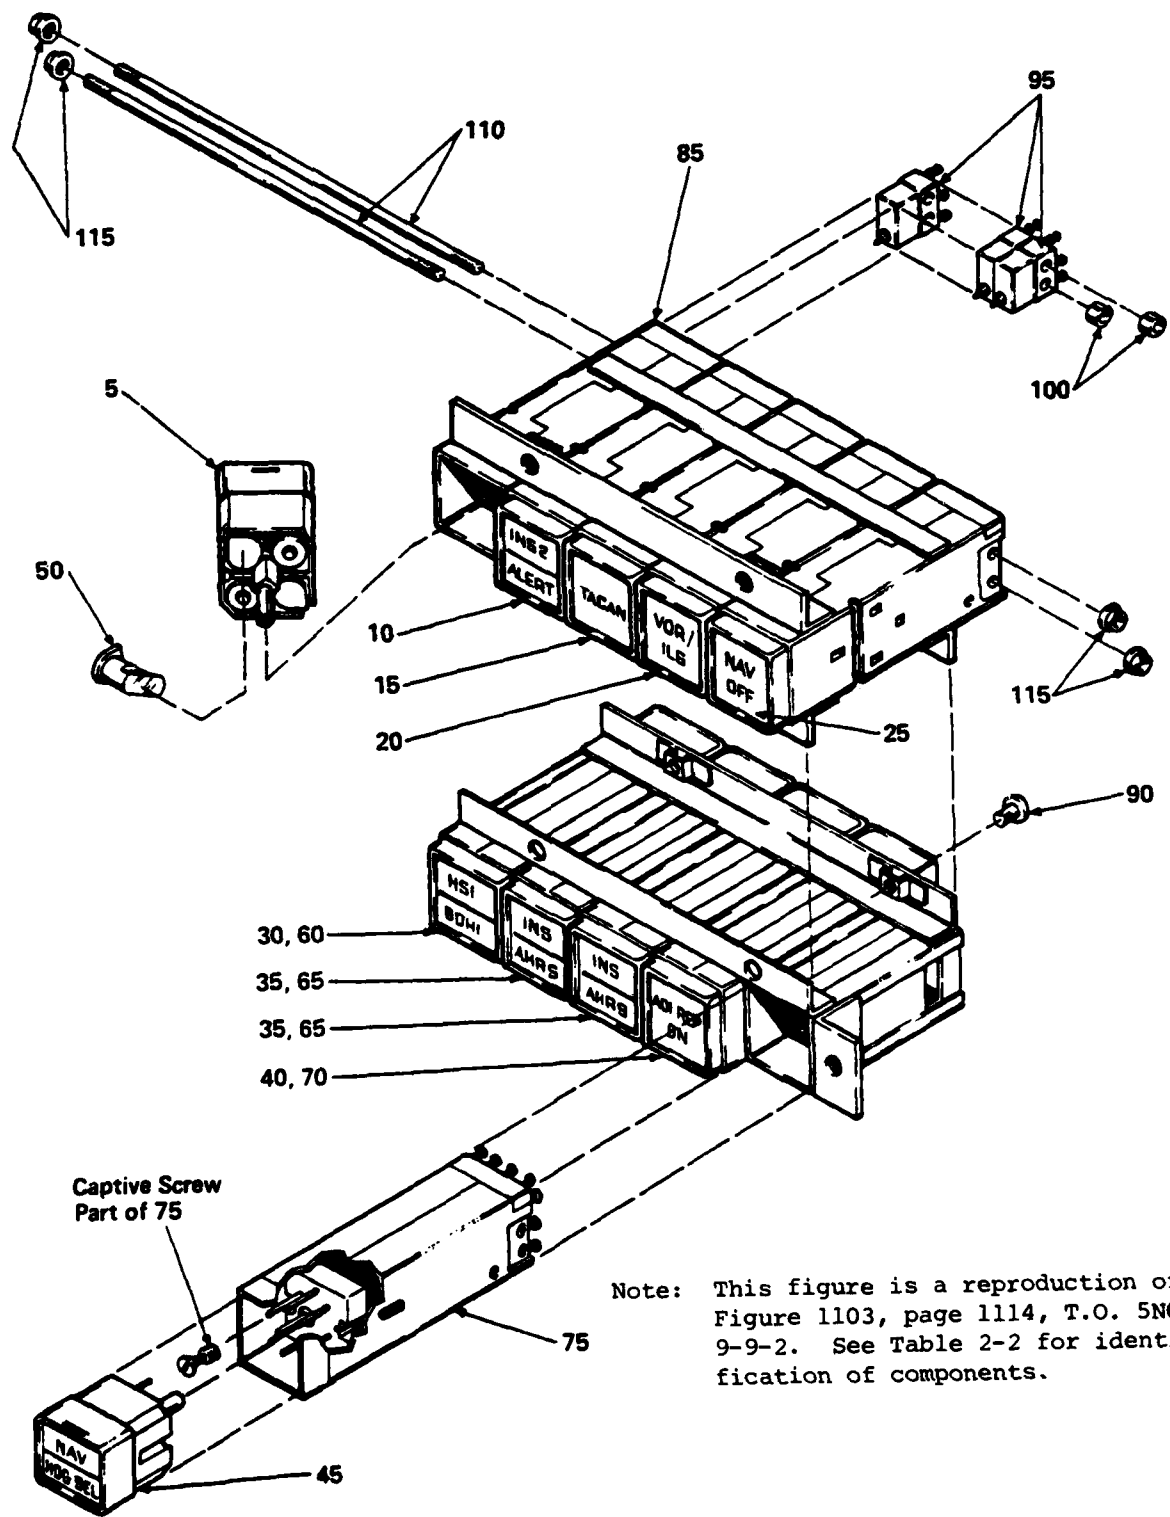
Figure 2-1. SWITCH ASSEMBLY

Maintenance was made more difficult and more expensive because the top row of interlocked switches (see No. 85 in Figure 2-1) were spot-welded together as required by the design of the mechanical interlock mechanism. As a result, if one of the switches failed, all five had to be discarded and a new assembly of five used to replace them. The assembly is not a repairable item and represents a considerable loss when discarded. In addition, the replacement of the assembly requires a considerable expenditure of time because 23 solder terminals must be disconnected and reconnected, some terminating more than one wire. As a result of these examinations, it was readily apparent that a replacement for the present switch assembly was needed.

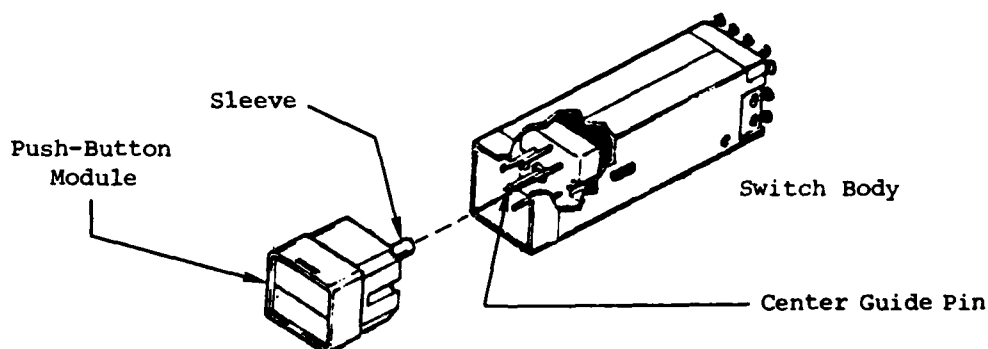
Figure 2-2. PRESENT SWITCH

A major problem can occur with this switch. The sleeve on the push-button module fits over the center pin in the switch body (see Figure 2-2) and is designed so that it snaps into place and is retained to the switch body by a ridge on the guide pin (see Figure 2-3). The dimensions of the push-button module, its sleeve, the switch body and its center guide pin are such that the module must be precisely aligned before any attempt is made to seat it. If not properly aligned, the sleeve does not fit over the pin but, instead, will slide alongside and will bend the guide pin as the module is pressed into the switch body. Eleven of the 20 guide pins in the assemblies examined were bent to some degree and two of them to such a degree that the push-button module could not be inserted into the switch body. There was one case of the sleeve being broken off the module and one case of the module being jammed into the switch body so that it could not be extracted. Both of these situations probably resulted from misalignment of the sleeve and guide pin.

We also discovered that the center guide pin could be bent so that contact was made with the lamp contacts, which could easily cause a short in a lamp circuit. This, in turn, could cause a component failure on the circuit board due to excessive current through the diodes and resistors. Although it was not possible to prove, it is speculated that this situation may have been a cause for some of the circuit board failures reported.

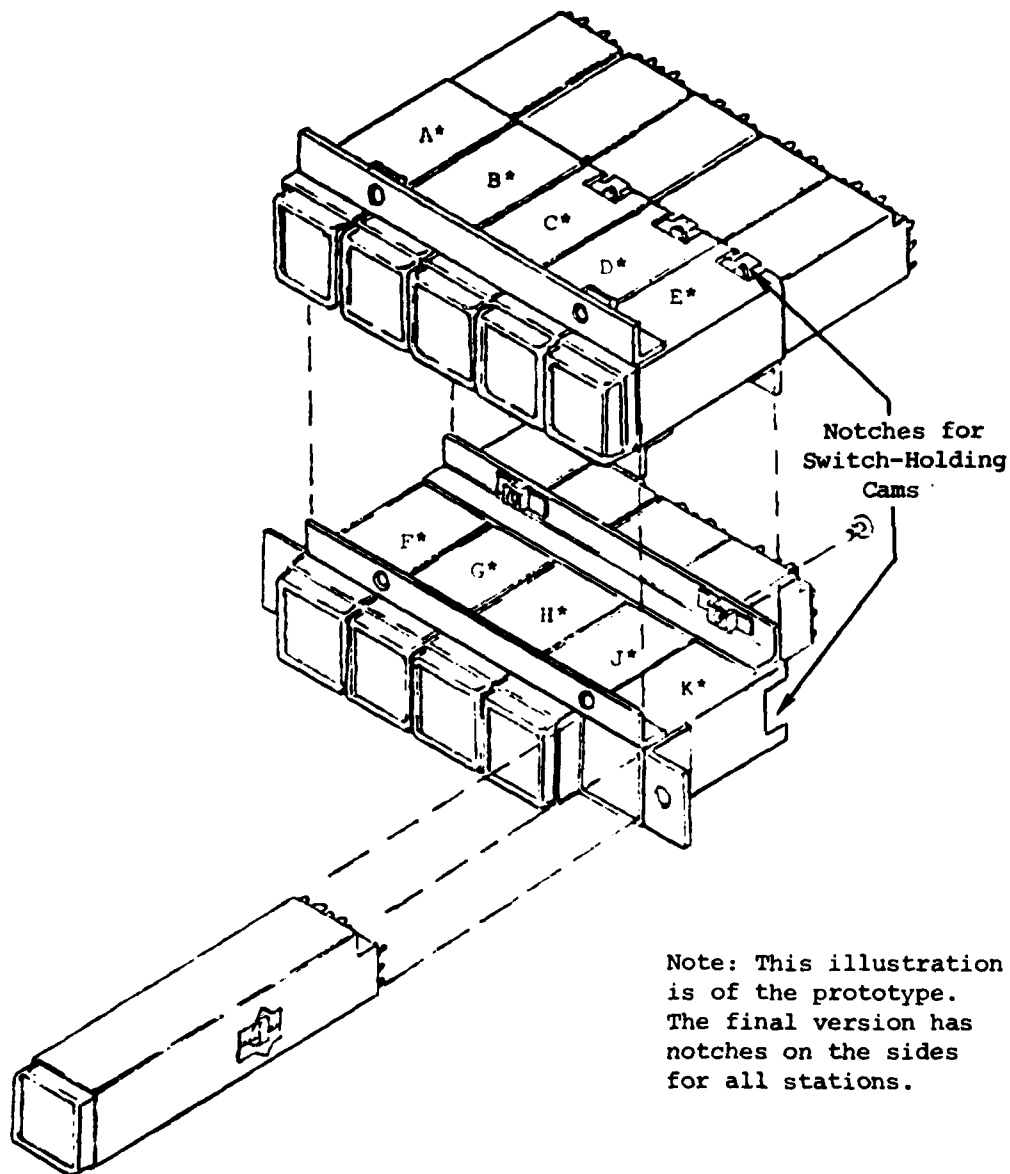
Figure 2-4. SWITCH ASSEMBLY AND STATION LOCATIONS

The two switch assemblies and NSPs were completely assembled following delivery of the second order, and arrangements were made to take them to McGuire AFB for testing on the CUT using the test procedures in T.O. 5N6-9-9-2. The tests were conducted by Mr. H. Riser of ARINC Research Corporation and Mr. J. Tye of WR-ALC on December 9. During the course of the test, one switch was found to be defective and was replaced with a spare. Another problem occurred when a lamp circuit in one of the switches was short-circuited. Displaced insulation on one of the lamp terminals on the switch was the cause. The insulation was replaced and both panels operated properly. The legends on three modules, stations C, D, and E in Figure 2-4 (see item numbers 15, 20, and 25 on Figure 2-1), were rotated 90 degrees clockwise because of a mistake in ordering. When the orders were initially prepared, we mistakenly believed that a certain legend style was needed that required that the switch body be rotated 90 degrees.

It did not have to be. The design of the upper housing bracket has been corrected to allow proper installation of the switch bodies. Figure 2-4 shows the rotation of the switches as they were assembled. Compare the notches for the switch holding cams in Station E with Station K. All should be like Station K.

The selection of the Jay-EI switch also determined the hardware requirements. A new switch housing bracket was designed to accommodate the switches and fabrication was ordered (see Figure 2-4 for new switch assembly design). The Jay-EI switches were also ordered (see paragraph 2.2.3 for a discussion of the fabrication and assembly actions).
