# DYNAMIC SEALS FOR ADVANCED HYDRAULIC SYSTEMS

Robert B. Olsen  
Vought Corporation  
P.O. Box 225907  
Dallas, Texas 75265

August 1981

Final Report for Period July 1978 - March 1981

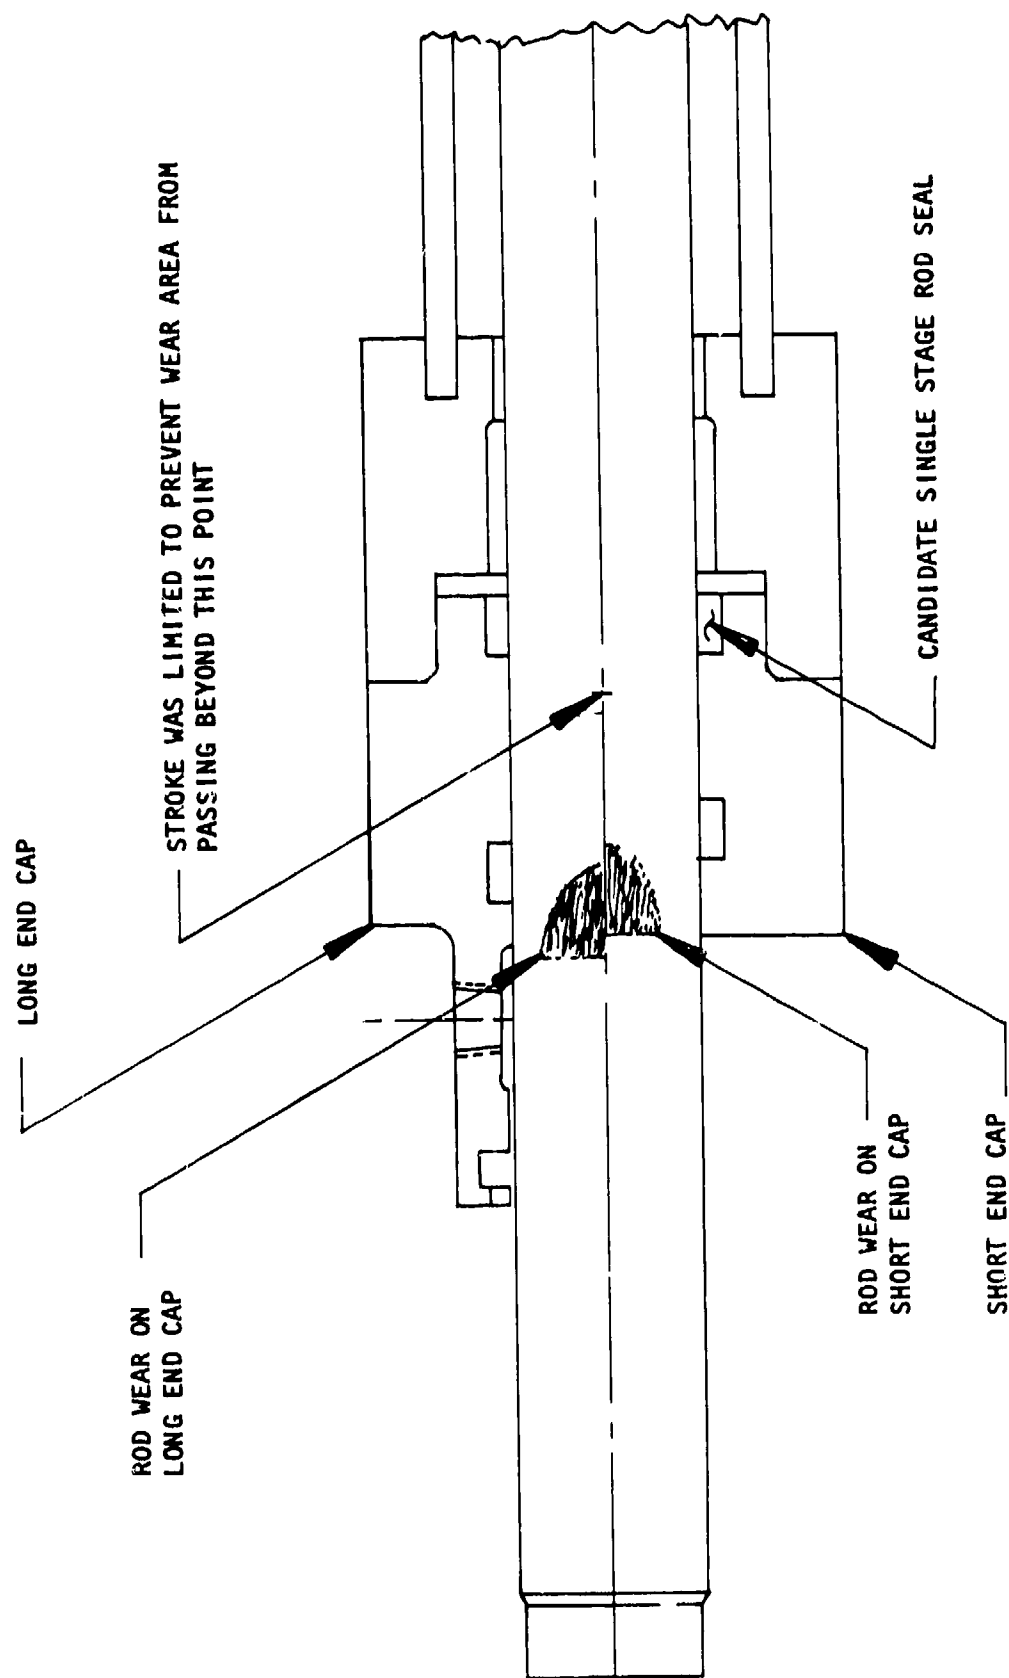
Figure 217. Location of Rod Wear in Relation to Candidate Seals on Single Stage Rod Seal Screening Tests.
