4. TITLE (and Subtitle) Foundation report, Supplement Unit 2 (Part 1) Pigeon Creek Three Pump Stations, Evansville, IN.		5. TYPE OF REPORT & PERIOD COVERED Final

ABSTRACT (Continue on reverse side if necessary and identify by block number)  
This report supplements the prior foundation report on the Evansville, IN, levee. It covers foundation conditions encountered and methods of constructing three pump stations within those conditions.

Foundation Report  
 Supplement No. 2 Volume II  
 Evansville, Indiana  
 Local Flood Protection Project  
 Pigeon Creek Section  
 Unit 2 (Part I) Pump Stations  
Sixth Ave., Dresden St., Delaware St.

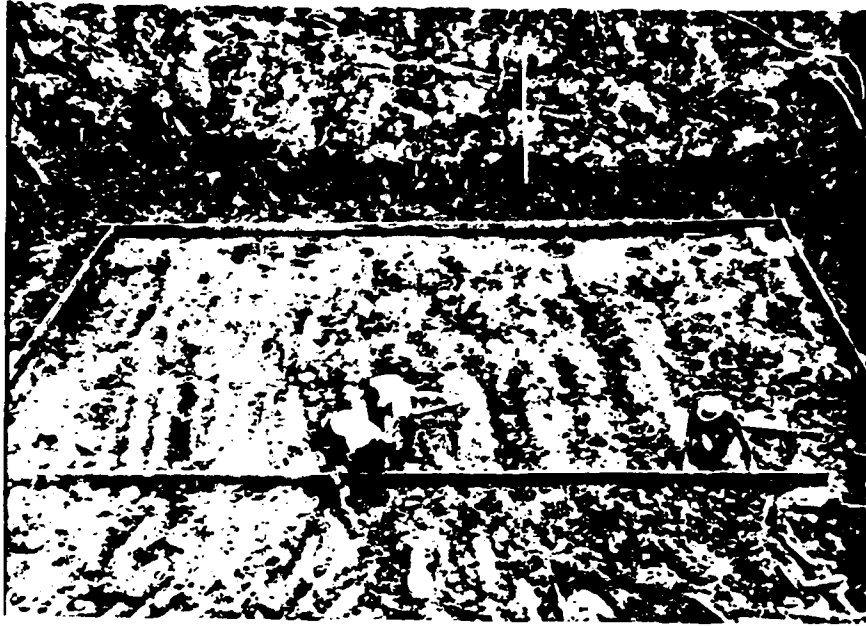
Sixth Avenue Pump Station Foundation - View East

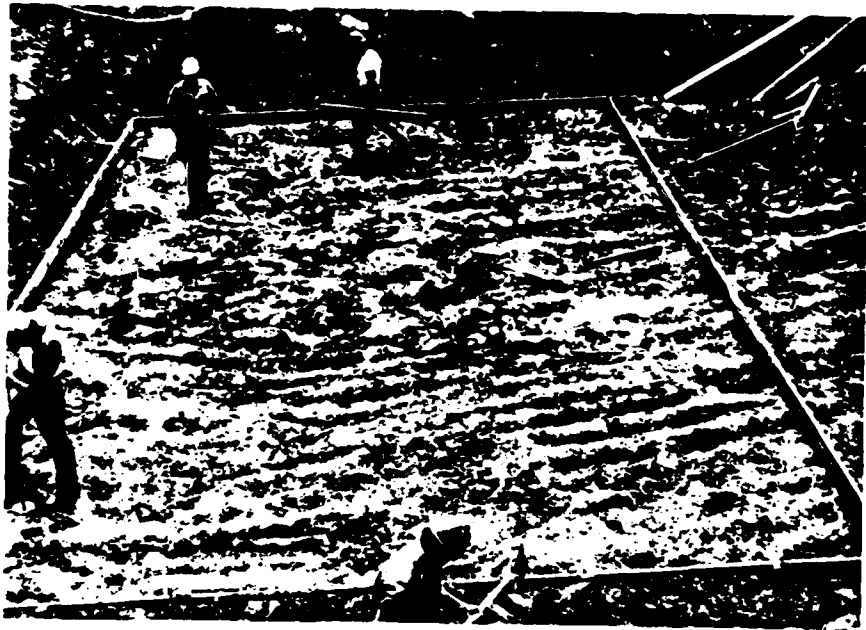
Sixth Avenue Pump Station Foundation - View South

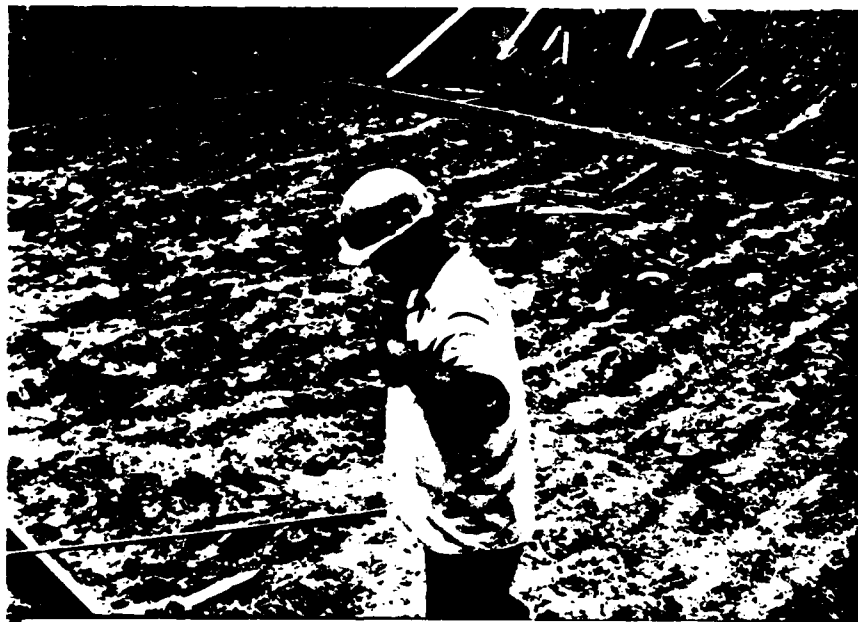
Southwest Corner of Foundation

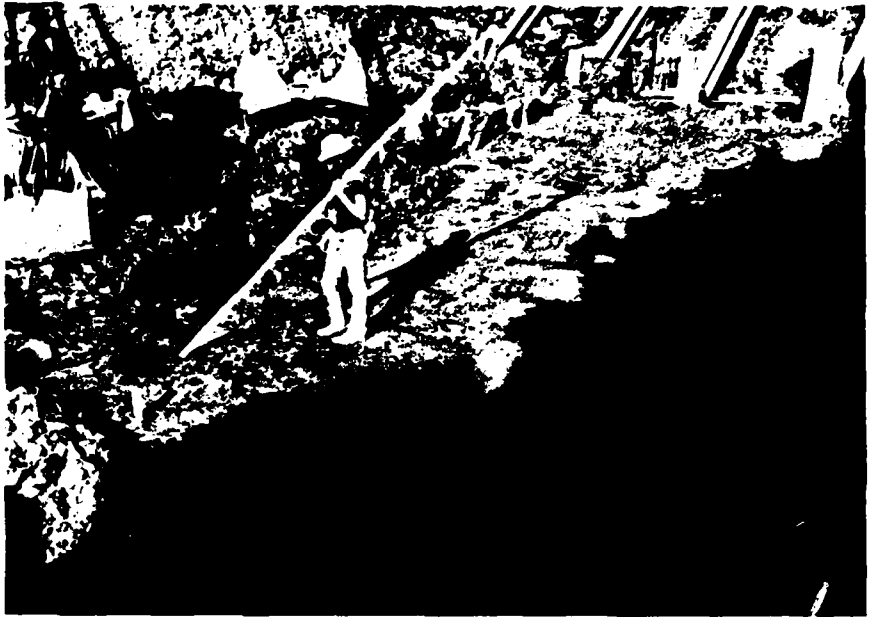
Northern Half of Foundation

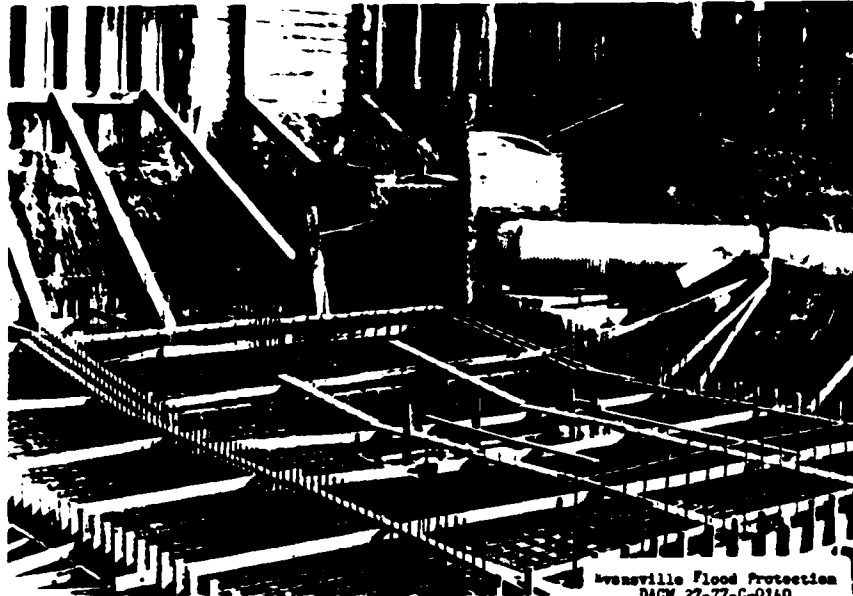
**View East  
Temporary Shoring  
Temporary Water By-Pass  
Foundation Resteal Just Prior to Concrete**

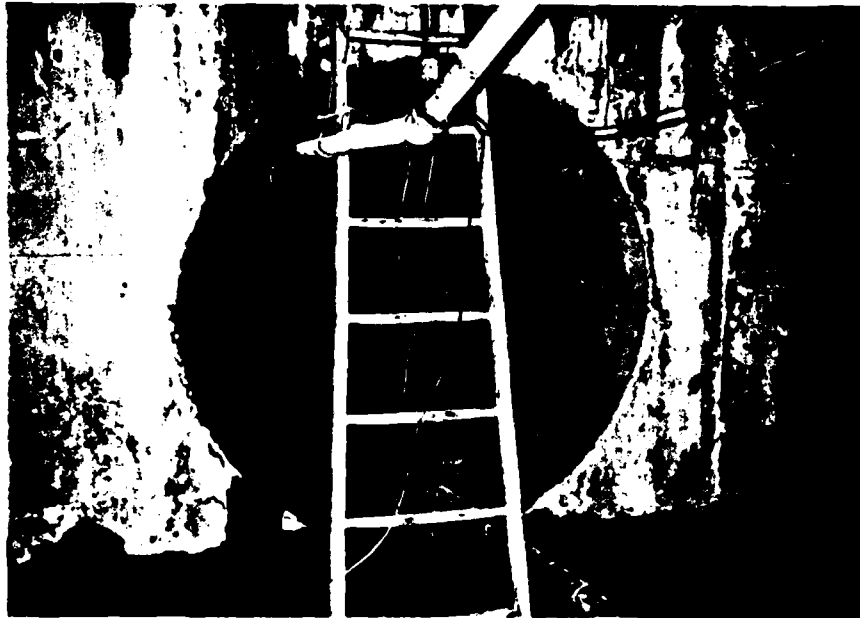
6-01 72" Influent Pipe - Delaware Street. Sometime in mid October 1981, 72-inch entrance pipe was discovered to have settled. The most obvious failure was the first joint outside the structure wall. There was approximately a 2-inch offset between the two sections at this joint. A subsequent profile of the pipe invert indicated that the lowest point was actually at the connecting collar between the existing pipe and three sections of new pipe used to connect to the structure. There did not appear to be any serious cracking or pipe failure in any joint except the first one outside the building structure. This was due to the fact that some 2 feet-9 inches of the first section of pipe is embedded in the structure wall and, therefore, could not flex. After monitoring the pipe for nearly two months, it did not appear that any more movement was taking place. There was a constant flow of water through the pipe joints that increased and decreased as the river elevation changed. Engineering Division decided the most economical repair would be to insert a 28 foot long, 66-inch diameter, 3/8-inch thick steel pipe inside the 72-inch pipe and fill the annular space with non-shrink grout. A change order was given to Indiana Construction Company to do the work. They engaged Penetryn System, Inc. from Knoxville, Tennessee to stop the flow of water through the joints by injecting a gel sealer. After this work was successfully completed, Deig Brothers Construction Company subcontracted the installation and grouting of the steel pipe. The steel pipe had to be cut into four pieces and then rewelded in the sump area due to the limiting size of the access hatch. The annular space was filled by pumping approximately 5 yards of 12 bag sand, cement

72" R.C.P. with 66" Steel Liner Installed
