AFWAL-TR-82-8029

RAIN EROSION EVALUATION AND ANALYSIS OF
SELECTED COATED MONOLITHIC POLYCARBONATE
TRANSPARENCY MATERIALS

May 1982

Final Report for Period July 1980 - December 1981

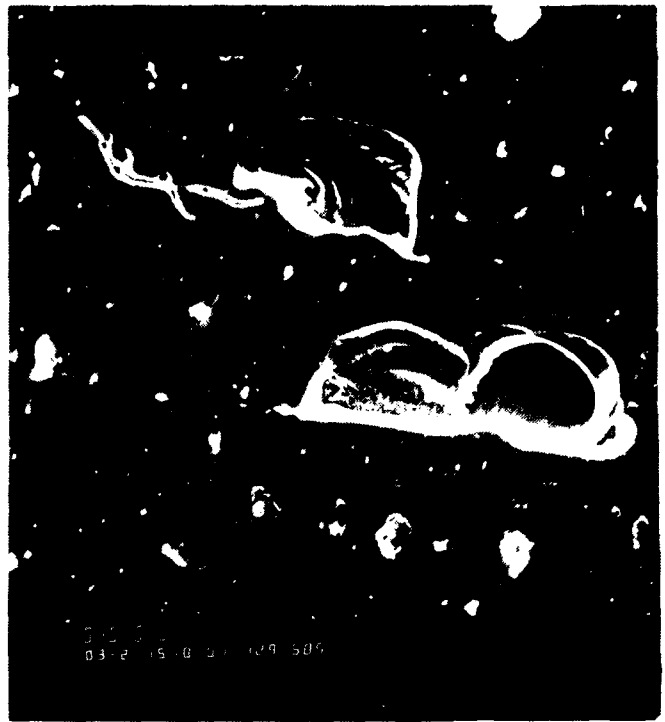
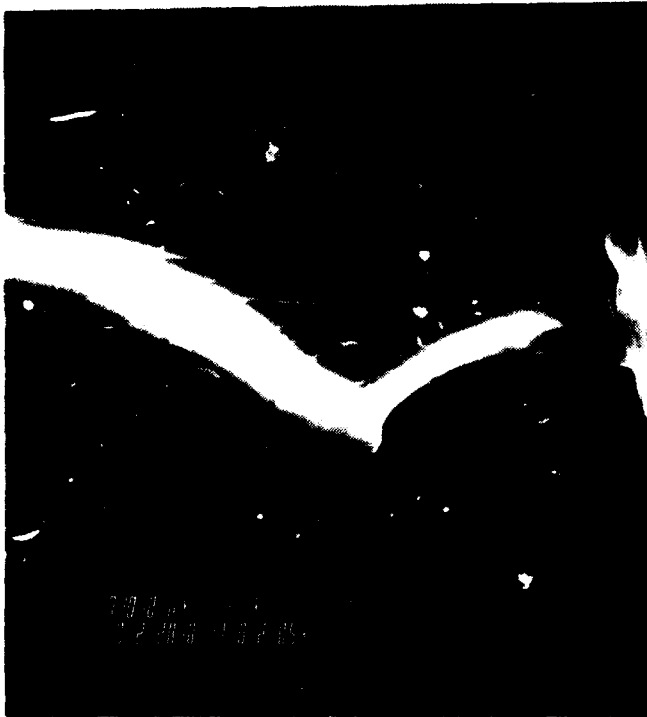
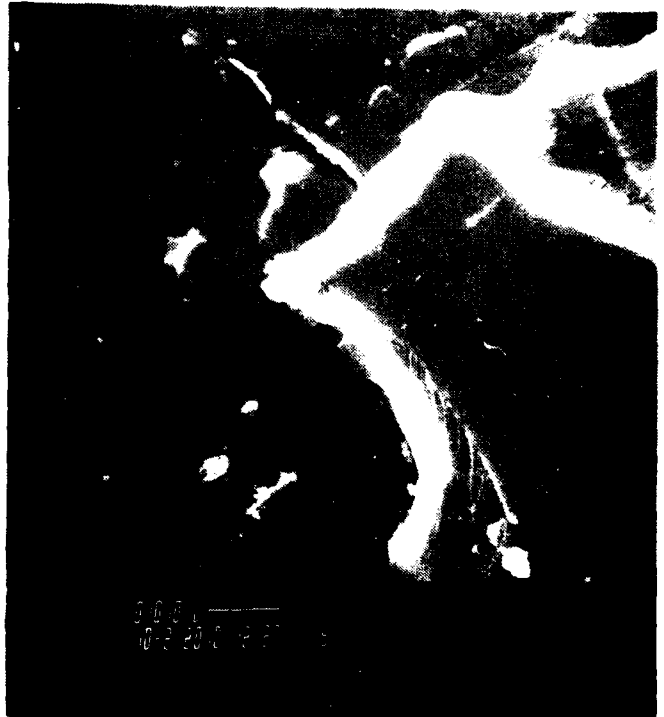
Figure B-1. Vendor P Coated Polycarbonate (No UV Exposure).

Exposure of the Vendor P non-UV exposed specimen to the previously described rain erosion test conditions resulted in coating surface damage as shown in Figure B-1. Short term exposure to rainfield conditions led to formation of localized defects in the coating surfaces up to 10 microns in diameter as shown in Figure B-1A. Further exposure to the rainfield led to the development of pits up to 30 microns in diameter at these localized damage sites and subsequently to localized coating removal (Figure B-1B). Continued exposures of five and 15 minutes to rainfield conditions resulted in substantial coating removal without introducing damage in the monolithic polycarbonate substrates as shown in Figures B-1C and B-1D, respectively.

Short-term rainfield exposure of Vendor P specimens with no accelerated UV exposure induced localized surface defects in the coating. Increased rainfield exposure time led to pit formation and localized coating removal. Further exposures resulted in substantial coating removal without introducing damage in the polycarbonate substrate. Short-term rainfield exposure of the one-year and three-year accelerated UV weathering specimens exhibited increased coating damage and coating removal, as well as localized cratering in the polycarbonate substrate at the 10 and 15-minute intervals of rainfield exposure for the one-year

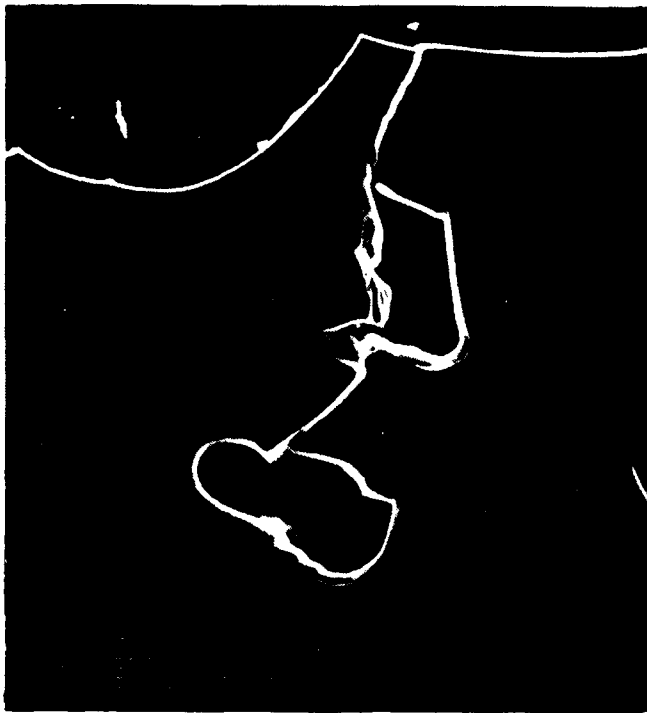
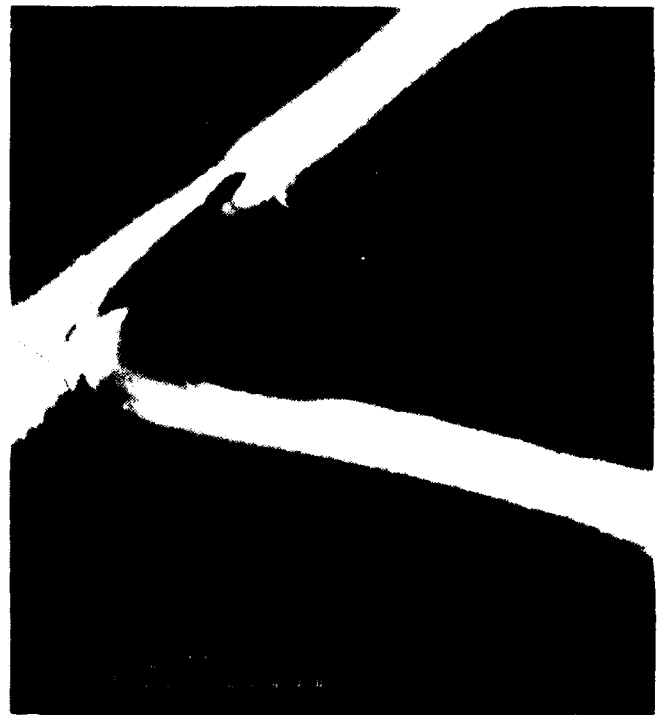
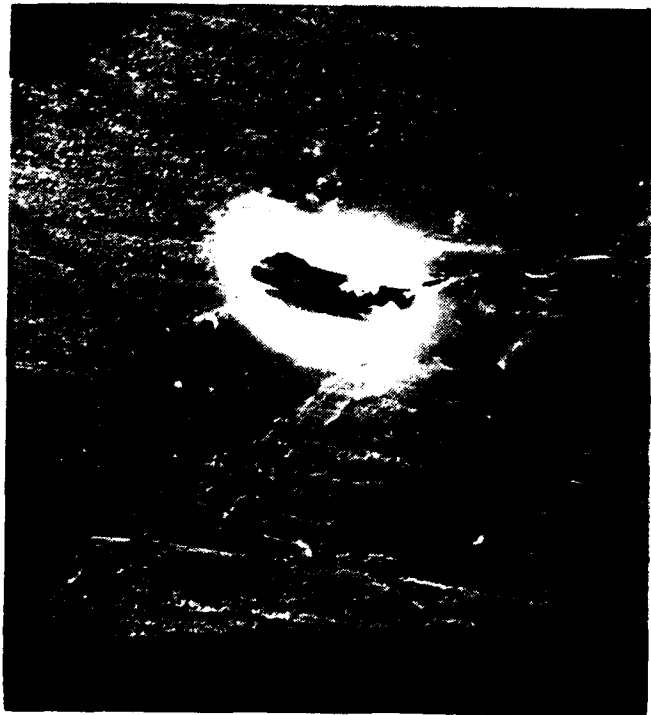
Figure B-2. Vendor P Coated Polycarbonate (1 Yr UV Exposure).

Two minutes exposure to rainfield conditions of the Vendor P one-year UV exposed specimens resulted in typical coating damage and removal, and these specimens are shown in Figures B-2A and B-2B. Further exposure to rainfield conditions resulted in progressive coating removal as well as introducing localized cratering of about 10 microns in diameter in the monolithic polycarbonate substrate as can be seen in Figures B-2C and B-2D.

exposure to accelerated UV weathering caused an increased coating removal rate as well as introducing damage into the polycarbonate substrates of Vendor P and Vendor A. These observations are depicted in Figures B-2C, B-2D, B-3B, B-3C, and in Figures B-6A, B-6B, and B-6C. These findings suggest the probability that accelerated UV weathering affected the polycarbonate substrates. Polycarbonate is known to be sensitive to UV radiation, especially in the presence of moisture as reported in References 2, 4, and 5. Consequently, the resultant reduction in adhesion of the coatings to the polycarbonate substrates at their interface led to the decrease in incubation time as well as an increase in the rate of coating removal in the Vendor P and Vendor A materials.

The propagation stage of the rain erosion process, affecting the surface coatings, occurred through the joining of the local damage events as depicted in Figure B-1B and B-2A. Continuation of the damage "growth" process of the local events resulted in the coating removal of large areas a few hundred microns in size, and subsequently from the entire area of the test specimens exposed to rainfield conditions. The results of this propagation process are clearly shown in Figure B-3A as well as in Figures B-10A and B-10B. Coating removal through the propagation stage correlated with the high rate of coating removal as shown in the S-type kinetic curves. Whenever the propagation stage of uniting local erosion events stopped, no general erosion damage, i.e. coating removal, occurred and the coating surface remained fundamentally undamaged as observed in the Vendor B materials (Figures B-8A, B-9A, and B-9D). The observation that no advanced propagation stage occurred in the Vendor B material was also reflected in the kinetic curves, where the amount of coating material removal was essentially insignificant.

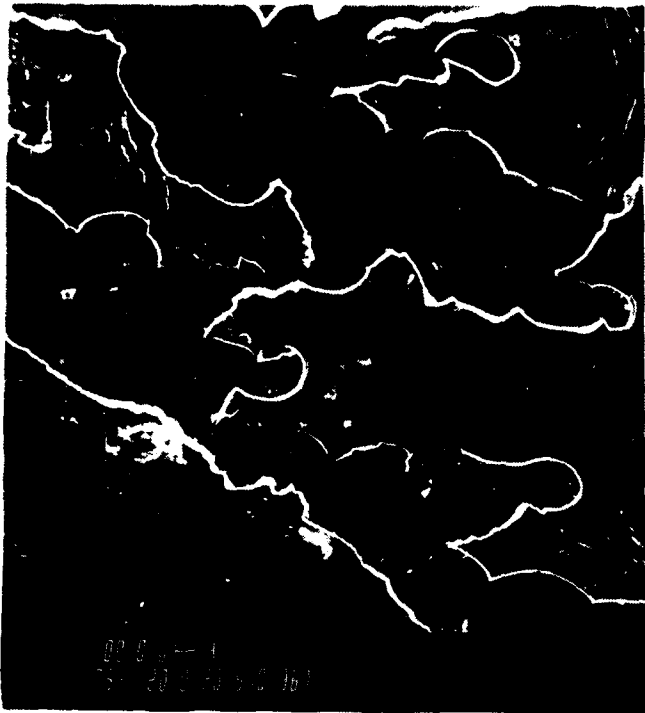
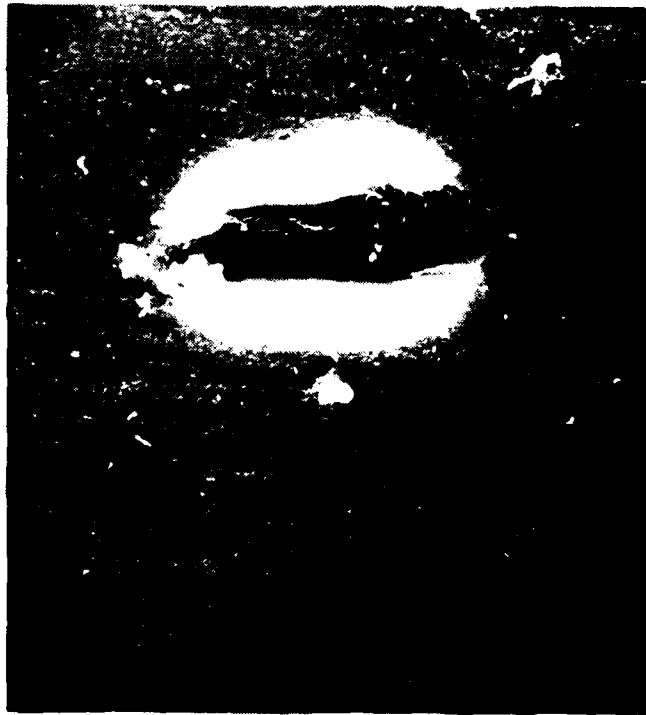
Figure B-3. Vendor P Coated Polycarbonate (3 Yr UV Exposure).

Typical surface damage of the Vendor P three-year UV exposed test specimens exposed to rainfield conditions is shown in Figure B-3. In Figure B-3A coating damage and removal from

the substrate after one minute of rainfield exposure is clearly shown. Coating damage and removal associated with damage to the polycarbonate substrate is revealed in the specimens exposed for two and 10 minutes of rainfield exposure as is shown in Figures B-3B and B-3C, respectively.

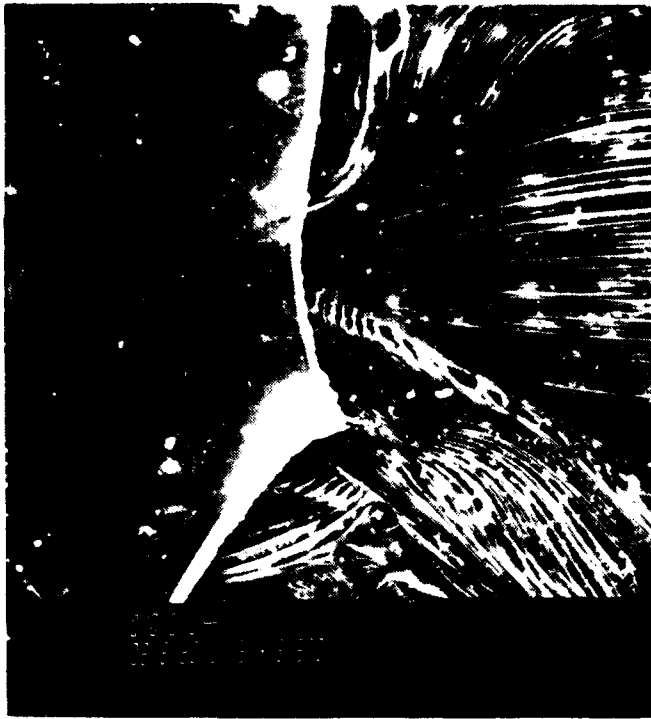
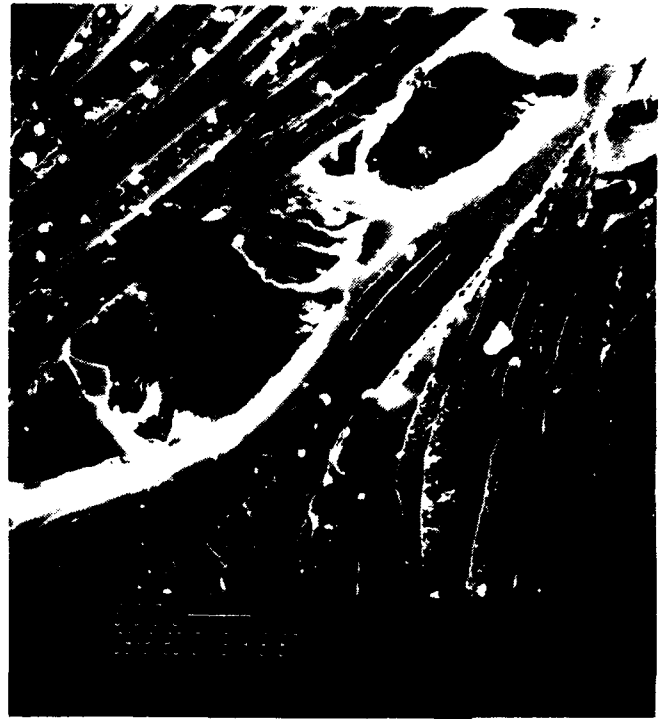
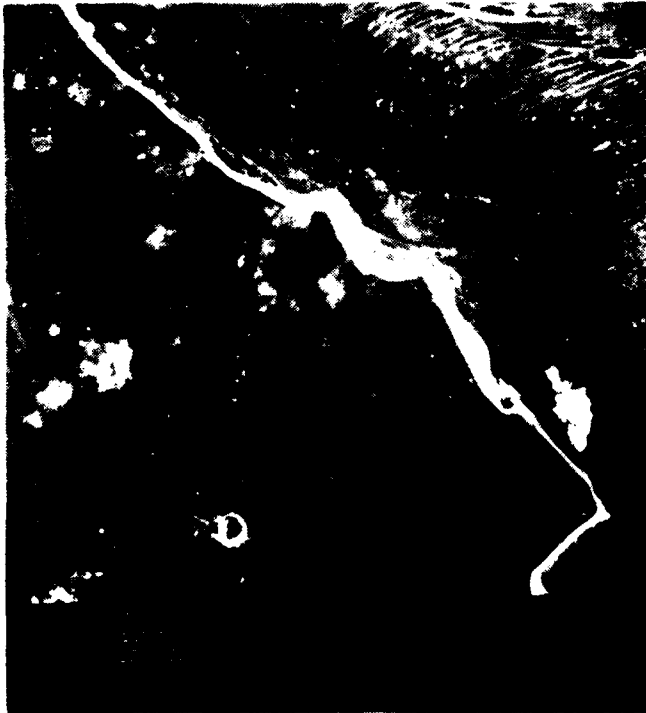
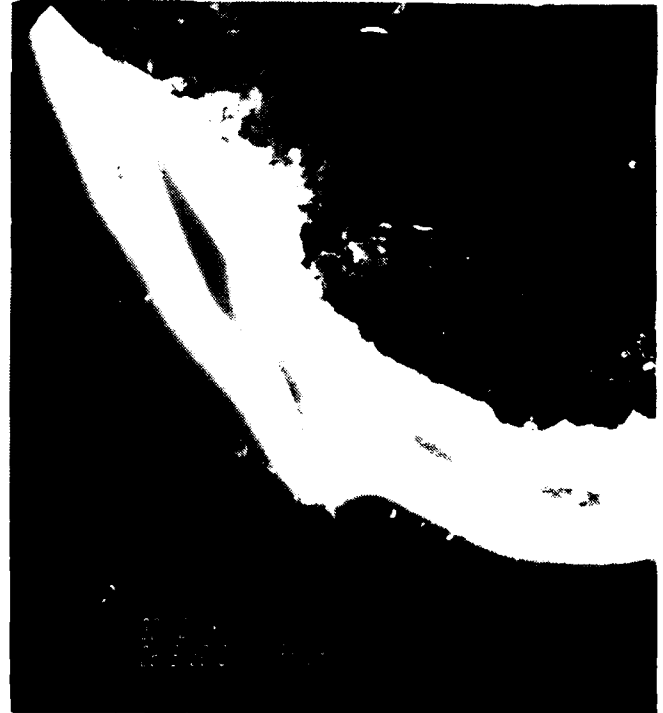
Figure B-6. Vendor A Coated Polycarbonate (3 Yr UV Exposure).

The Vendor A test specimens subjected to the equivalent of three years UV exposure and subsequently to rainfield exposure underwent surface damage as shown in Figure B-6. Coating material was removed as well as formation of elongated channels of 1 to 10 microns in width together with craters or pits up to 20 microns in diameter were detected in the polycarbonate substrate surface

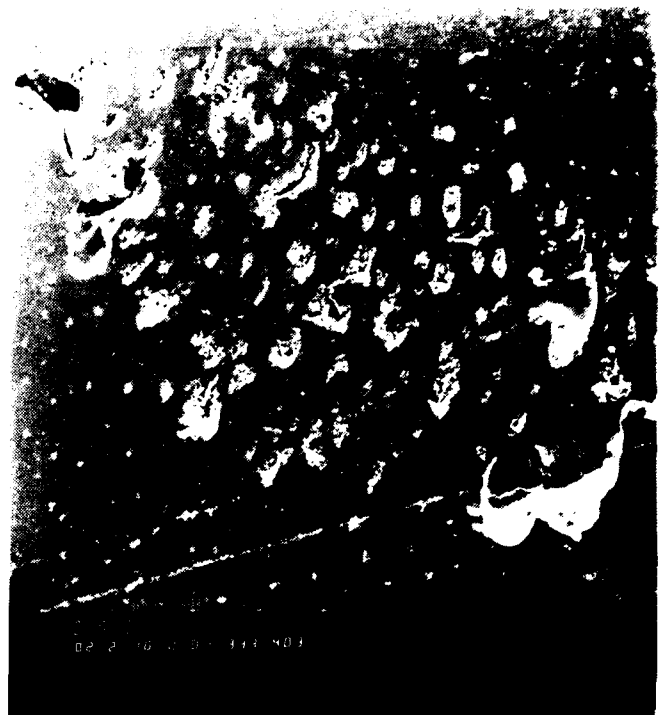
Figure B-7. Vendor B Coated Polycarbonate (No UV Exposure).

Surface morphology of the Vendor B no UV treatment test specimens is shown in Figure B-7. Rainfield exposure of the test specimens for periods ranging from 2 to 15 minutes resulted in localized erosion sites up to 20 microns in diameter as shown in Figures B-7A, B-7B, and B-7C, respectively. These erosion sites were characterized by the formation of craters or pits engendering one another (Figure B-7A) as well as micro cracks in the coating (Figures B-7A and B-7C). Furthermore, in only a few of the erosion sites was the coating completely removed from the substrate. This is depicted in Figure B-7C; however, no substantial coating removal was detected.
