*Shoreline conditions and bank recession  
along the U.S. shorelines of the St. Marys,  
St. Clair, Detroit and St. Lawrence rivers*

# CRREL Report 82-11

May 1982

Lawrence W. Gatto

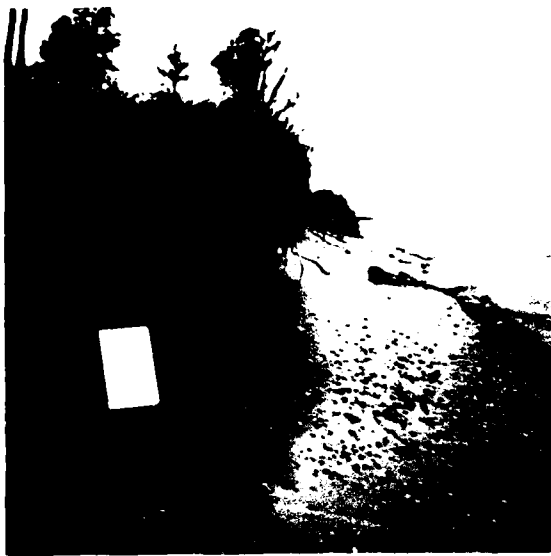
*a. Undercutting.*

*b. Collapse of overlying sediments.*

*c. Removal of slumped material.*

*Figure 2. Typical erosion sequence (St. Clair River Reach 17).*

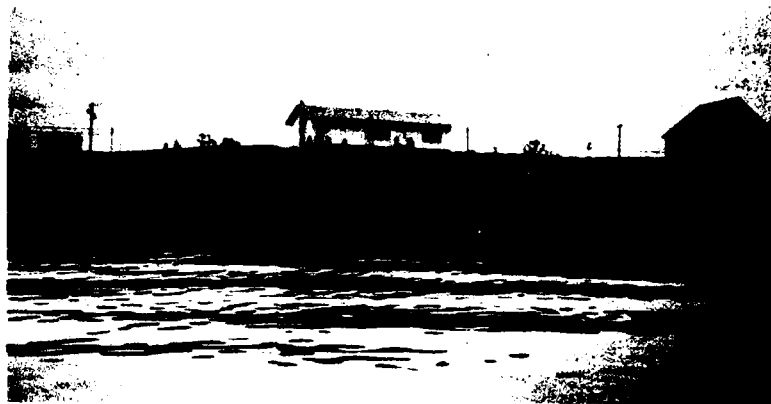
Figure 3. Gullies and rills along the bank crest and face (St. Lawrence River reach 12).

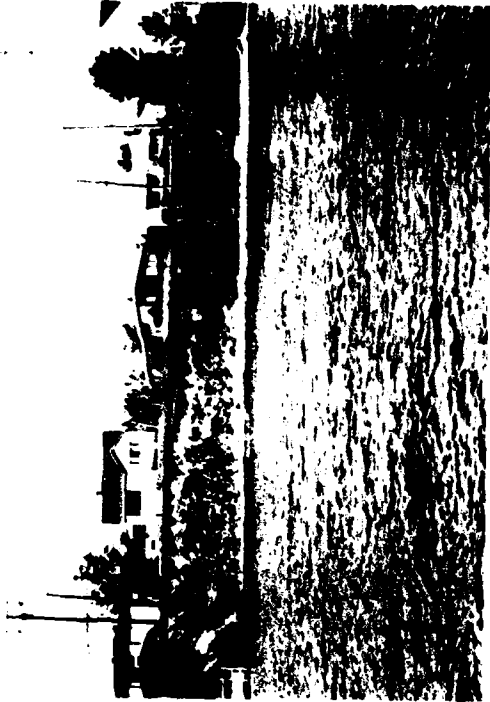
a. St. Marys River reach 16b.

b. St. Clair River reach 4a.

c. Detroit River reach 21b.

d. St. Lawrence River reach 38.

Figure 4. Partially vegetated and bare riverbanks typical of those mapped during the initial survey.

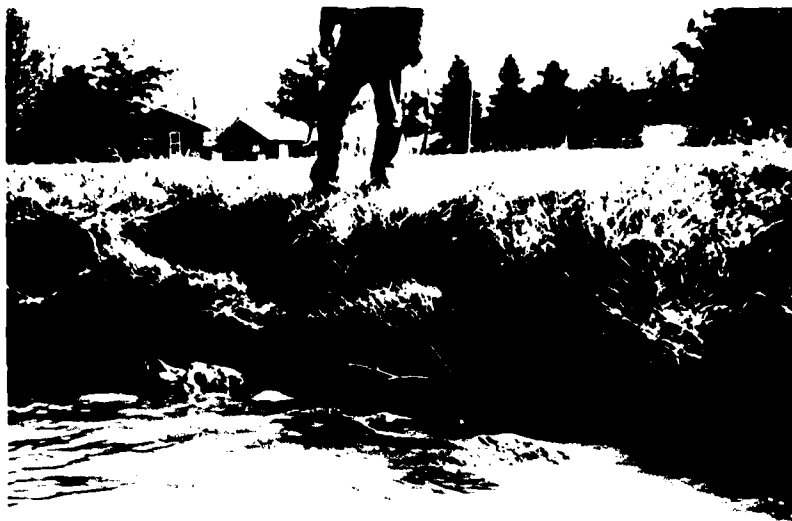
The types of bank failure along most of the eroding reaches were soil falls and slides (Fig. 7) (Code 1973). Soil falls generally result from extreme undercutting at the toe of a bank, and they usually produce vertical bank faces. Slides are due to shear failures, which result in relatively undeformed masses of soil moving along a single slide plane. These are common, especially where banks are composed of massive lake sediments or fine-grained tills. The slides along the St. Marys River are also due to the loss of support at the bank toe resulting from undercutting and material removal by river water. A few reaches show rotational slumping, and some show evidence of surface erosion (i.e. rills and gullies).

*a. Soil fall (St. Marys River reach 27b).*

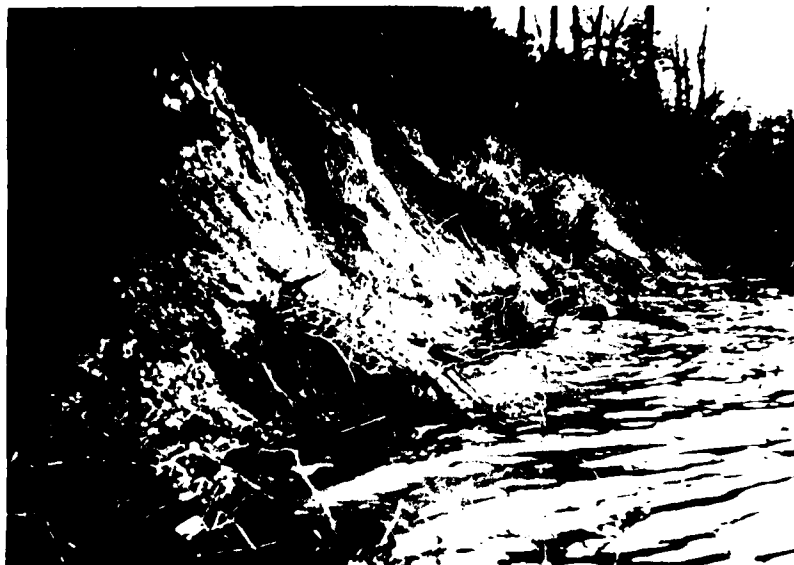
*c. Soil fall (Detroit River reach 18).*

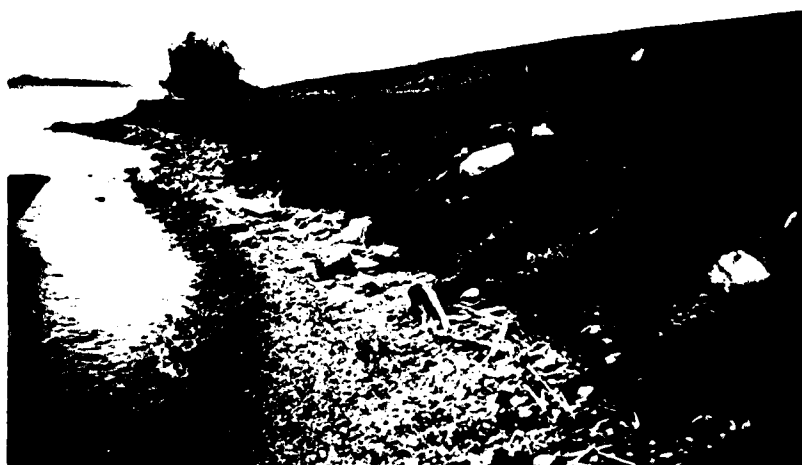
*d. Soil slide (St. Lawrence River reach 26).*

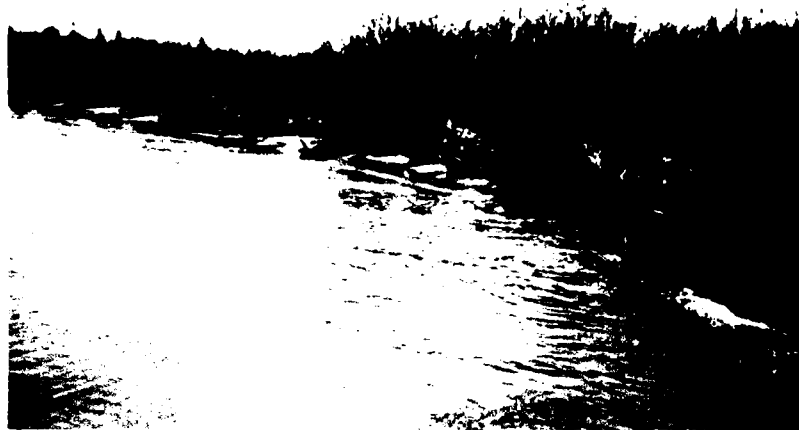
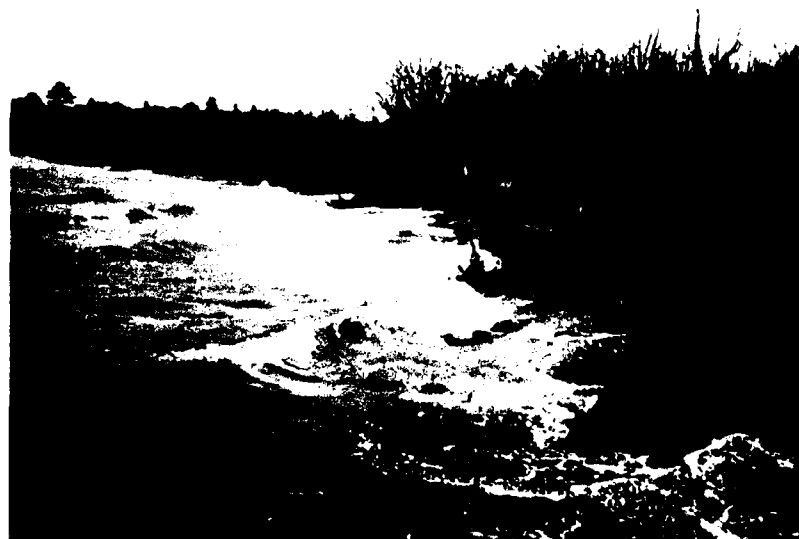
fects of ship passage. The weather was clear with a mild breeze, and there were no breaking waves along the shore (Fig. 8a). Two ships, the *Mesabi Miner* (downbound) and the *Canadian Olympic* (upbound), passed Brush Point simultaneously. The water level was drawn down, the river currents reversed, and water flowed upstream at a

noticeably higher velocity than the normal currents. Shortly after the sterns of the ships passed, the water surface rose rapidly behind an 8-inch wave to a level higher than the pre-passage level, and nearshore currents returned to a downstream flow. The velocity was still higher than

that of the pre-passage downstream currents and 6- to 8-inch waves broke while the water was at this higher level (Fig. 8b). This sequence of changes also occurred when the *A.H. Ferbert* (downbound) passed Brush Point a half hour later, but the changes were much less pronounced.

*a. Nearshore conditions prior to ship passage.*

*b. Ship-induced changes in waves.*

*Figure 8. Hydraulic effects of ship passage (St. Marys River reach 4b, 22 May 1978).*
