**THE STREAMBANK EROSION CONTROL  
EVALUATION AND DEMONSTRATION ACT OF 1974  
SECTION 32, PUBLIC LAW 93-251**

# **FINAL REPORT TO CONGRESS**

**U.S. ARMY CORPS OF ENGINEERS  
December 1981**

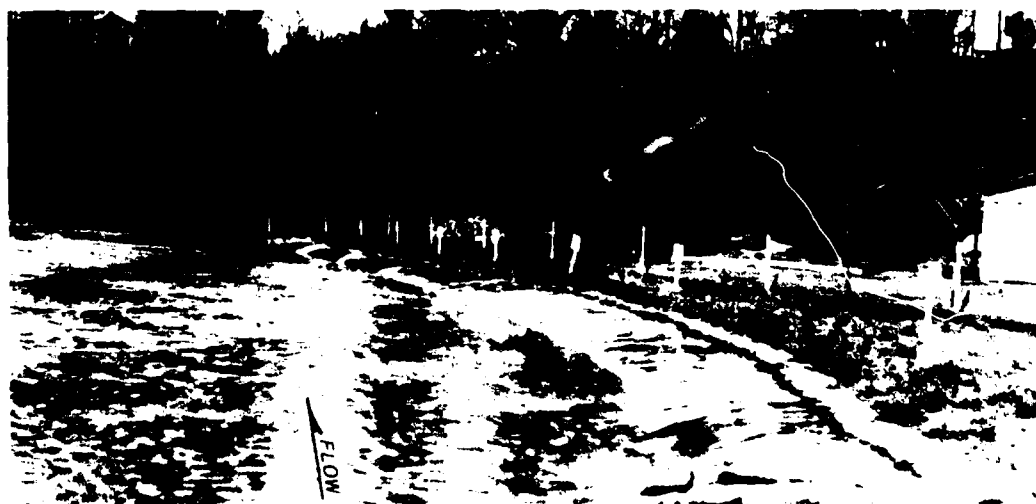
During the limited monitoring period from August 1979 through December 1980, stream velocities up to 3.9 fps and discharges up to 280 cfs tested the protection under maximum flow conditions. Two minor problems were ballooning of the membrane on the stepped-MESL item and deterioration of all sandbags; these construction problems were solved before tests were initiated at the Big Black River test site. Observations during flood conditions (Exhibit VI-16) indicated that all of the test sections on Durden Creek performed satisfactorily.

*Exhibit VI-16. Flood conditions at test site on Durden Creek*

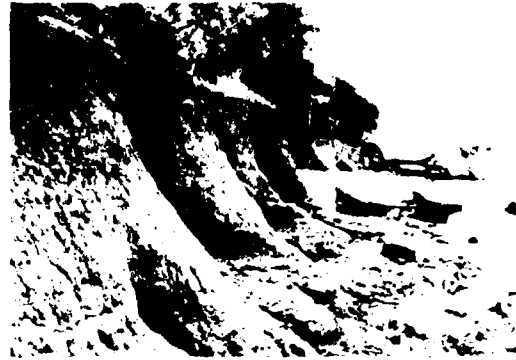
*Right bank near South Point, Ohio  
(View toward upstream, January 1977)*

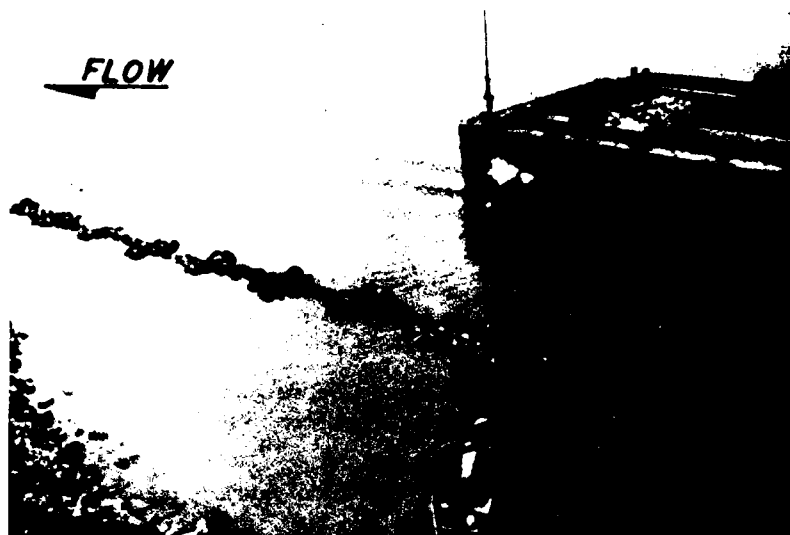
Exhibit XII-3. Floating tire breakwater, Kanawha River, West Virginia  
(damaged by debris and impacts of tow traffic)

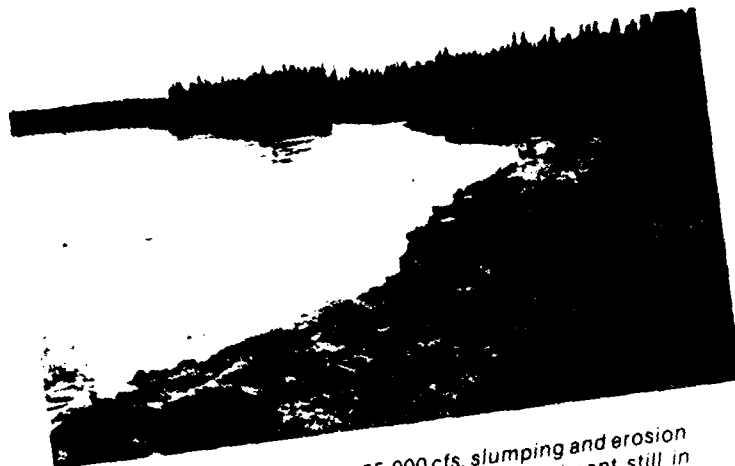
5 May 1979, discharge is 55,000 cfs, slumping and erosion of riverbank on downstream end, ice revetment still in place on upstream end

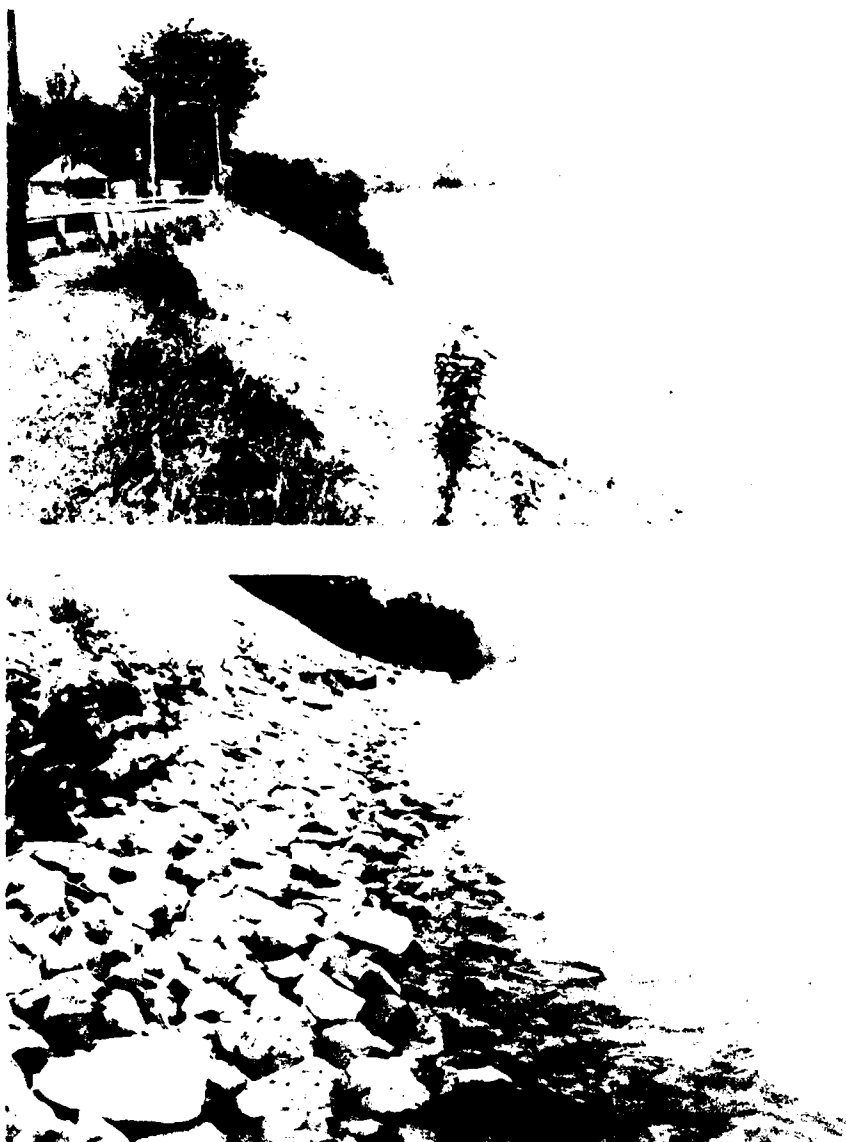
*Exhibit XIII-4. Ohio River (left bank) at Cloverport, Kentucky. Downstream view shows toe of revetment under wave attack due to passing barge traffic (19 June 1978). Typical riprap revetment constructed by the Corps of Engineers (successful)*
