# Field Experiences With Floating Breakwaters in the Eastern United States

MISCELLANEOUS REPORT NO. 82-4

JULY 1982

U.S. ARMY, CORPS OF ENGINEERS  
COASTAL ENGINEERING  
RESEARCH CENTER

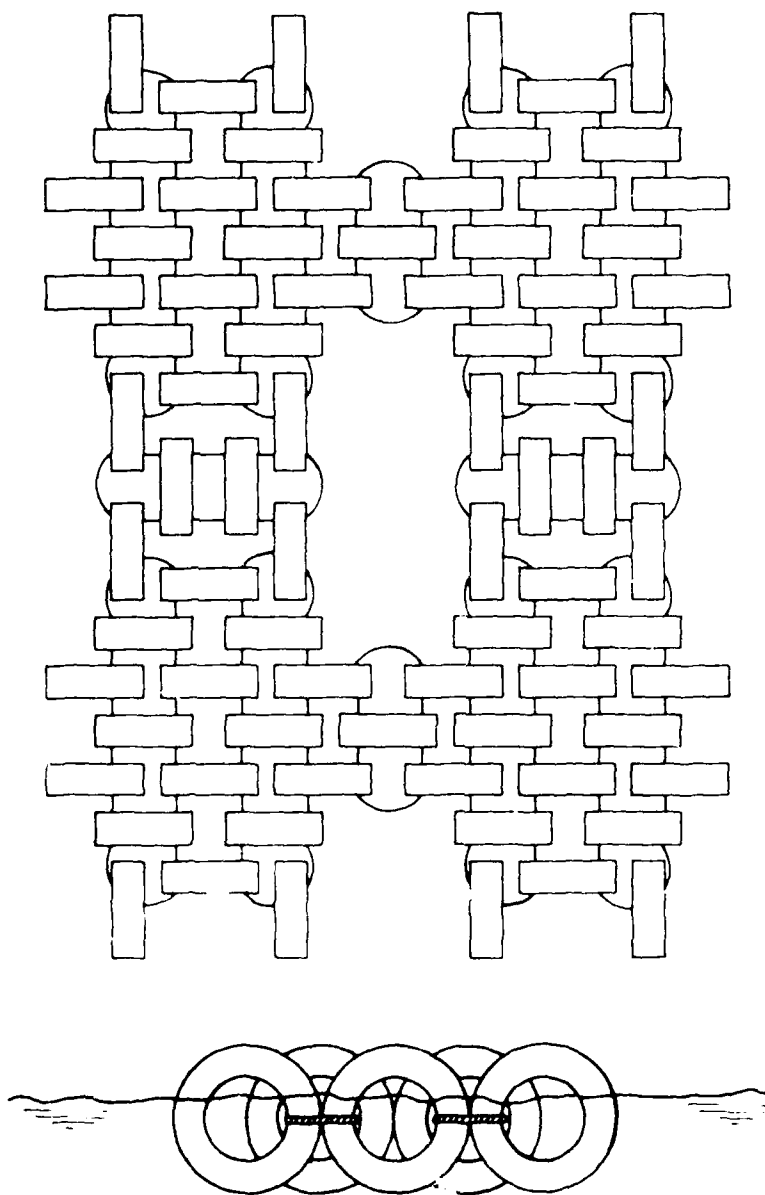
Figure 1. Goodyear FTB--top view of four connected modules (scale - 1:44, spacing between tires exaggerated) and side view of single module (scale - 1:52).

b. Inadequate Buoyancy (2.3/1.4). The original Goodyear design advocated a flotation system which relied on air trapped in the crowns of the tires and was replenished by normal wave action. By 1975, GRI researchers had determined that this system was inadequate for long-term continuous use in saltwater; nonetheless, many of the structures surveyed, including some built in the late seventies, relied on this method for buoyancy. Without exception, this system failed for structures in saltwater and often failed for those in freshwater. In saltwater, an FTB usually will be overcome by fouling growth and however much air is trapped in the tire crowns will be inadequate to prevent some, if not all, of the structure from sinking. In freshwater, the system appears to work if compressed air is regularly blown into the structure to replace that which has escaped or been absorbed into the water. Often-times, such a measure was not included in routine maintenance, particularly for unattended sites.

To overcome flotation problems, many operators attempted to insert polyethylene blocks into the tire crowns. This procedure was usually a very difficult undertaking and a stopgap measure at best. Those blocks inserted in tires on the outer modules came loose and floated away under moderate wave action. Internal tires typically retained the foam under most sea conditions, which did allow for a modest improvement in buoyancy. A more successful approach was to pour liquid polyurethane foam into the tire crowns before assembling the modules. This expanded foam formed a much tighter fit and provided much greater buoyancy. While the foam is brittle and can break, then wash out under severe wave action, this method appears to be the most successful of all methods, for both saltwater- and freshwater-based designs. The greatest drawback with poured foam is its initial expense.

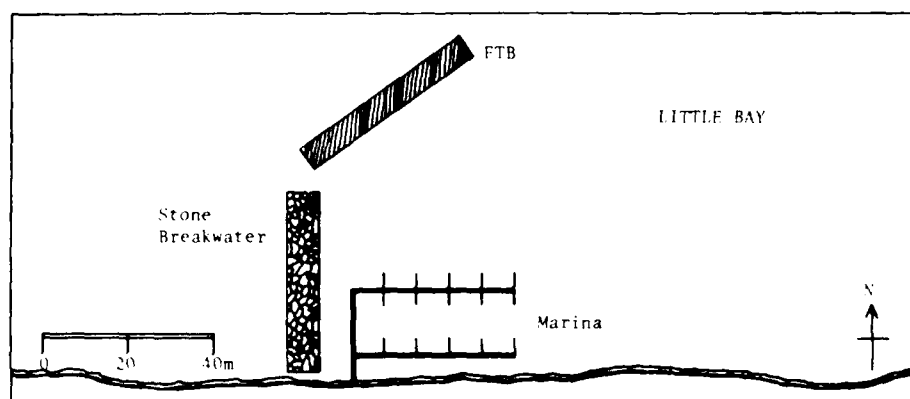
**Site:**

**Operation:** Numerous problems have been encountered in the operation of this breakwater. Litter entrapment is cited as an extreme problem. Fouling growth and inadequate buoyancy are regarded as major problems. To improve flotation which originally relied solely on trapped air, the operator later inserted polyethylene blocks into the tires. Because this repair was done while the FTB was in the water, it was a very difficult task with few blocks actually installed and little improvement made. The operator acknowledges the inadequacy of the present flotation system and notes that a much better one is needed. Anchoring system and mooring-line failures are considered moderate problems. On several instances, the anchors have dragged under strong wave and current action. Structural failure is cited as a moderate problem and instability as a minor one. Coupling failure is also considered a minor problem. Under typical storm conditions with

Project Analysis: The operator's analysis of this project appears exact. This FTB is a good wave suppressor; otherwise, it is providing but moderate performance. Inadequate buoyancy is the key problem. Although poured polyurethane foam is the best flotation system presently available, this was not the case in 1975. Anchoring system failure is also understandable considering the extreme tidal currents encountered at the site. Perhaps mushroom anchors should have been used instead of stone blocks, so that some additional resistance is met when the structure starts to shift. Finally, the specific purpose should be noted that was originally assigned this FTB--to extend the launching and haul-out periods of the marina during poor early spring and late fall weather. In this capacity, the breakwater met design goals perfectly.

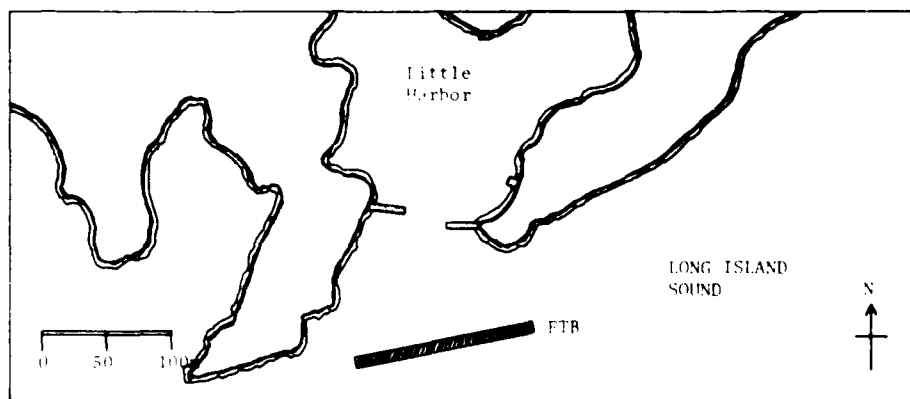
Site:

Construction: This FTB is 137.2 m (450.0 ft) in length and 9.1 m (30.0 ft) in width. The original structure relied on polyethylene blocks inserted in the tire crowns for proper flotation. After reconstruction, the breakwater relied on polyethylene scrap sealed in the tires by wire mesh and polyurethane foam for adequate buoyancy. Rubber conveyor belting fastened by nylon bolts was used to couple the tires. The operator noted that punching holes in the conveyor belting and tightening the belts was difficult.
